January 24, 2013  
Proposal No. ADCON-04-00

**North Slope Surface Drainage Monitoring and  
Inspection Report**

San Francisco VA Medical Center  
San Francisco, CA

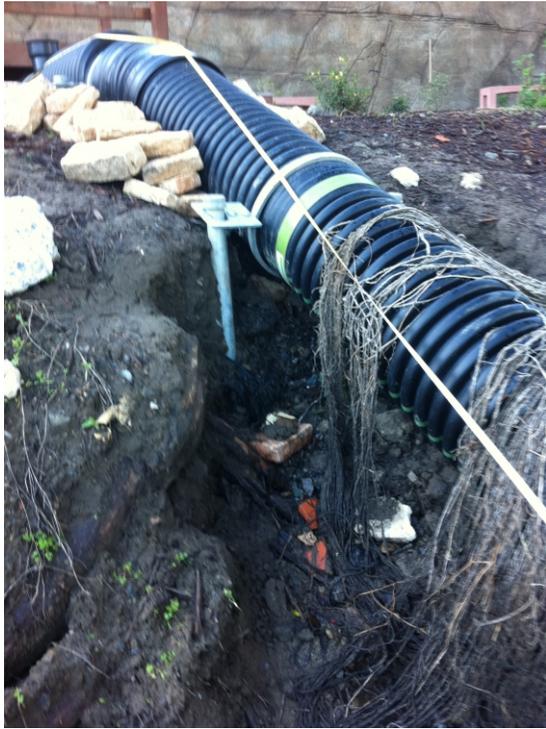
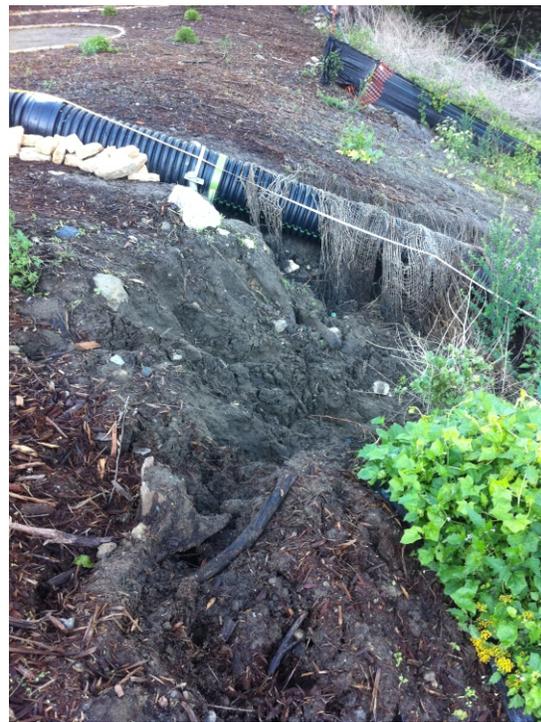
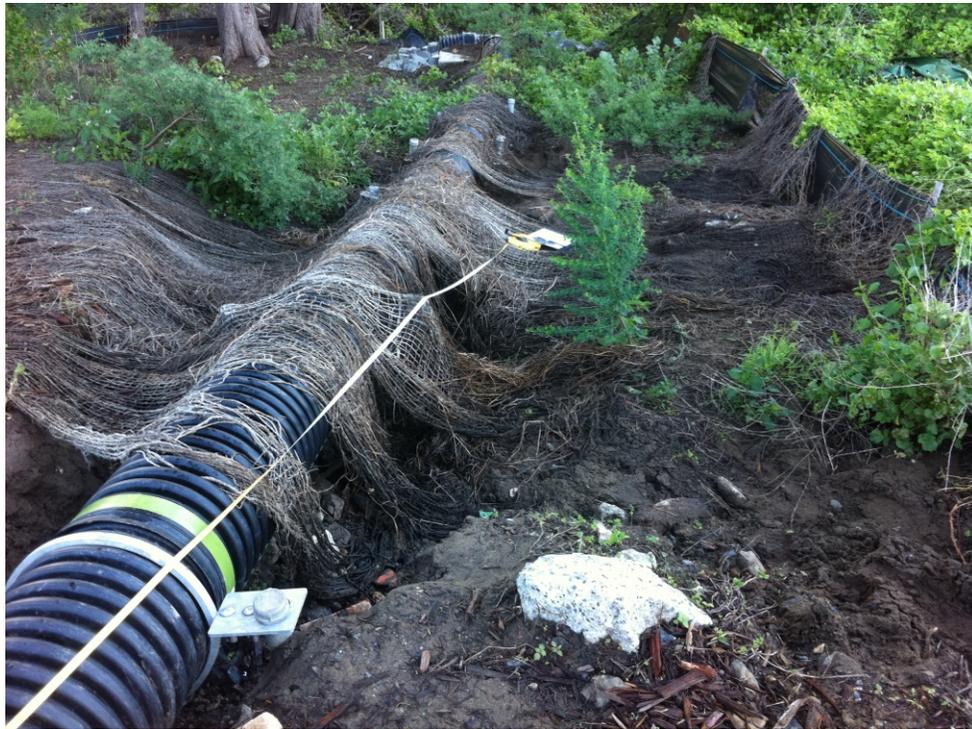
**PICTURES**

**NORTH SLOPE  
& SURFACE DRAINAGE MONITORING  
SAN FRANCISCO VA MEDICAL CENTER  
SAN FRANCISCO, CA**

During our site visit on December 18, 2012, we noticed that the ground adjacent to the wall had moved relative to the wall near the western stairways. Ground cracks indicative of the slope movement away from the wall were visible in the area around Drainage Line 1, and the western stairways.

Our measurements indicate that Outfall Line 2 moved by approximately 9 inches between August 9, 2012 and December 18, 2012. The extension of the outfall pipe was likely caused by the movement of the outfall structure which may have moved with the underlying slope. We noticed that the pipeline had pulled apart near one of the joints and the water leaking out of the disconnected pipe had resulted in the formation of a deep erosional gully. It is very likely that the slope movement got exacerbated by the infiltration of water leaking out of the pipeline into the surrounding area. Therefore Outfall Line 2 needs to be repaired immediately and should be routinely monitored for any leaks as the saturated underlying sloping ground could further move. The erosional gully could be backfilled with sand bags created by using native

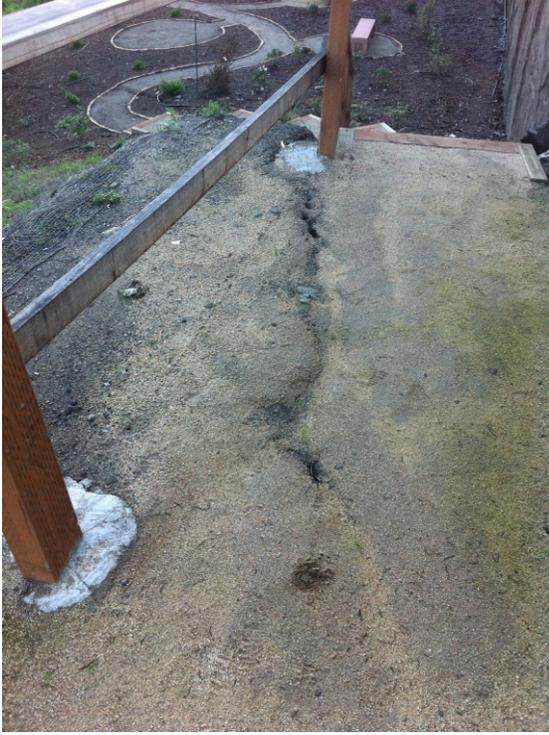
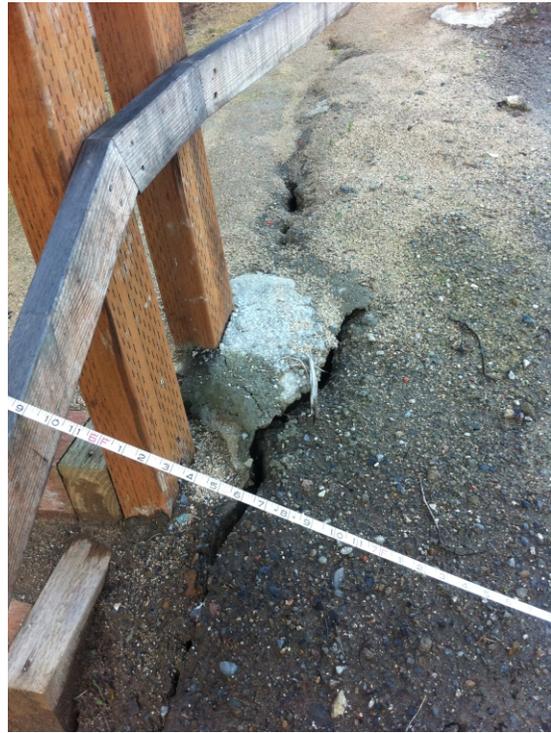
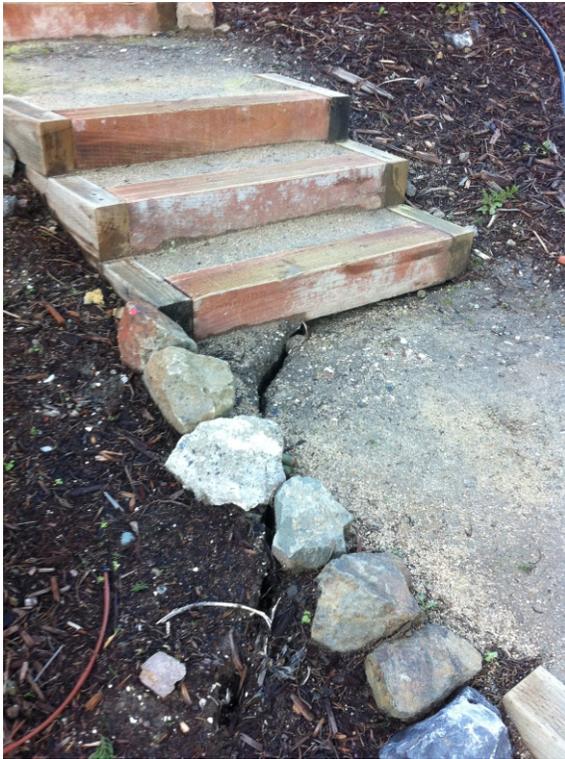
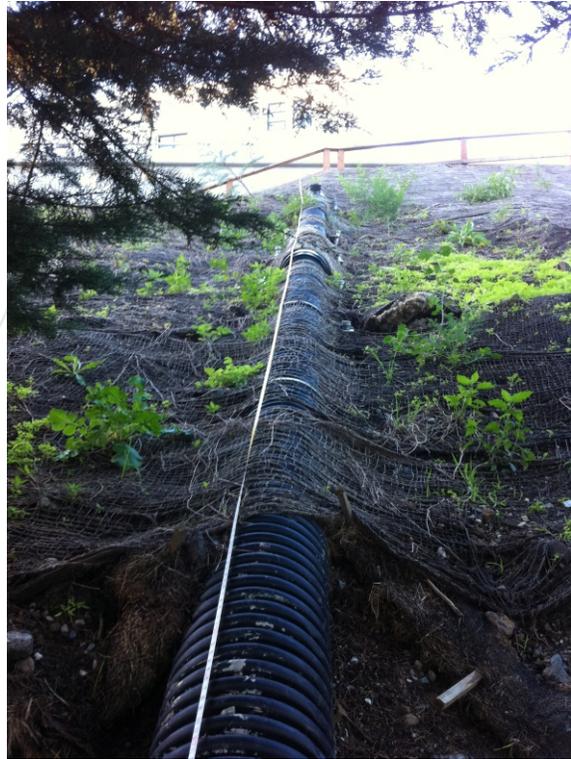
**PICTURES**

**NORTH SLOPE  
& SURFACE DRAINAGE MONITORING  
SAN FRANCISCO VA MEDICAL CENTER  
SAN FRANCISCO, CA**

Some old drainage lines were observed in the areas downhill of outfall structures associated with Drainage Lines 1 and 2. It is not clear if these lines are still functional or are abandoned. If these lines are currently functional, then they should be provided with an energy dissipation system similar to the newly constructed outfall structures, and if they are abandoned, then they should be either plugged or removed from site.

The ground cracks observed near the western stairs will allow deeper penetration of surface water runoff into the sloping ground to the north of the wall. Deeper water penetration will likely result in further destabilizing the slopes and thus need to be filled immediately.
