**Re: Lead-based Paint Inspection Report
Buffalo VA Steam Risers
3495 Bailey Avenue
Buffalo, New York 14215**

Lead-based Paint Inspection

**Buffalo VA Steam Risers
3495 Bailey Avenue
Buffalo, New York 14215**

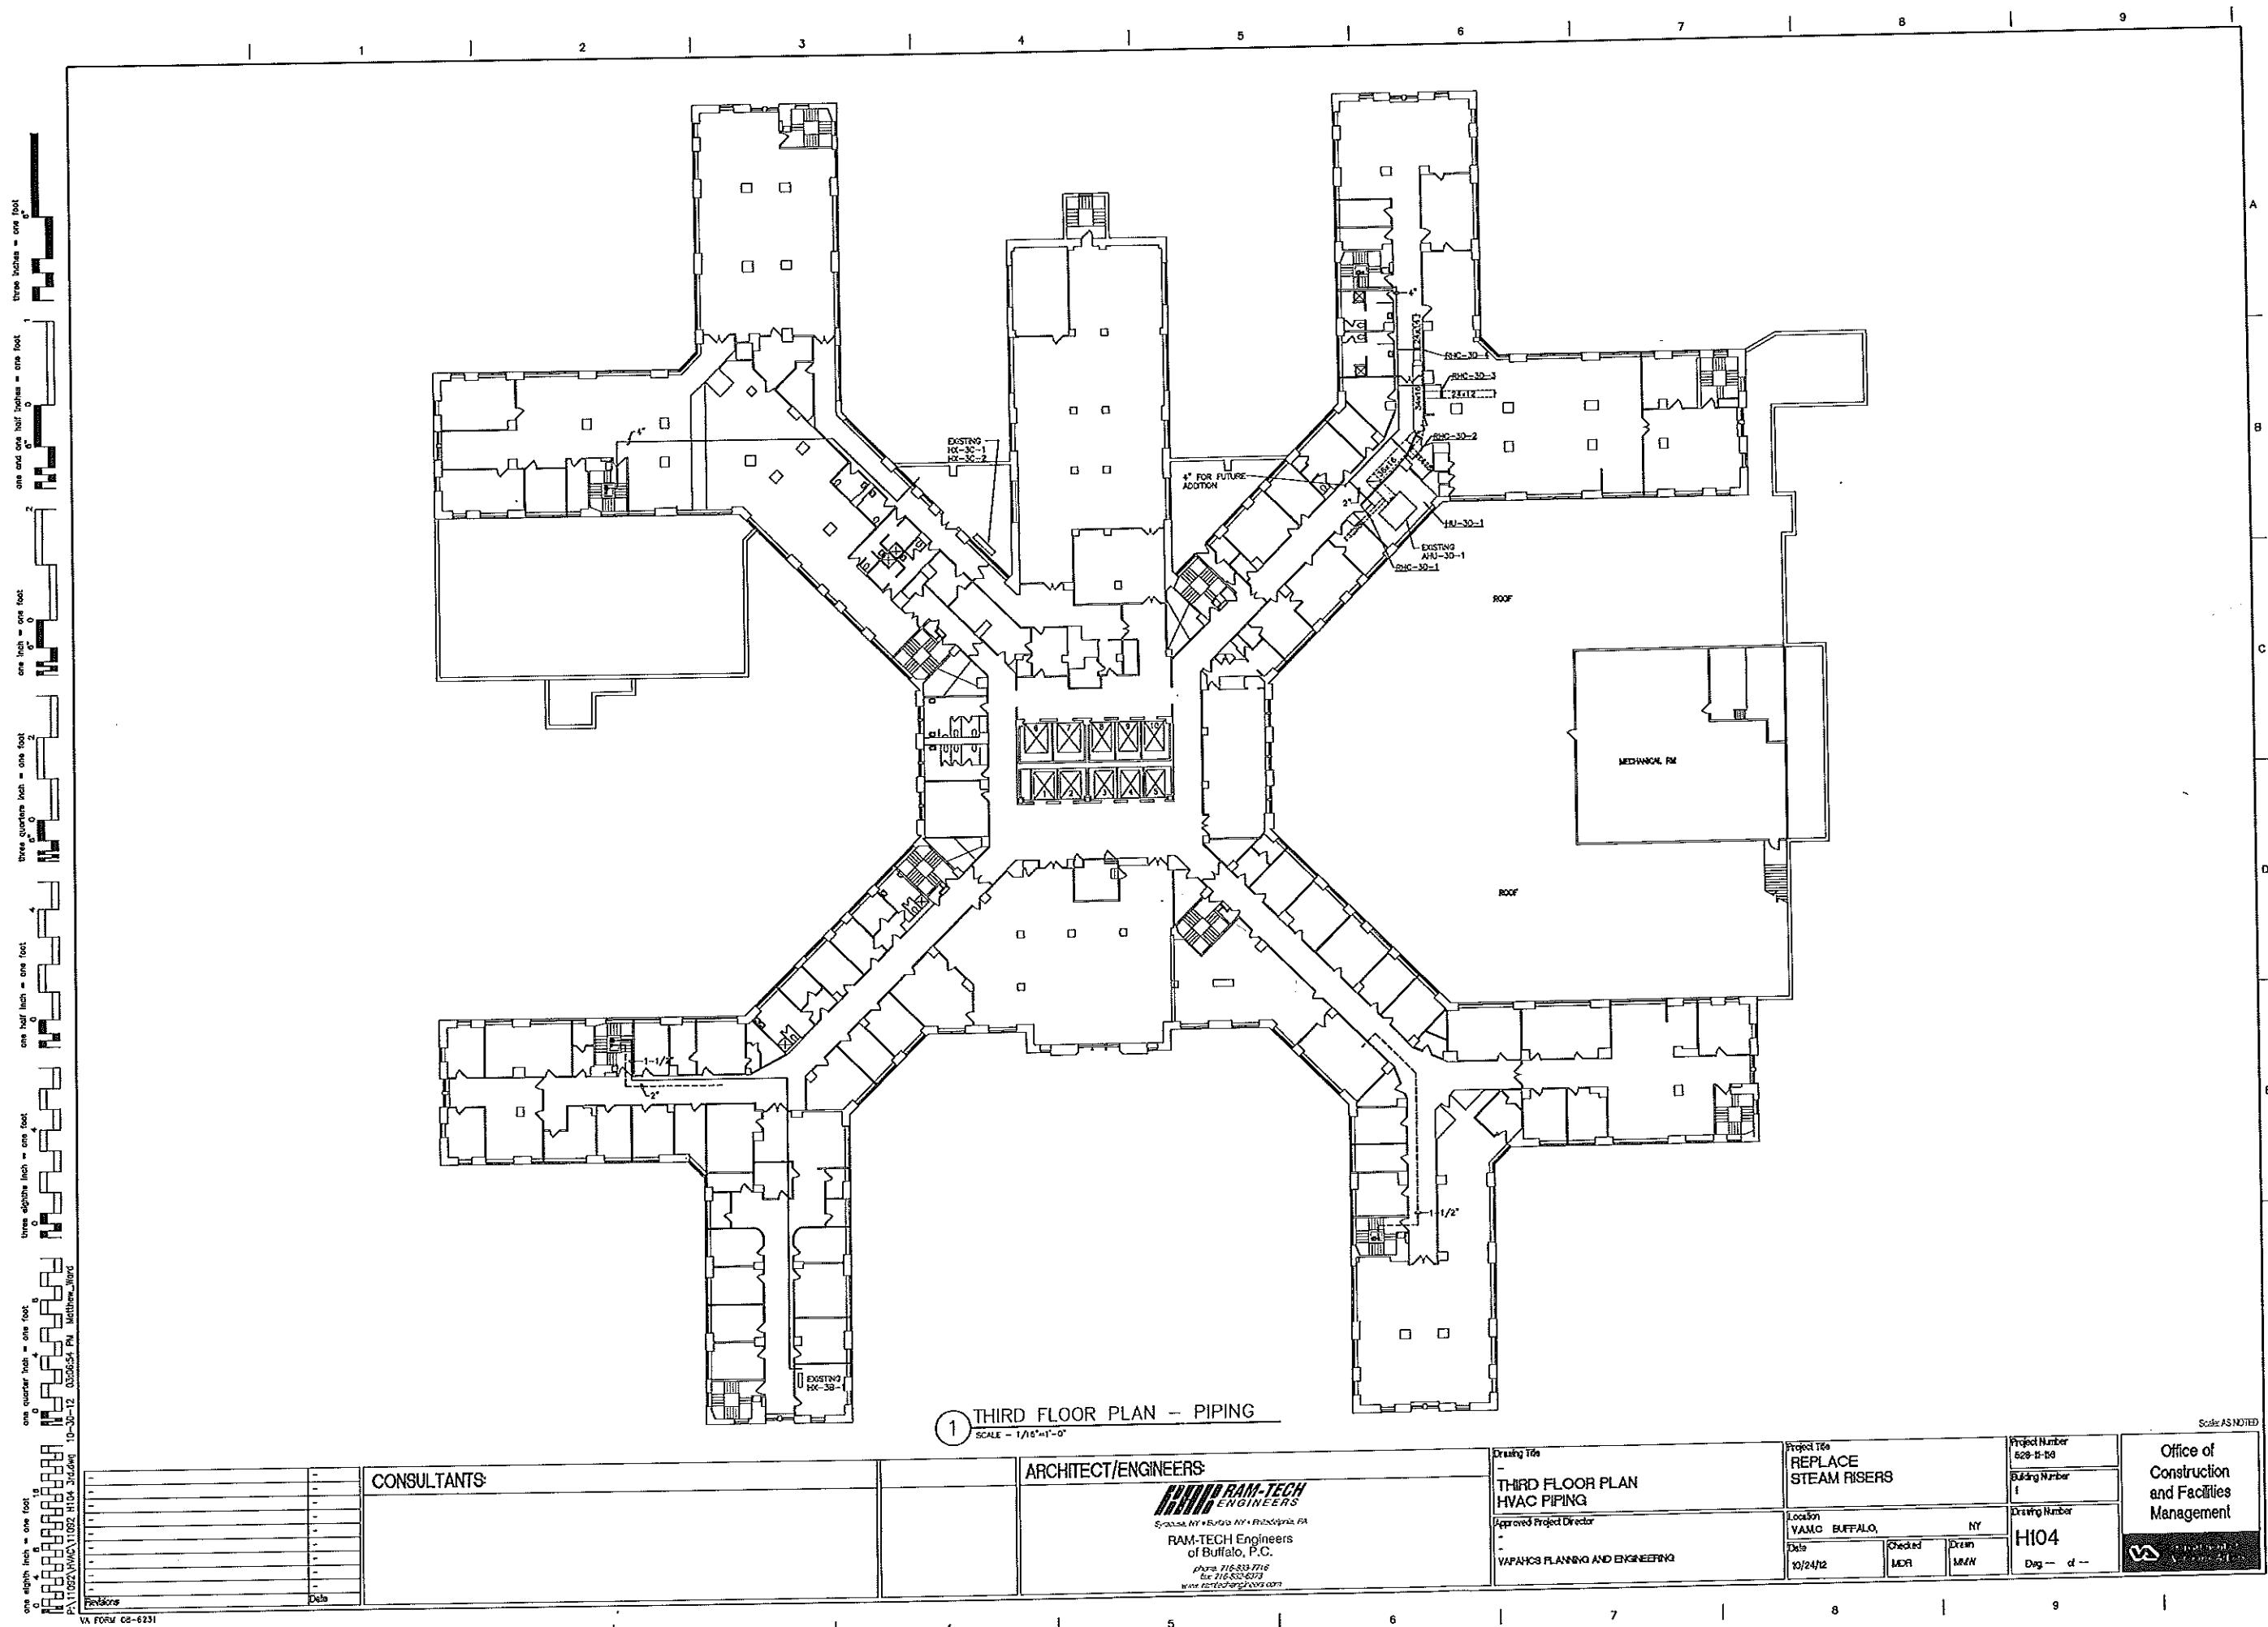
1 THIRD FLOOR PLAN - PIPING
SCALE - 1/16"=1'-0"

Drawing Title - THIRD FLOOR PLAN HVAC PIPING	Project Name REPLACE STEAM RISERS	Project Number 628-H-10	Office of Construction and Facilities Management
Approved Project Director - VAPAHO'S PLANNING AND ENGINEERING	Location VAMC BUFFALO, NY	Drawing Number H104	
	Date 10/24/12	Checked MOR	Drawn MHN
		Dwg -	d -

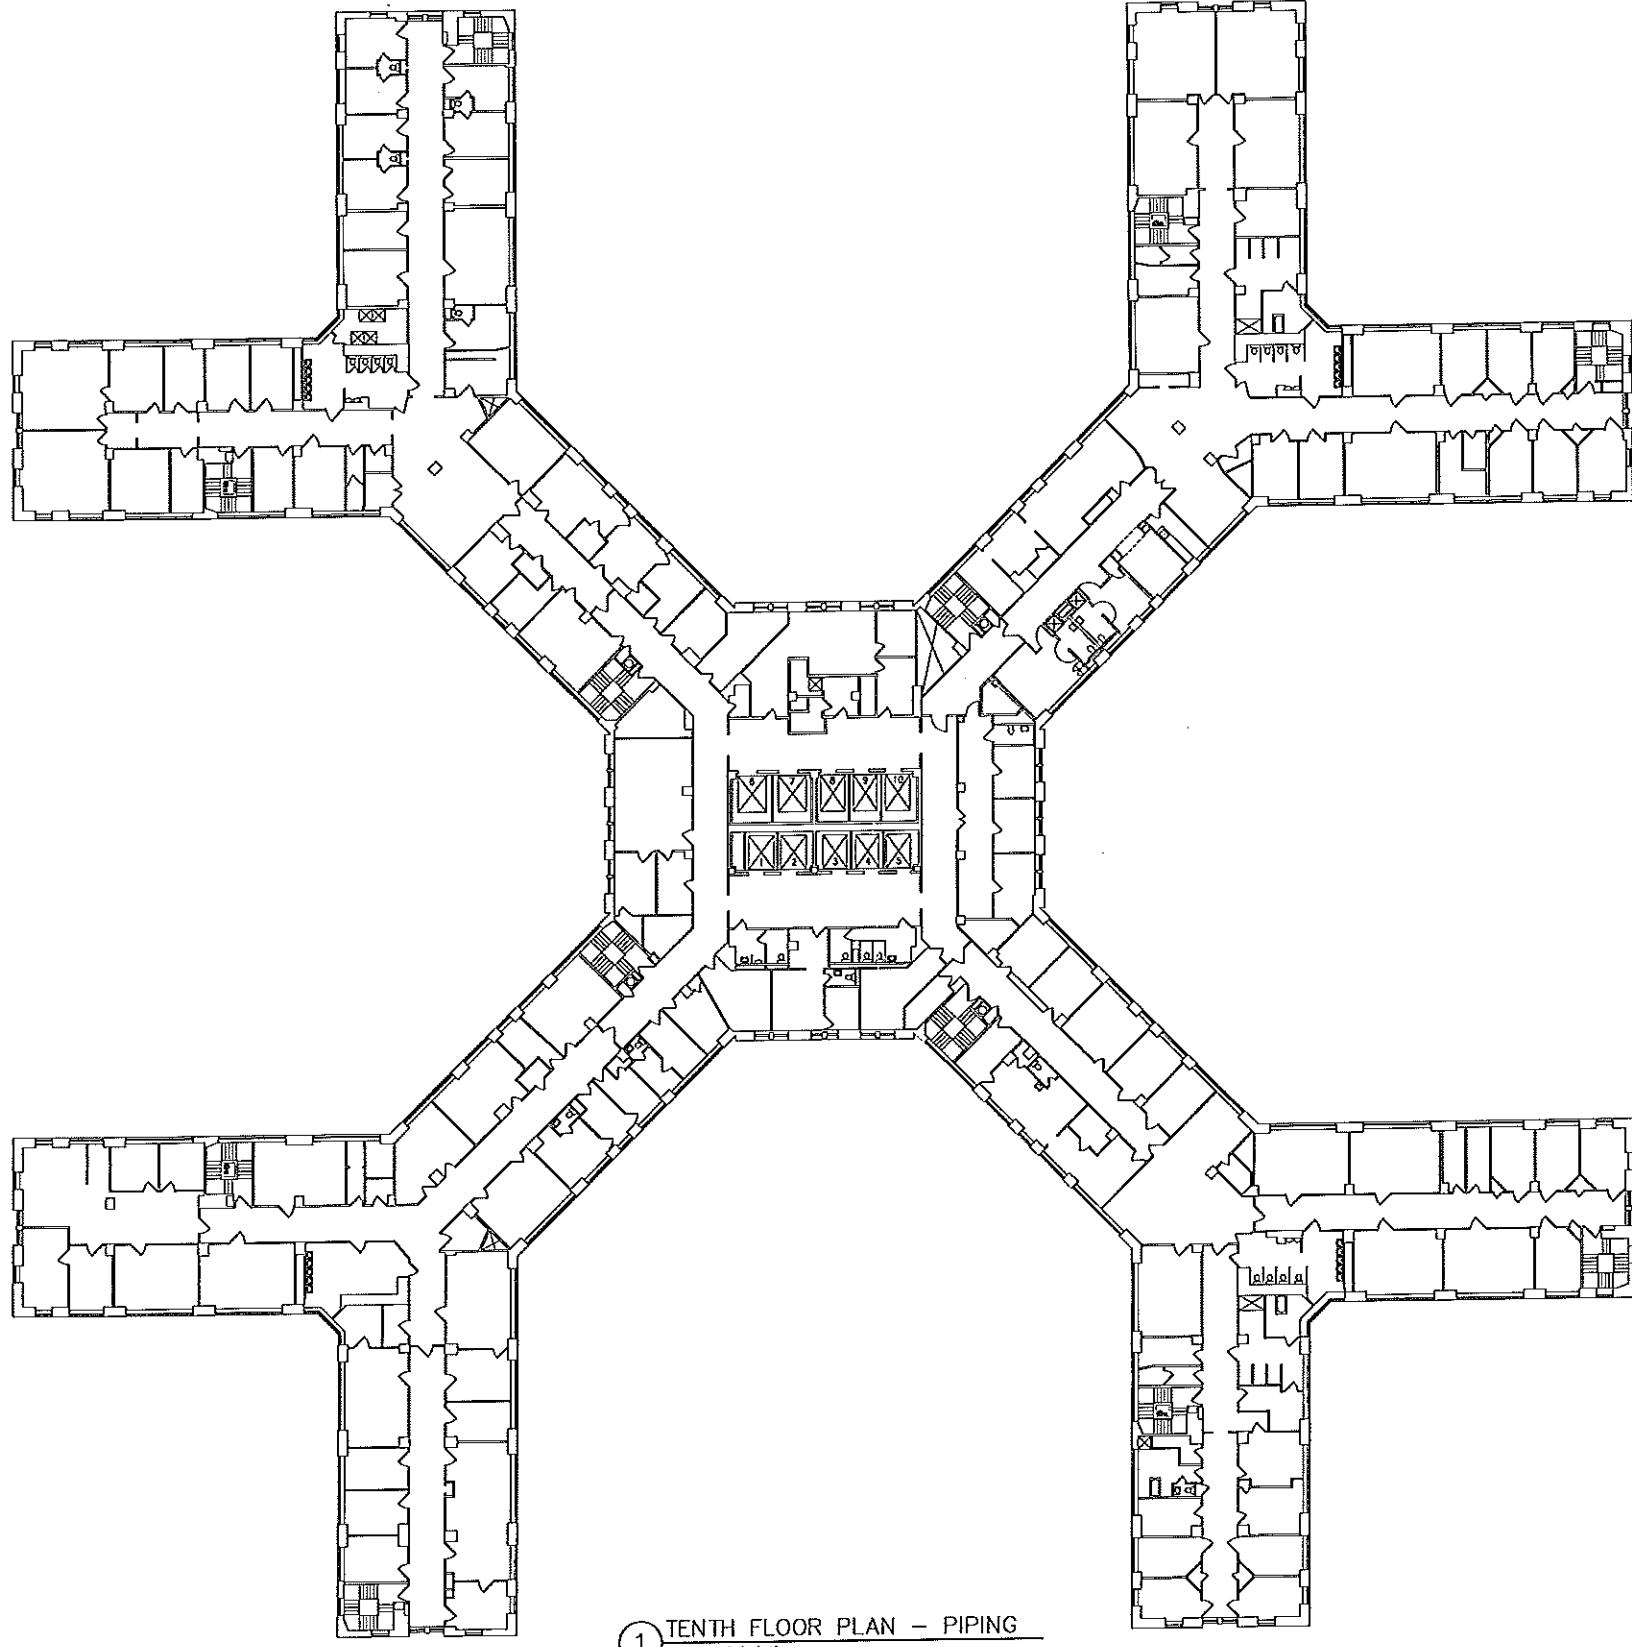
<p>TENTH FLOOR PLAN - PIPING</p> <p>SCALE - 1/16"=1'-0"</p>								
CONSULTANTS:			ARCHITECT/ENGINEERS:			Drawing Info: Project No.: REPLACE STEAM RISERS Drawing Number: 1 Location: VANC BUFFALO, NY Date: 10/24/12 Checked: MHR Drawn: MWH Approved Project Director: VAPAHCS PLANNING AND ENGINEERING RAM-TECH ENGINEERS Syracuse, NY • Buffalo, NY • Philadelphia, PA RAM-TECH Engineers of Buffalo, P.C. P.O. #16332715 Tel: 716.532.6715 www.ramtecheng.com		
Scale AS NOTED								
Office of Construction and Facilities Management
