All work associated with Phase II as outlined by the Phasing Key Plan Drawing GI-103.

ASBESTOS ABATEMENT GENERAL NOTES:

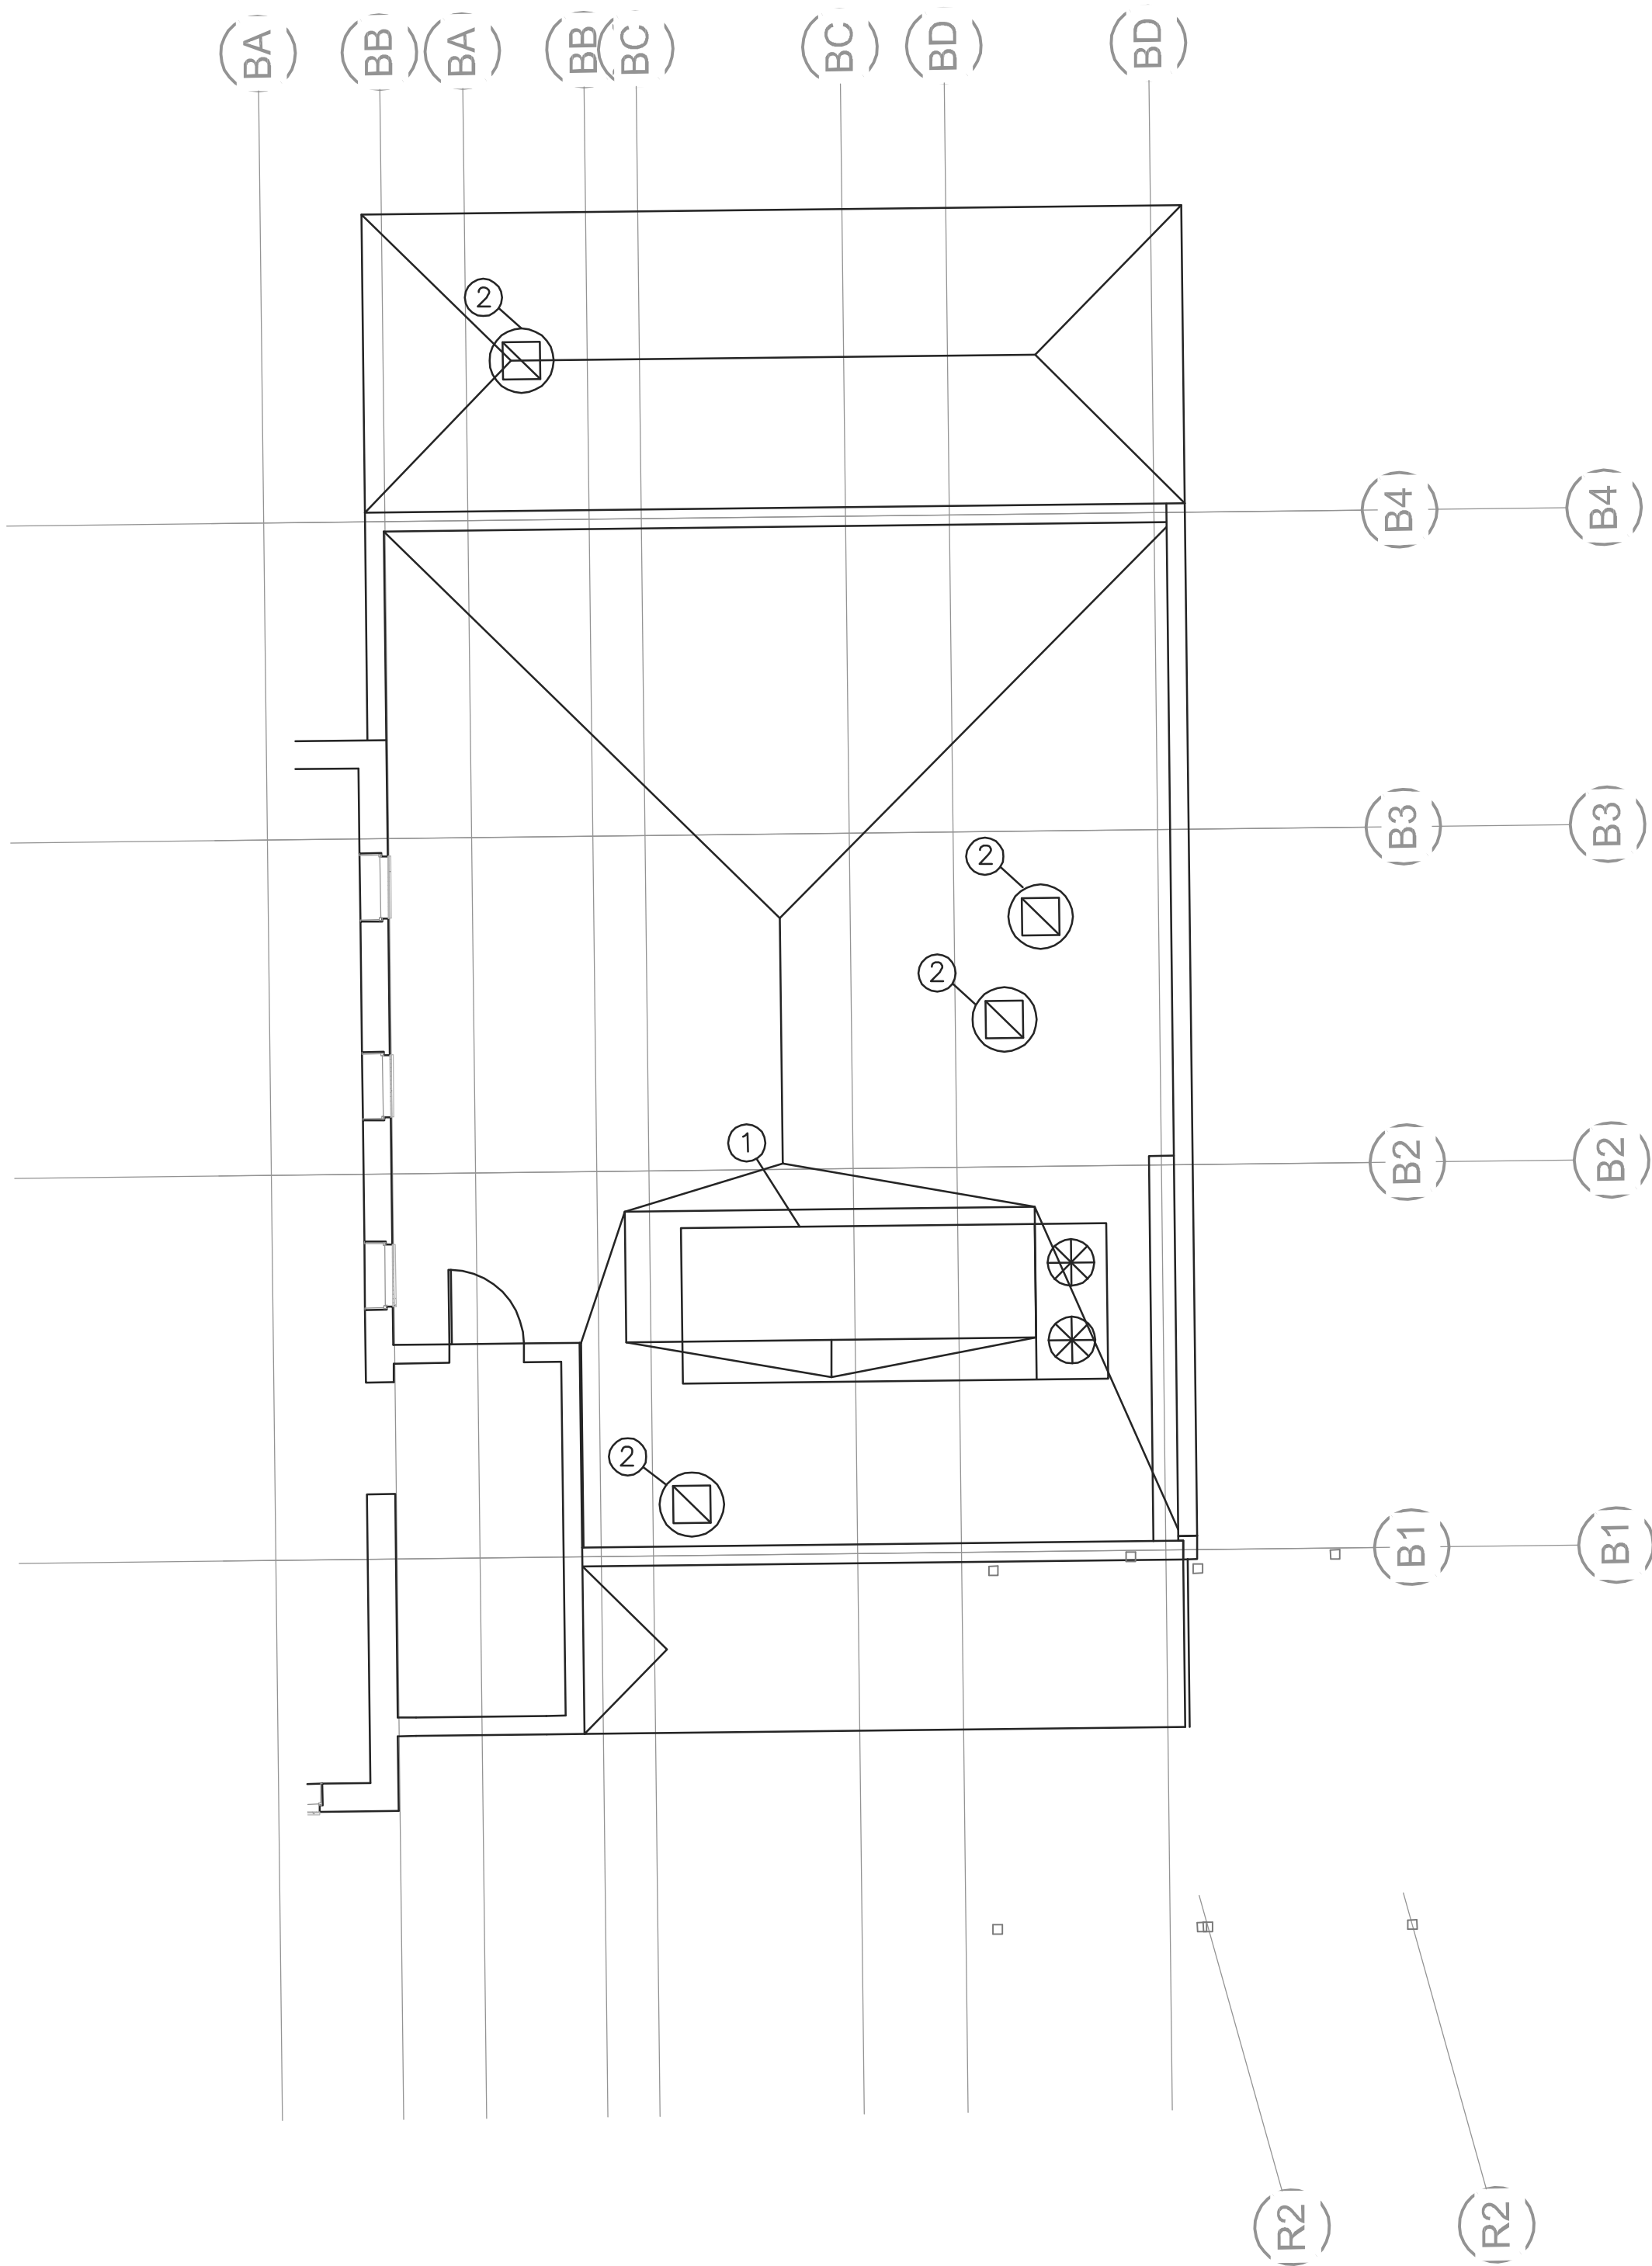
(B4) Column line associated with Building 15E

- Asbestos Containing roof flashing associated with the removal of existing rooftop air handling unit and all associated ductwork, piping and control connections. Asbestos-containing materials (ACM) flashing to be removed around perimeter of air handling unit.
- Asbestos Containing roof flashing associated with the removal of the existing fan. ACM flashing to be removed around perimeter of fan unit.

Contractor responsible to provide temporary roof to prevent water damage.

First floor data/communication roof penetration should be assumed to have asbestos containing flashing; however, area was not evaluated by NY State Inspector.
