Drawing Title ROOF DETAILS	Project Title PHASE 3 BUILDING ONE-SEISMIC CORRECTIONS AND RENOVATIONS			Project Number 672-085A	Office of Construction and Facilities Management
				Building Number 1	
Approved : Project Director	Location VA Caribbean Healthcare System 10 Casia Street, San Juan, PR 00921-3201			Drawing number AS6-206D	
	Date 06/12/2015	Checked by Checker	Drawn Author	0

Department of Veterans Affairs

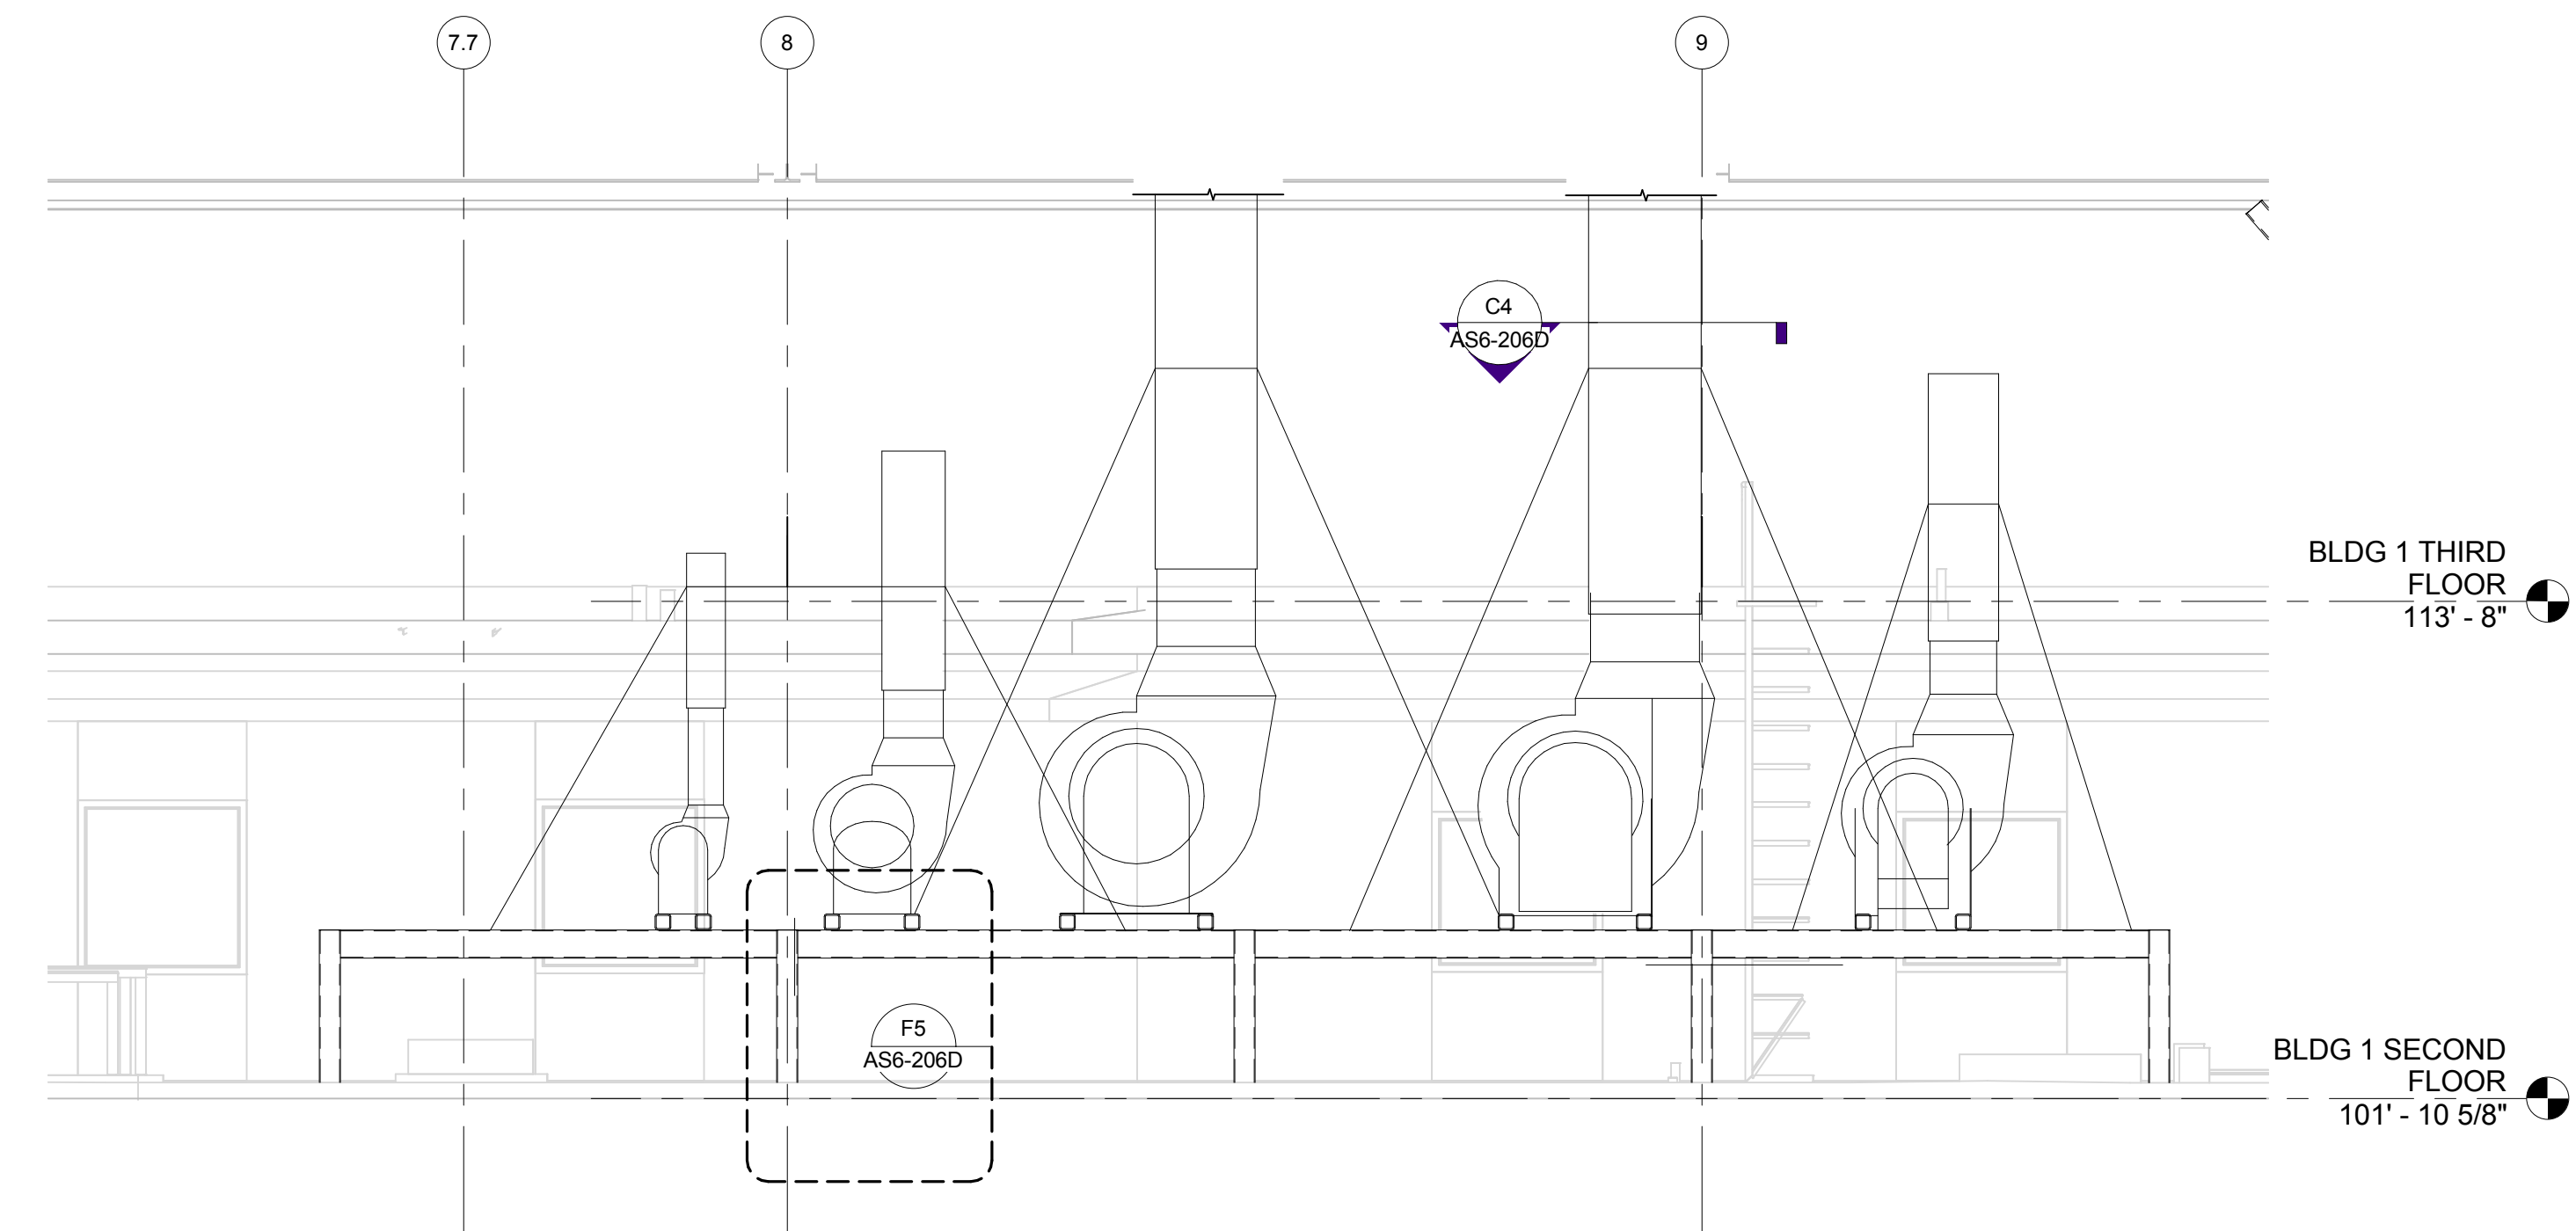
B1 SECOND FLOOR ROOF EQUIPMENT ELEVATION STRUCTURE DETAIL
1/4" = 1'-0"

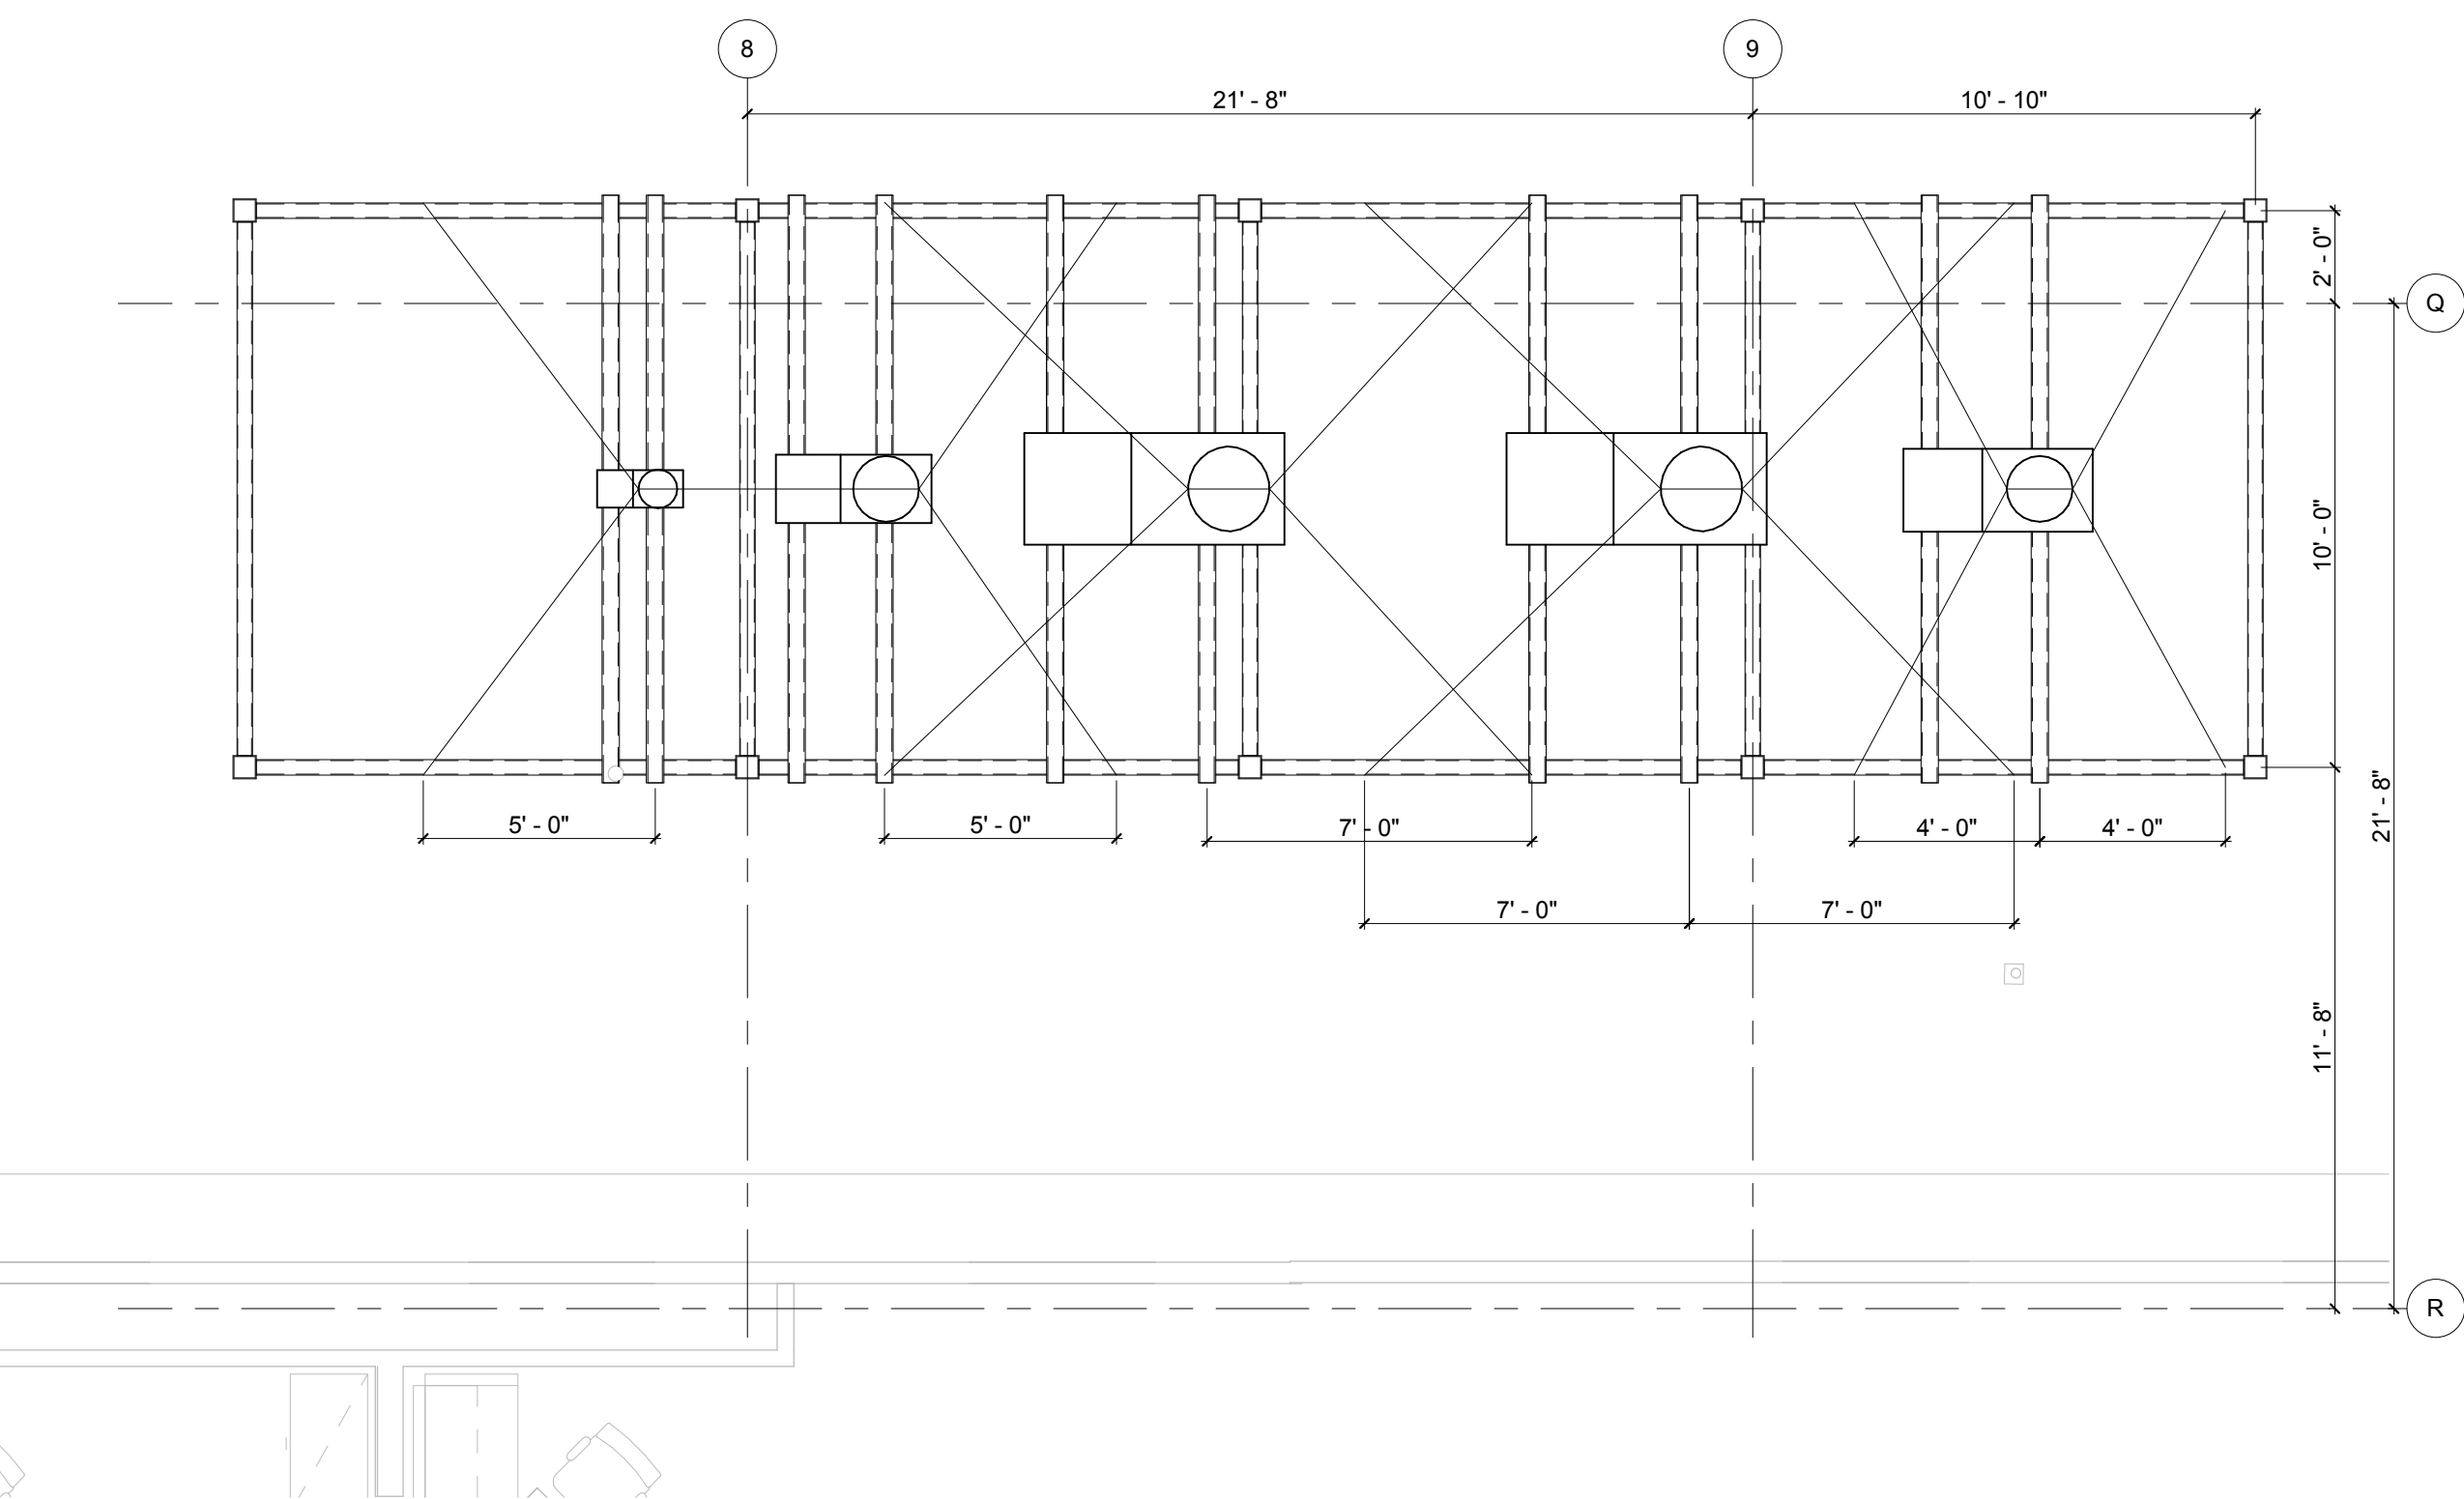
F1 SECOND FLOOR ROOF EQUIPMENT PLAN STRUCTURE DETAIL
1/4" = 1'-0"

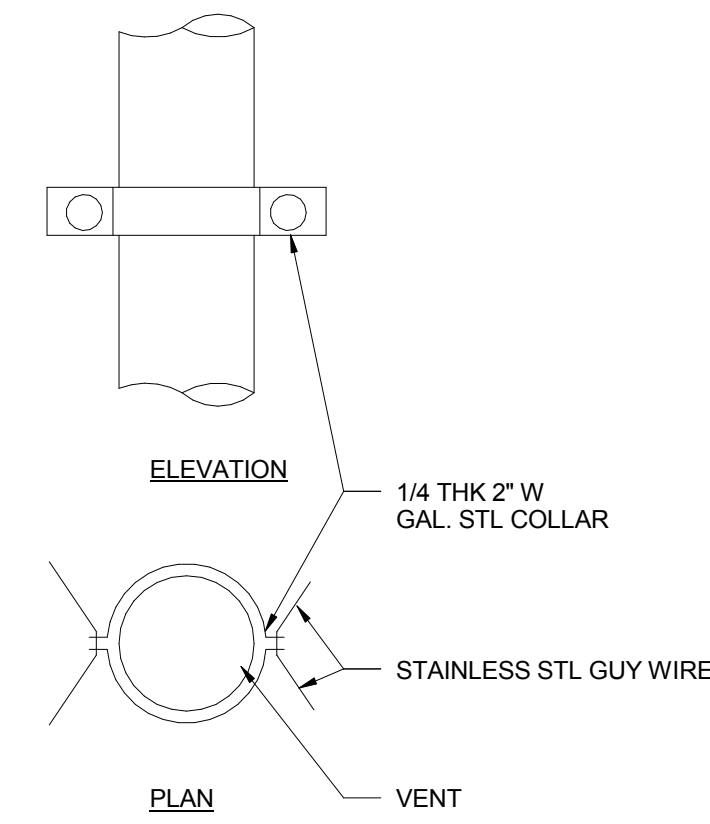
C5 VENT SUPPORT DETAIL
1 1/2" = 1'-0"

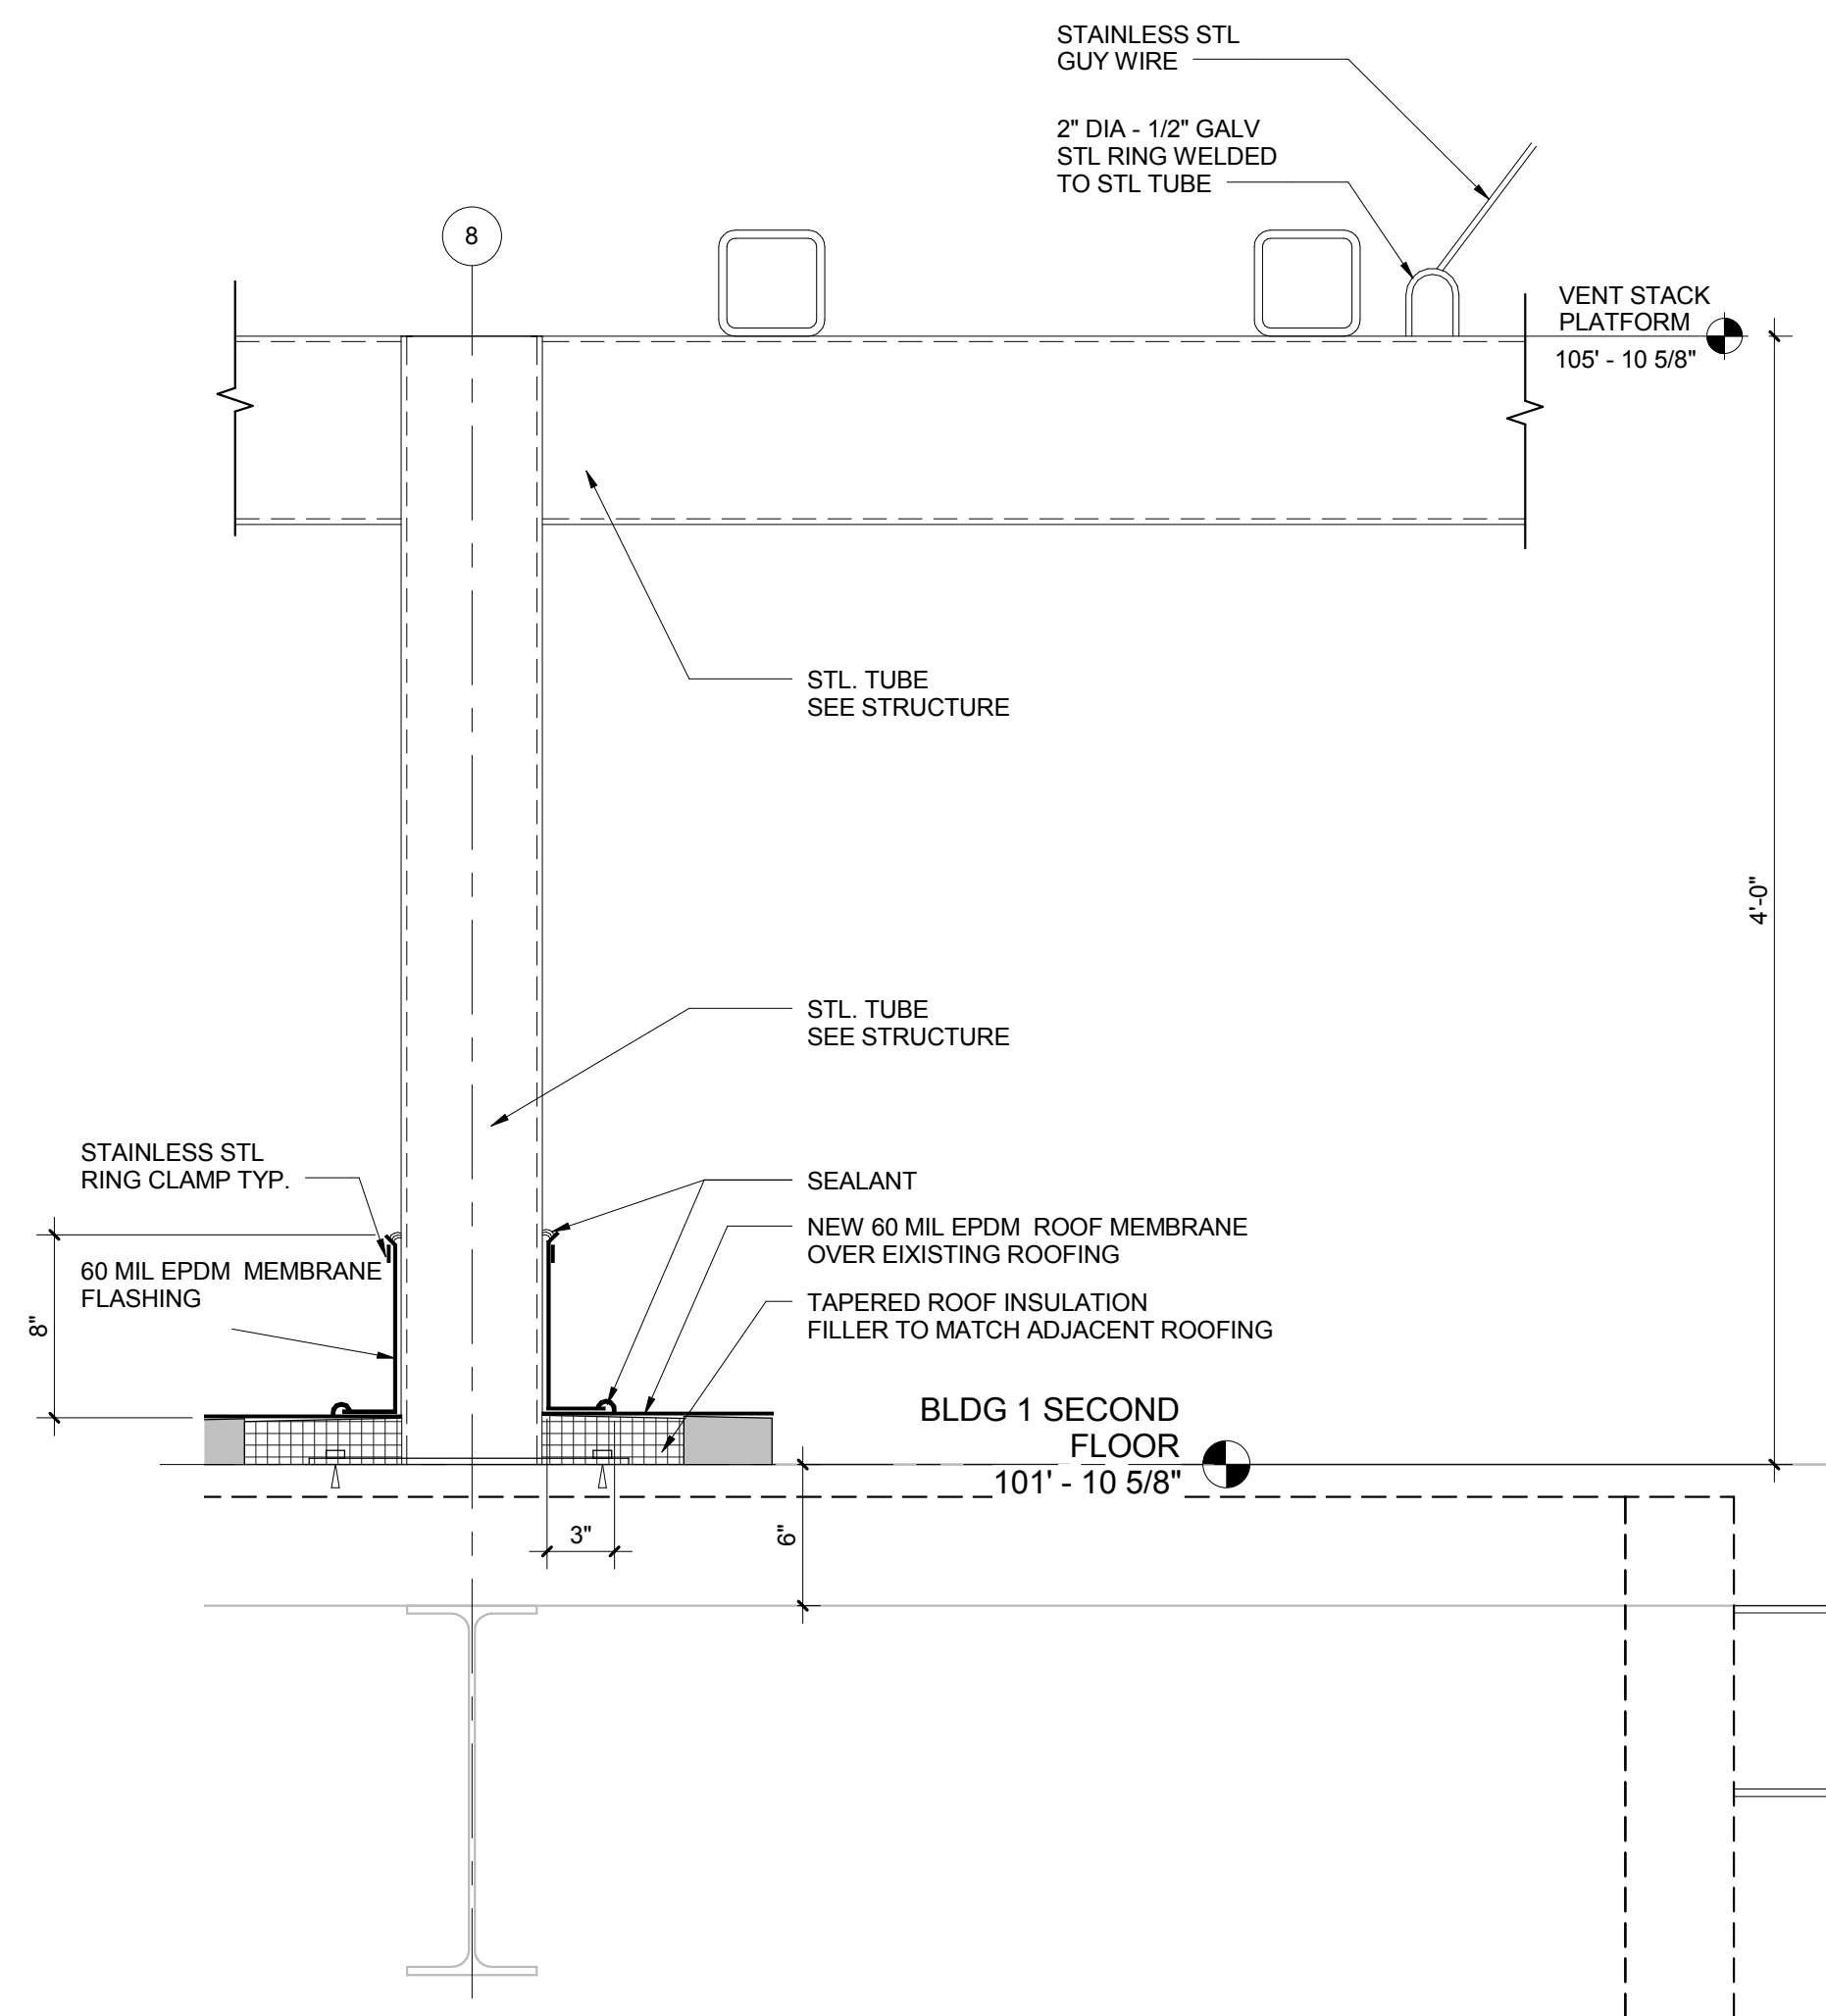
F5 SECOND FLOOR ROOF EQUIPMENT POST DETAIL
1 1/2" = 1'-0"

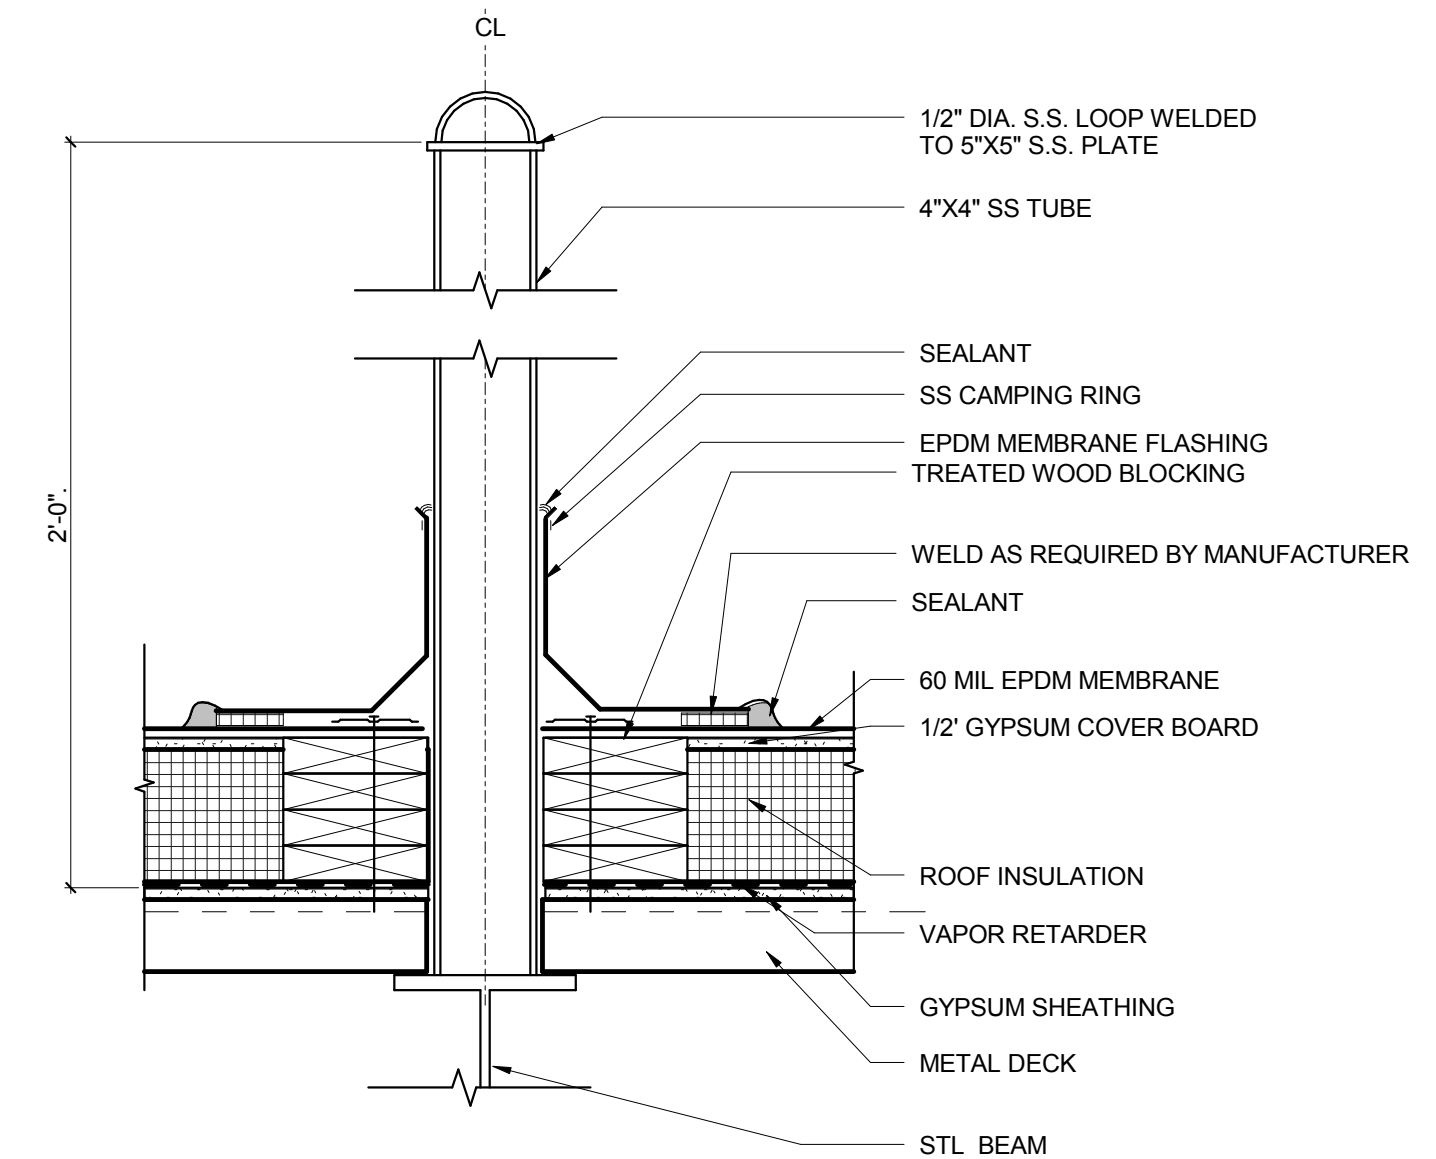
C8 TYPICAL STACK SUPPORT DETAIL AT NEW PENTHOUSE ROOF
1 1/2" = 1'-0"

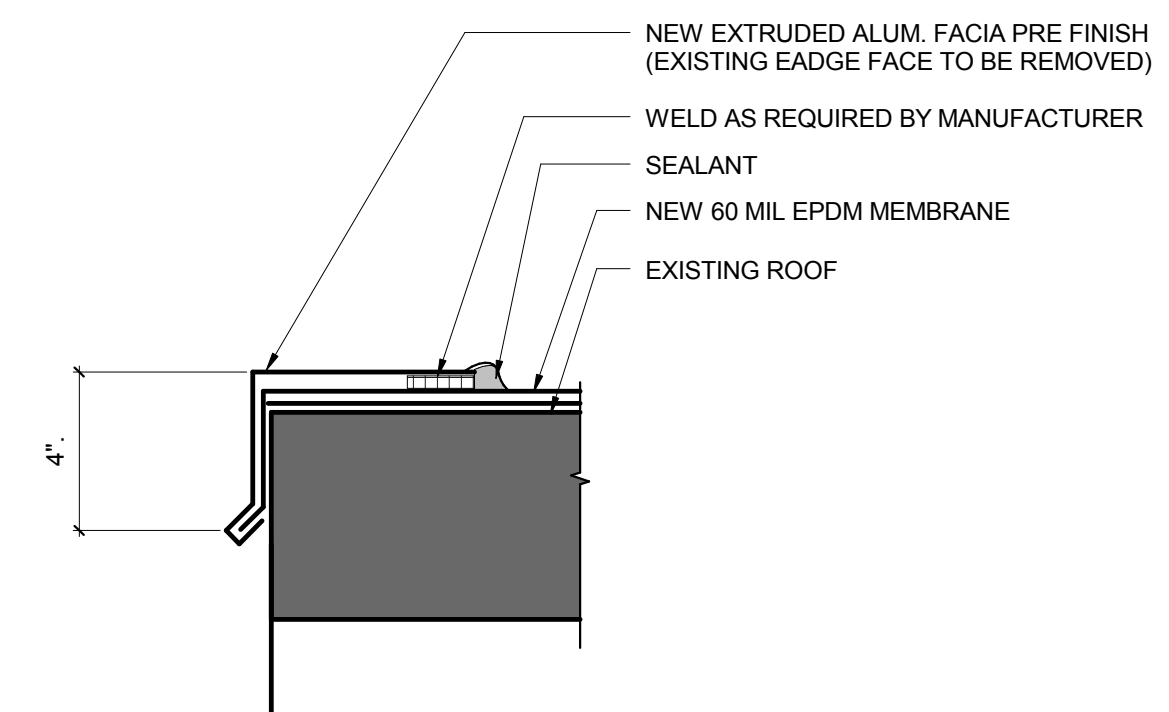
E8 TYPICAL NEW FACIA EDGE DETAIL @ EXISTING ROOF FACE
1 1/2" = 1'-0"
