**Response to Bidder Questions  
Replace/Restore Building 2 Roof and Appurtenances  
At Salem VA Medical Center, Salem, VA  
Amendment 0000  
Solicitation No. VA246-15-B-0313 Project No. 658-14-125**

**10-27-2015**

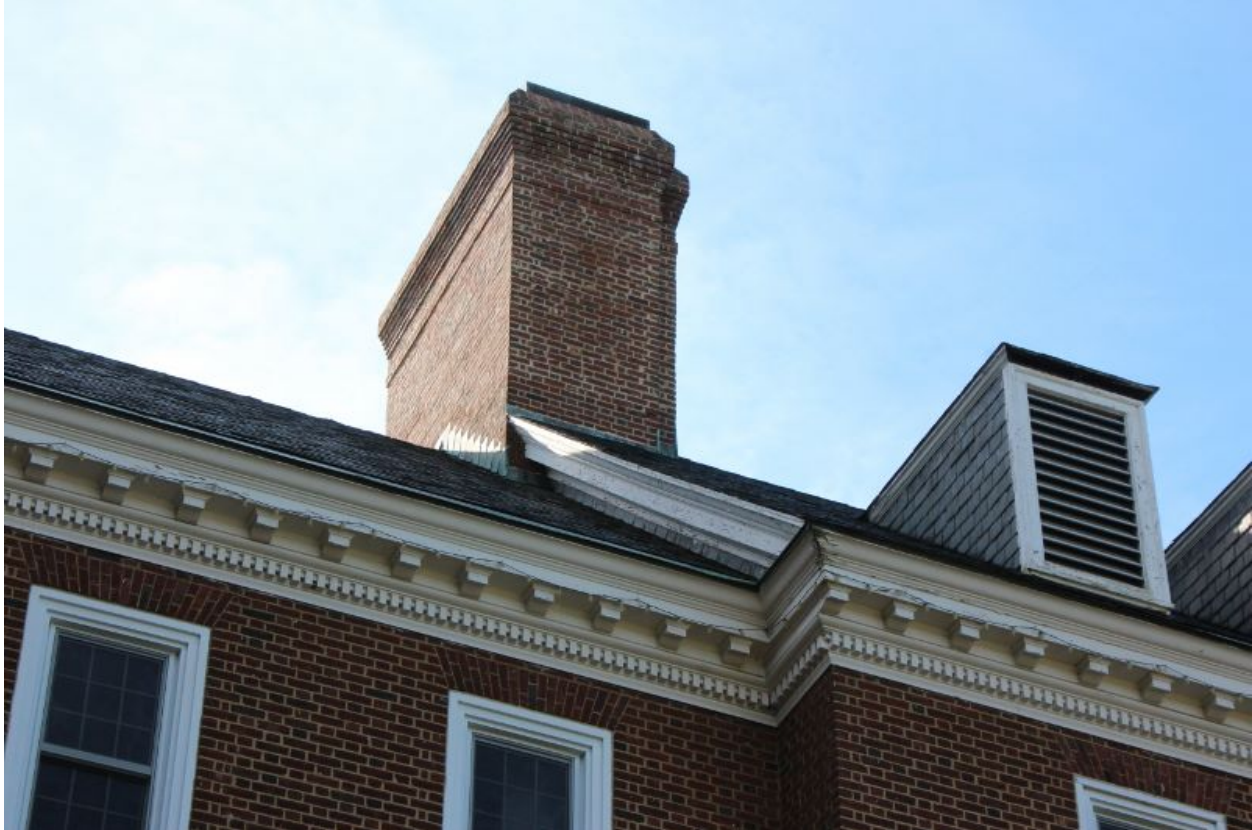
6. The attached image IMG 5383 shows a gable condition that is not specifically address on the drawings. Does this condition receive the new paint procedures? Flashing Details?

**Answer: All new roof surfaces are to be flashed with new copper flashing. The existing roof/vertical surface condition will dictate the attachment means and methods.**

7. The dormer in the picture is also missing the eave trim across the front, see question 4 above.

**Answer: See response to Question 4.**

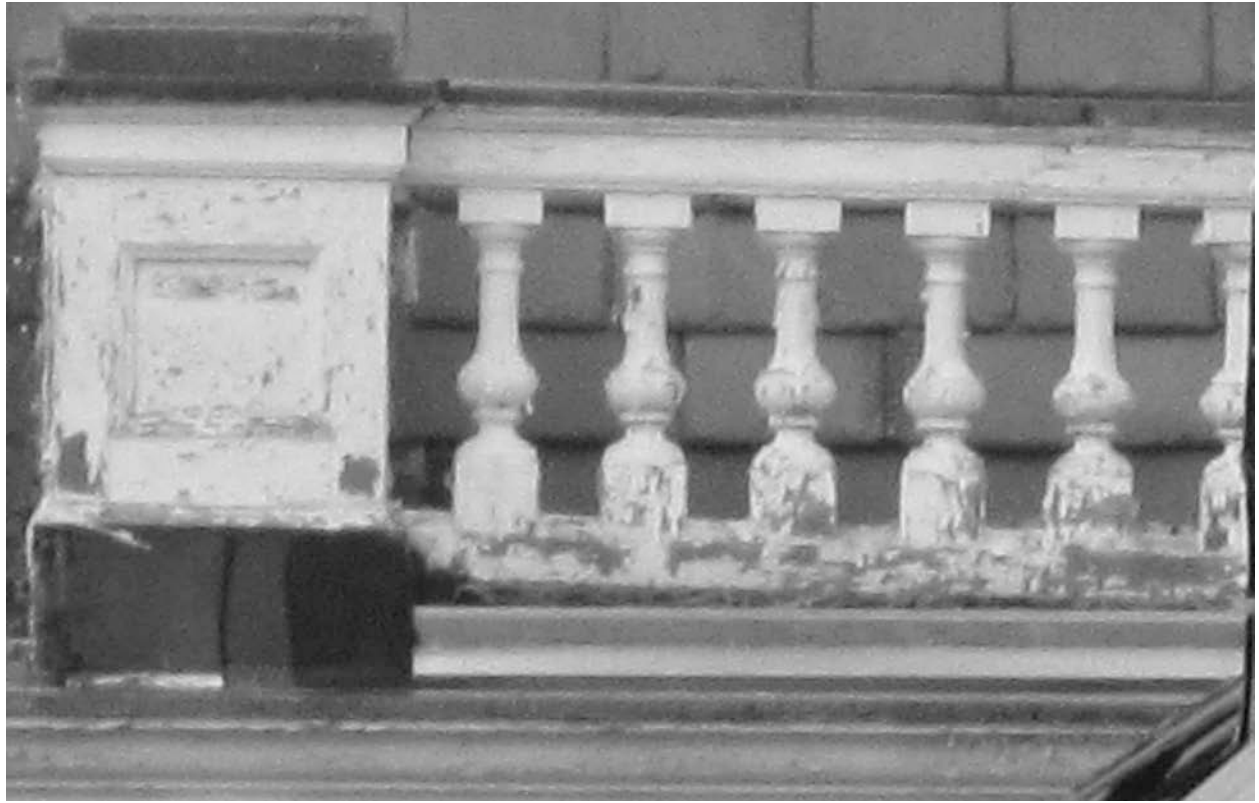
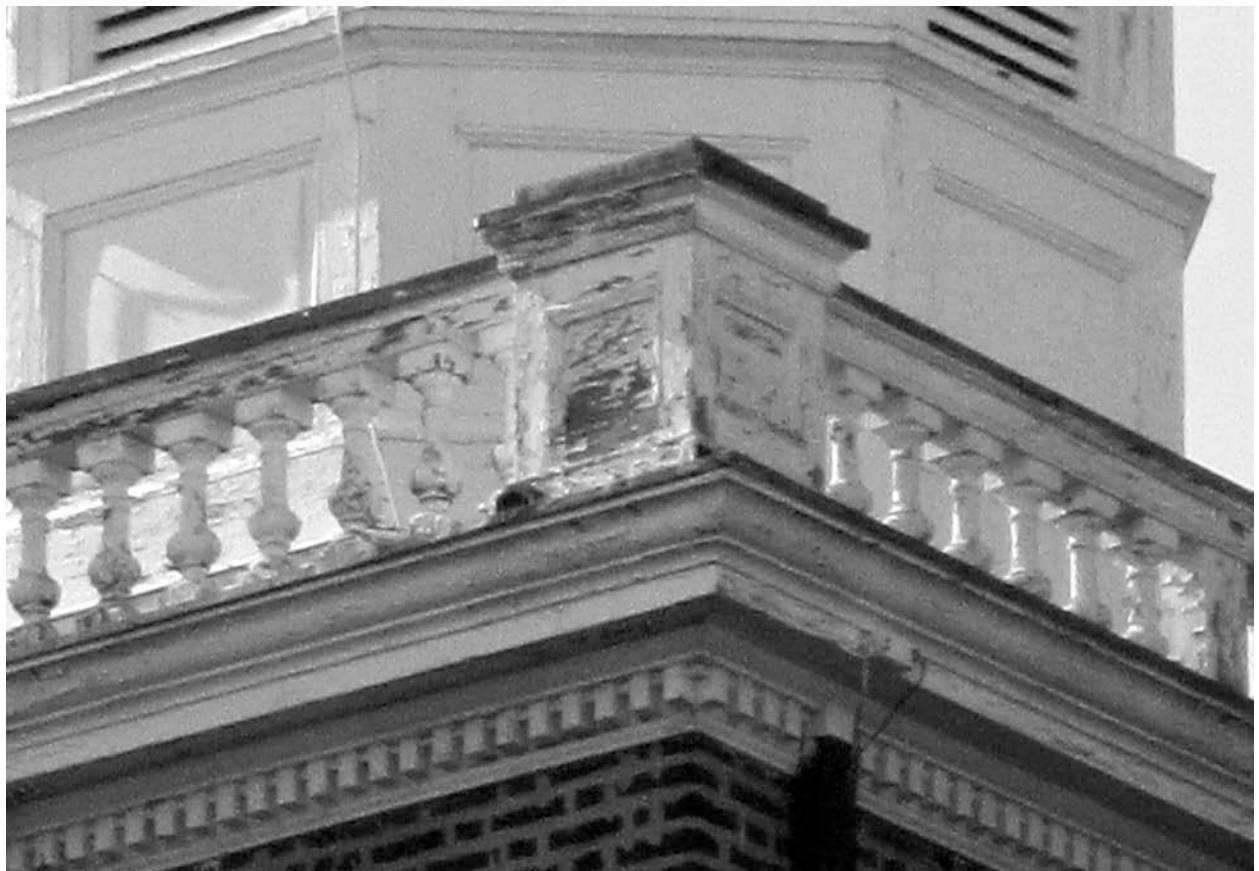
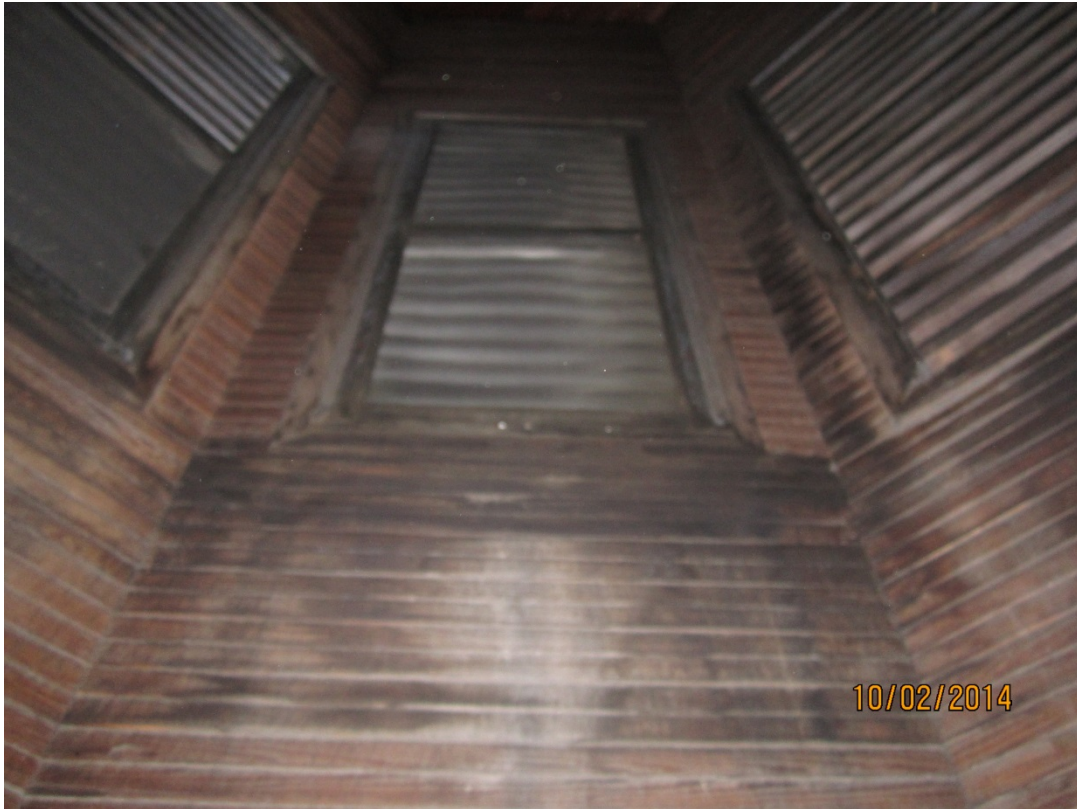
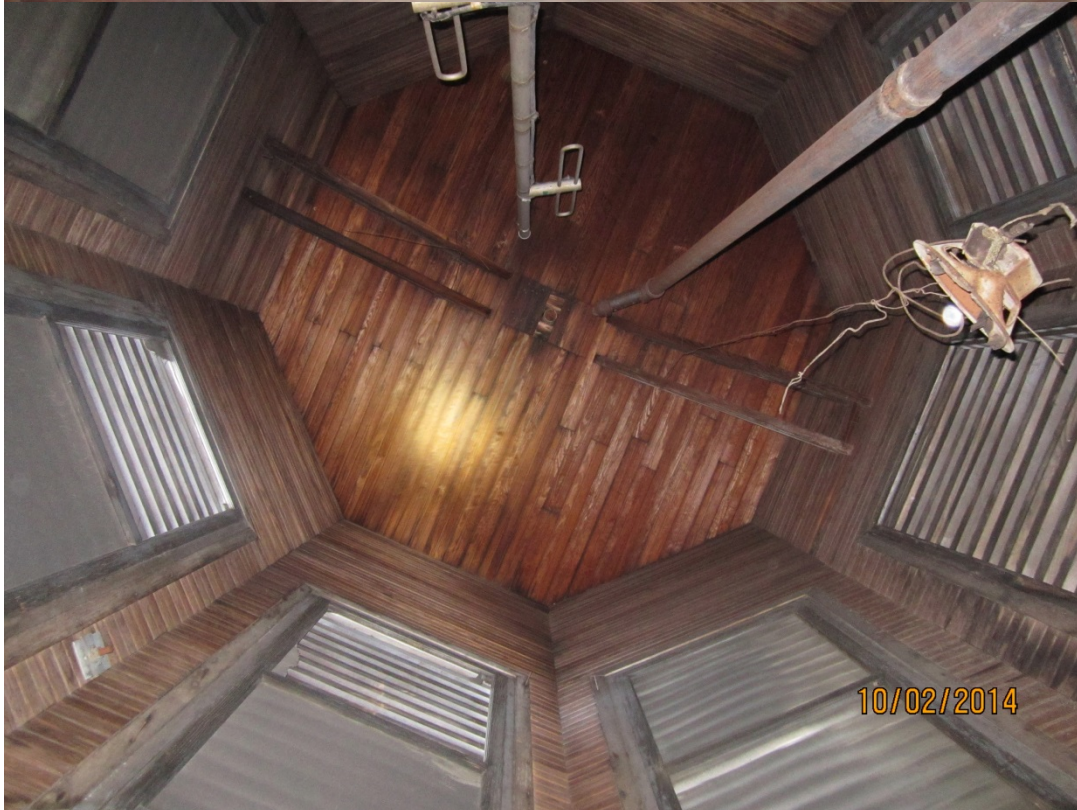
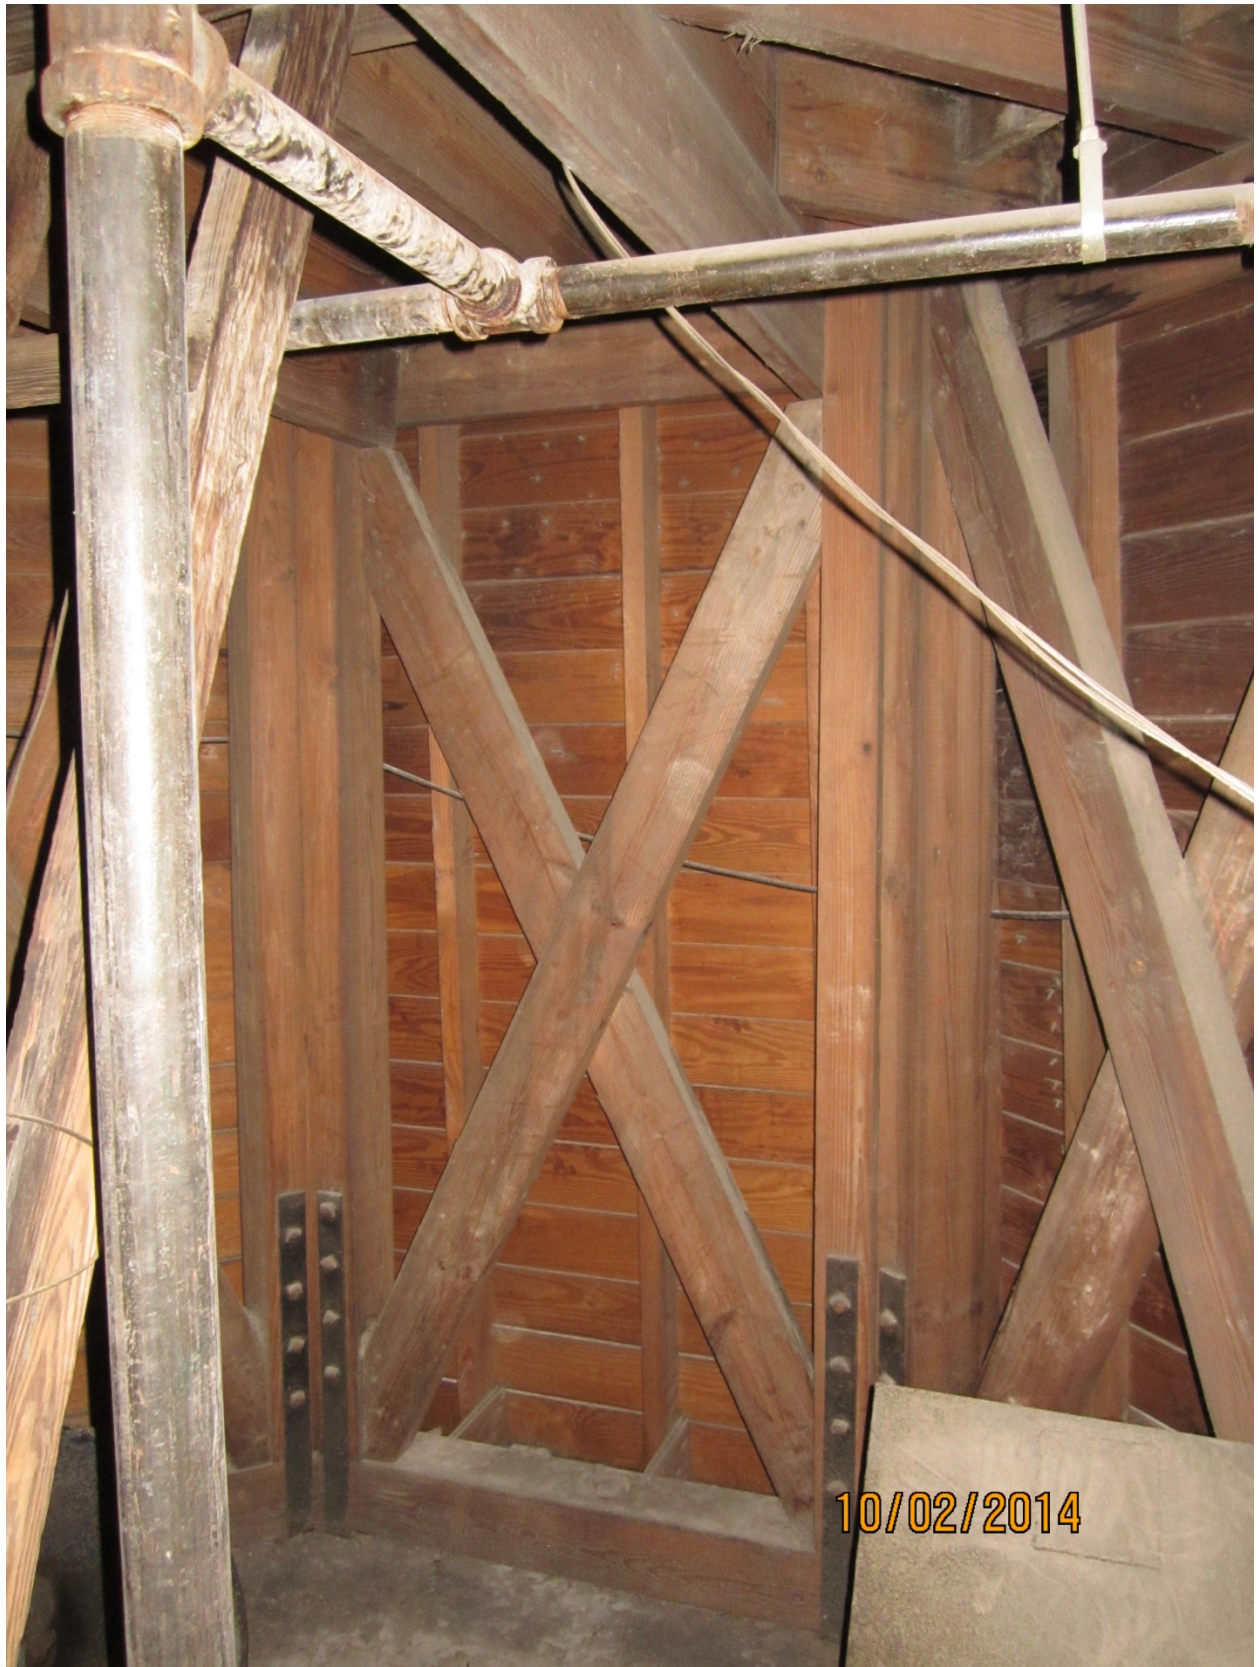
11. As the cupola could not be accessed during the pre-bid walk through, are there more detailed pictures, especially interior photos of the cupola available for bidders to verify the condition of the wood per General sheet note #3 on sheet AE201?

**Answer: Photos are included at the end of this document.**

12. As the flat roof area could not be accessed during the pre-bid walk through, are there detailed pictures of the flat roof to include the balusters and pedestals available for bidders?

**Answer: Photos of the balusters and pedestal are included at the end of this document. No existing photos are available for the flat roof.**
