NO.	DATE	DESCRIPTION
REVISIONS		
CLOSURE PANELS		
B34G SPD GETINGE STERILIZER		
WCC	09/30/2011	DATE
	2941	DRAWING NUMBER
	3 OF 6	SHEET
	528A5-12-508	PROJECT NUMBER
V.A. MEDICAL CENTER		
CANANDAIGUA, NY 14424

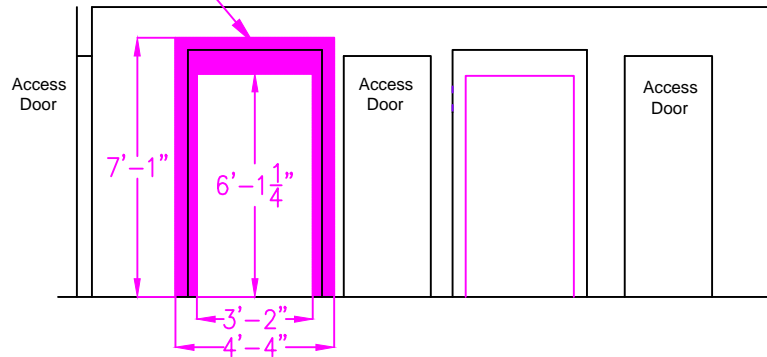
Interior Chase - Elevation in Room 15B Looking North

Stainless Steel Closure at North face in Room 15D - Inverted U Shape at Exterior of Chase - 16 ga. (.0625) Brushed Finish - Continuous w/o joints, OD 7'-1" x 4' - 4", 1/8" radius. at 2-top corners, 1/16" longitude architectural radius bend at 3 exterior edges, Mount with SS machine screws and finishing washers 8" OC at face, Finish smooth all edges. Provide fitting for smooth transition at floor tile base. Gap to sterilizer N.G.T. 1/16". Provide continuous bead clear silicone caulk between tile wall and SS closure. Field measure to confirm dimensions on all drawings. Submit shop drawings for approval by COTR.

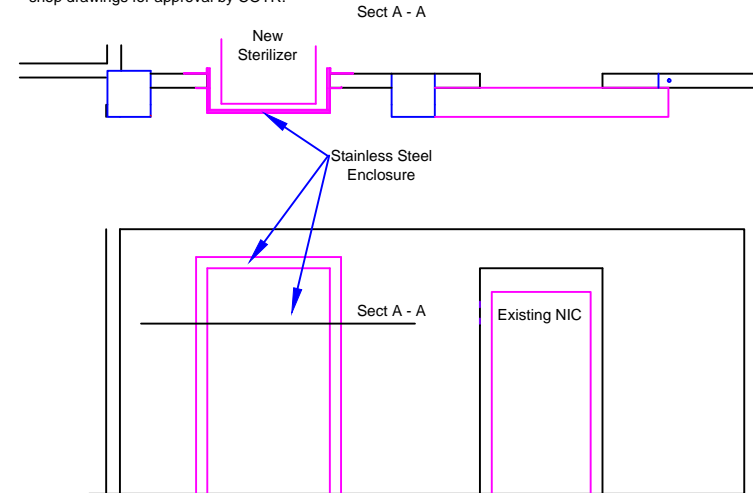
Exterior of Chase - Elevation in Room 16 Looking North

Stainless Steel Closure at South exterior face of chase in Room 16 - 16 ga. (.0625) Brushed Finish - Continuous w/o joints, OD 7'-1" x 4' - 4", 1/16" radius corners, 1/16" longitude architectural radius bend at 3 exterior edges, Interior 1" x 1" angle reinforcing @ 16" O.C. w/ spot weld. 2" x 2" x 8" interior mounting brackets w/ bolt to secure and aid removal. Secure exterior face with SS machine screws and finishing washers 8" OC at face, finish smooth all edges. Provide fitting for smooth transition at floor tile base. Provide continuous bead clear silicone caulk between tile wall. Gap to sterilizer N.G.T. 1/16". Field measure to confirm dimensions on all drawings. Submit shop drawings for approval by COTR.
