Drawing Title
ROOM PRESSURIZATION PLAN

Project Title
**ANIMAL RESEARCH
RENOVATIONS**

Location
VAMC - WAIDE PARK

Drawing Number
1-H12

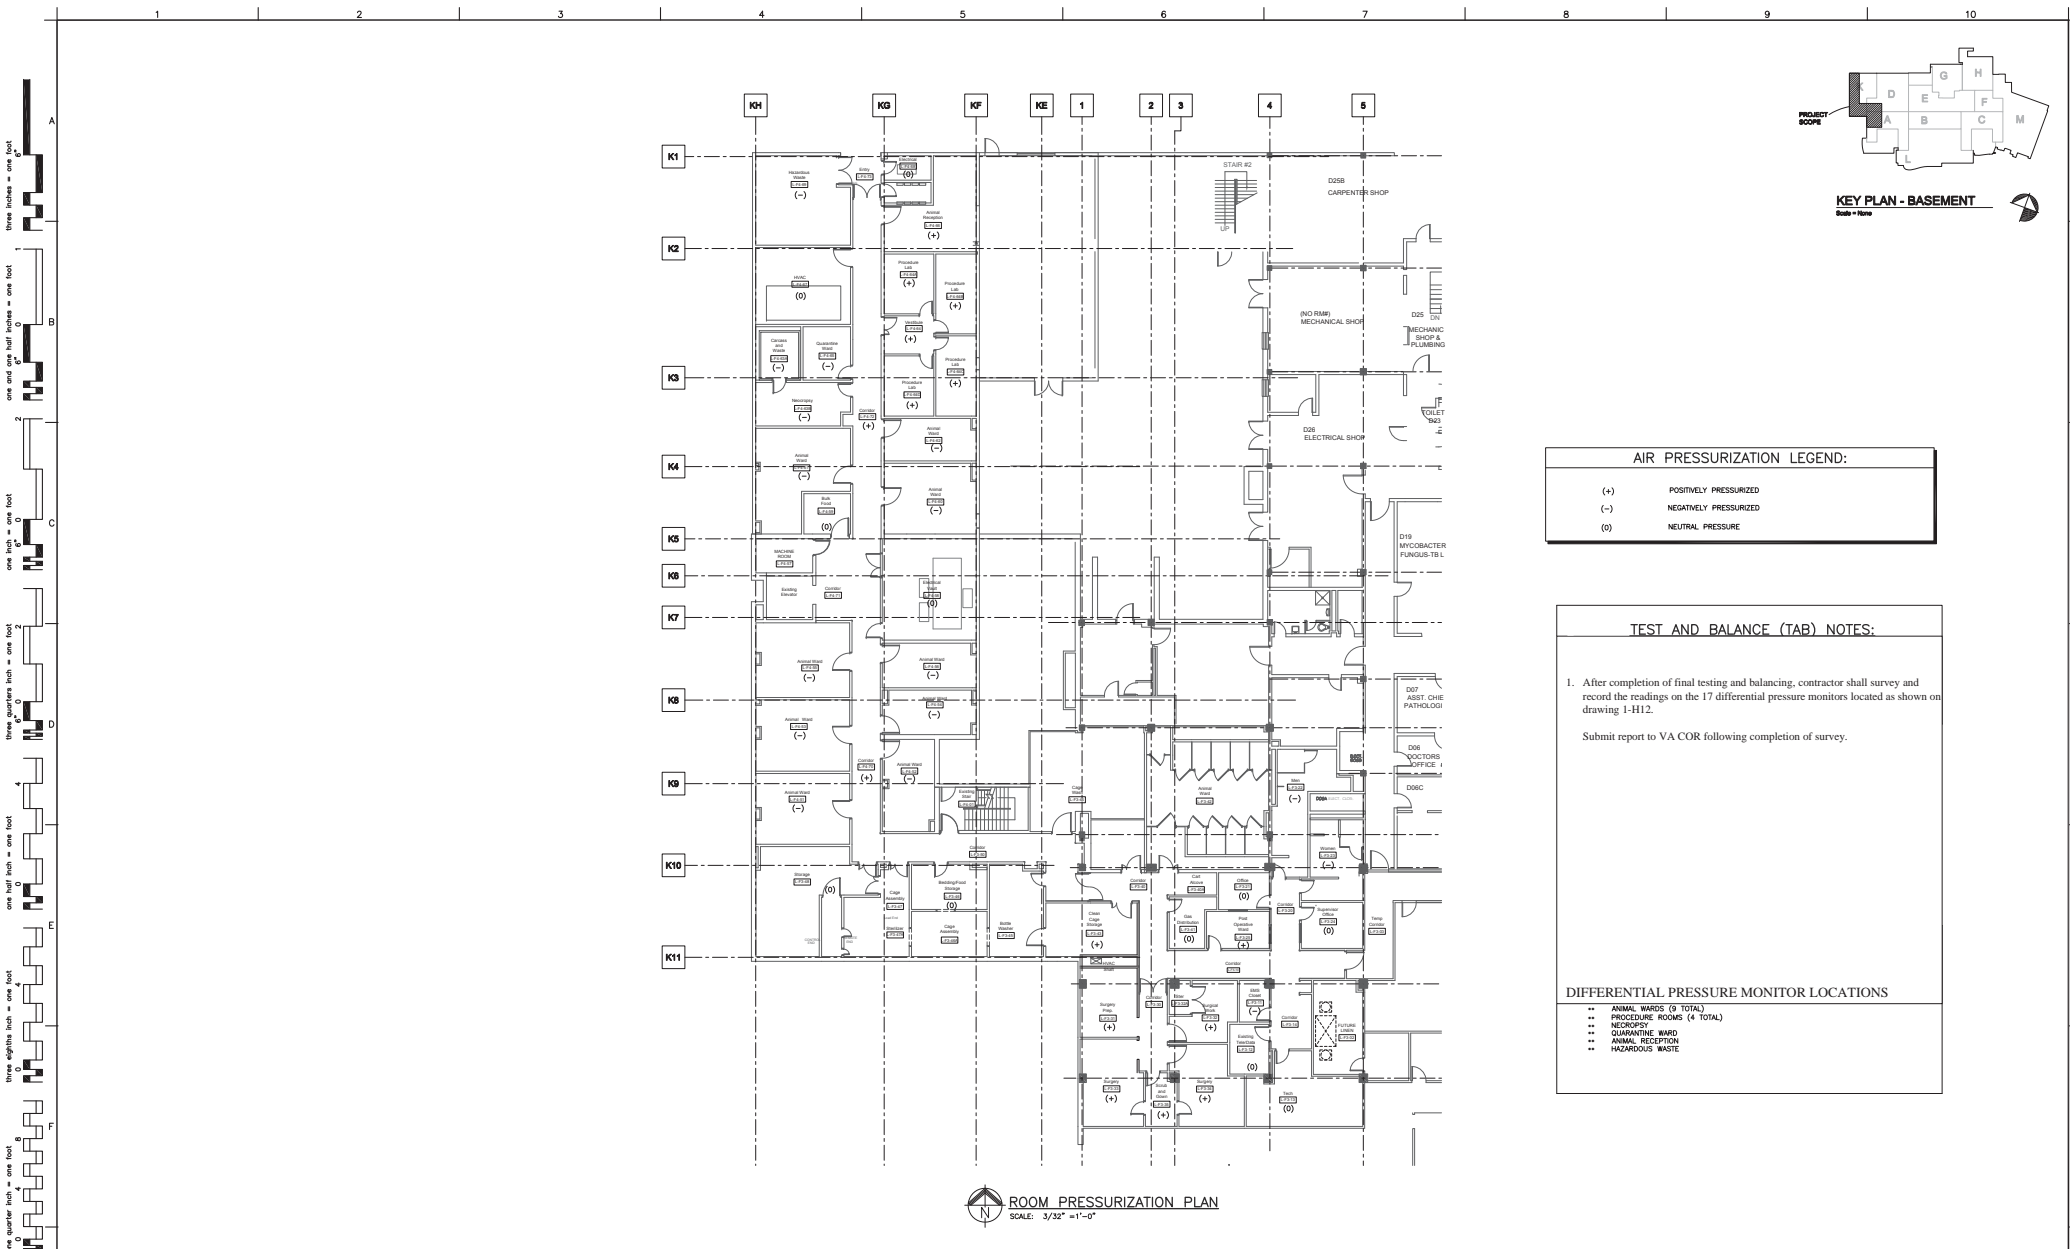
TEST AND BALANCE (TAB) NOTES:	
1. After completion of final testing and balancing, contractor shall survey and record the readings on the 17 differential pressure monitors located as shown on drawing 1-H12.	
Submit report to VA COR following completion of survey.	
DIFFERENTIAL PRESSURE MONITOR LOCATIONS	
** ANIMAL WARDS (9 TOTAL) ** PROCEDURE ROOMS (4 TOTAL) ** ISOLATION ** QUARANTINE WARD ** ANIMAL RECEPTION ** HAZARDOUS WASTE
