LIMITED HAZARDOUS MATERIAL PRE-RENOVATION SURVEY REPORT

Syracuse VA Medical Center
Capital Improvement Project – Window Replacement Project
800 Irving Avenue
Syracuse, New York 13210

**RE: Limited Hazardous Material Pre-Renovation Survey Report
Syracuse VA Medical Center – 800 Irving Avenue, Syracuse, New York 13210
Capital Improvement Project – Window Replacement Project
AECC Project Number: 14-129**

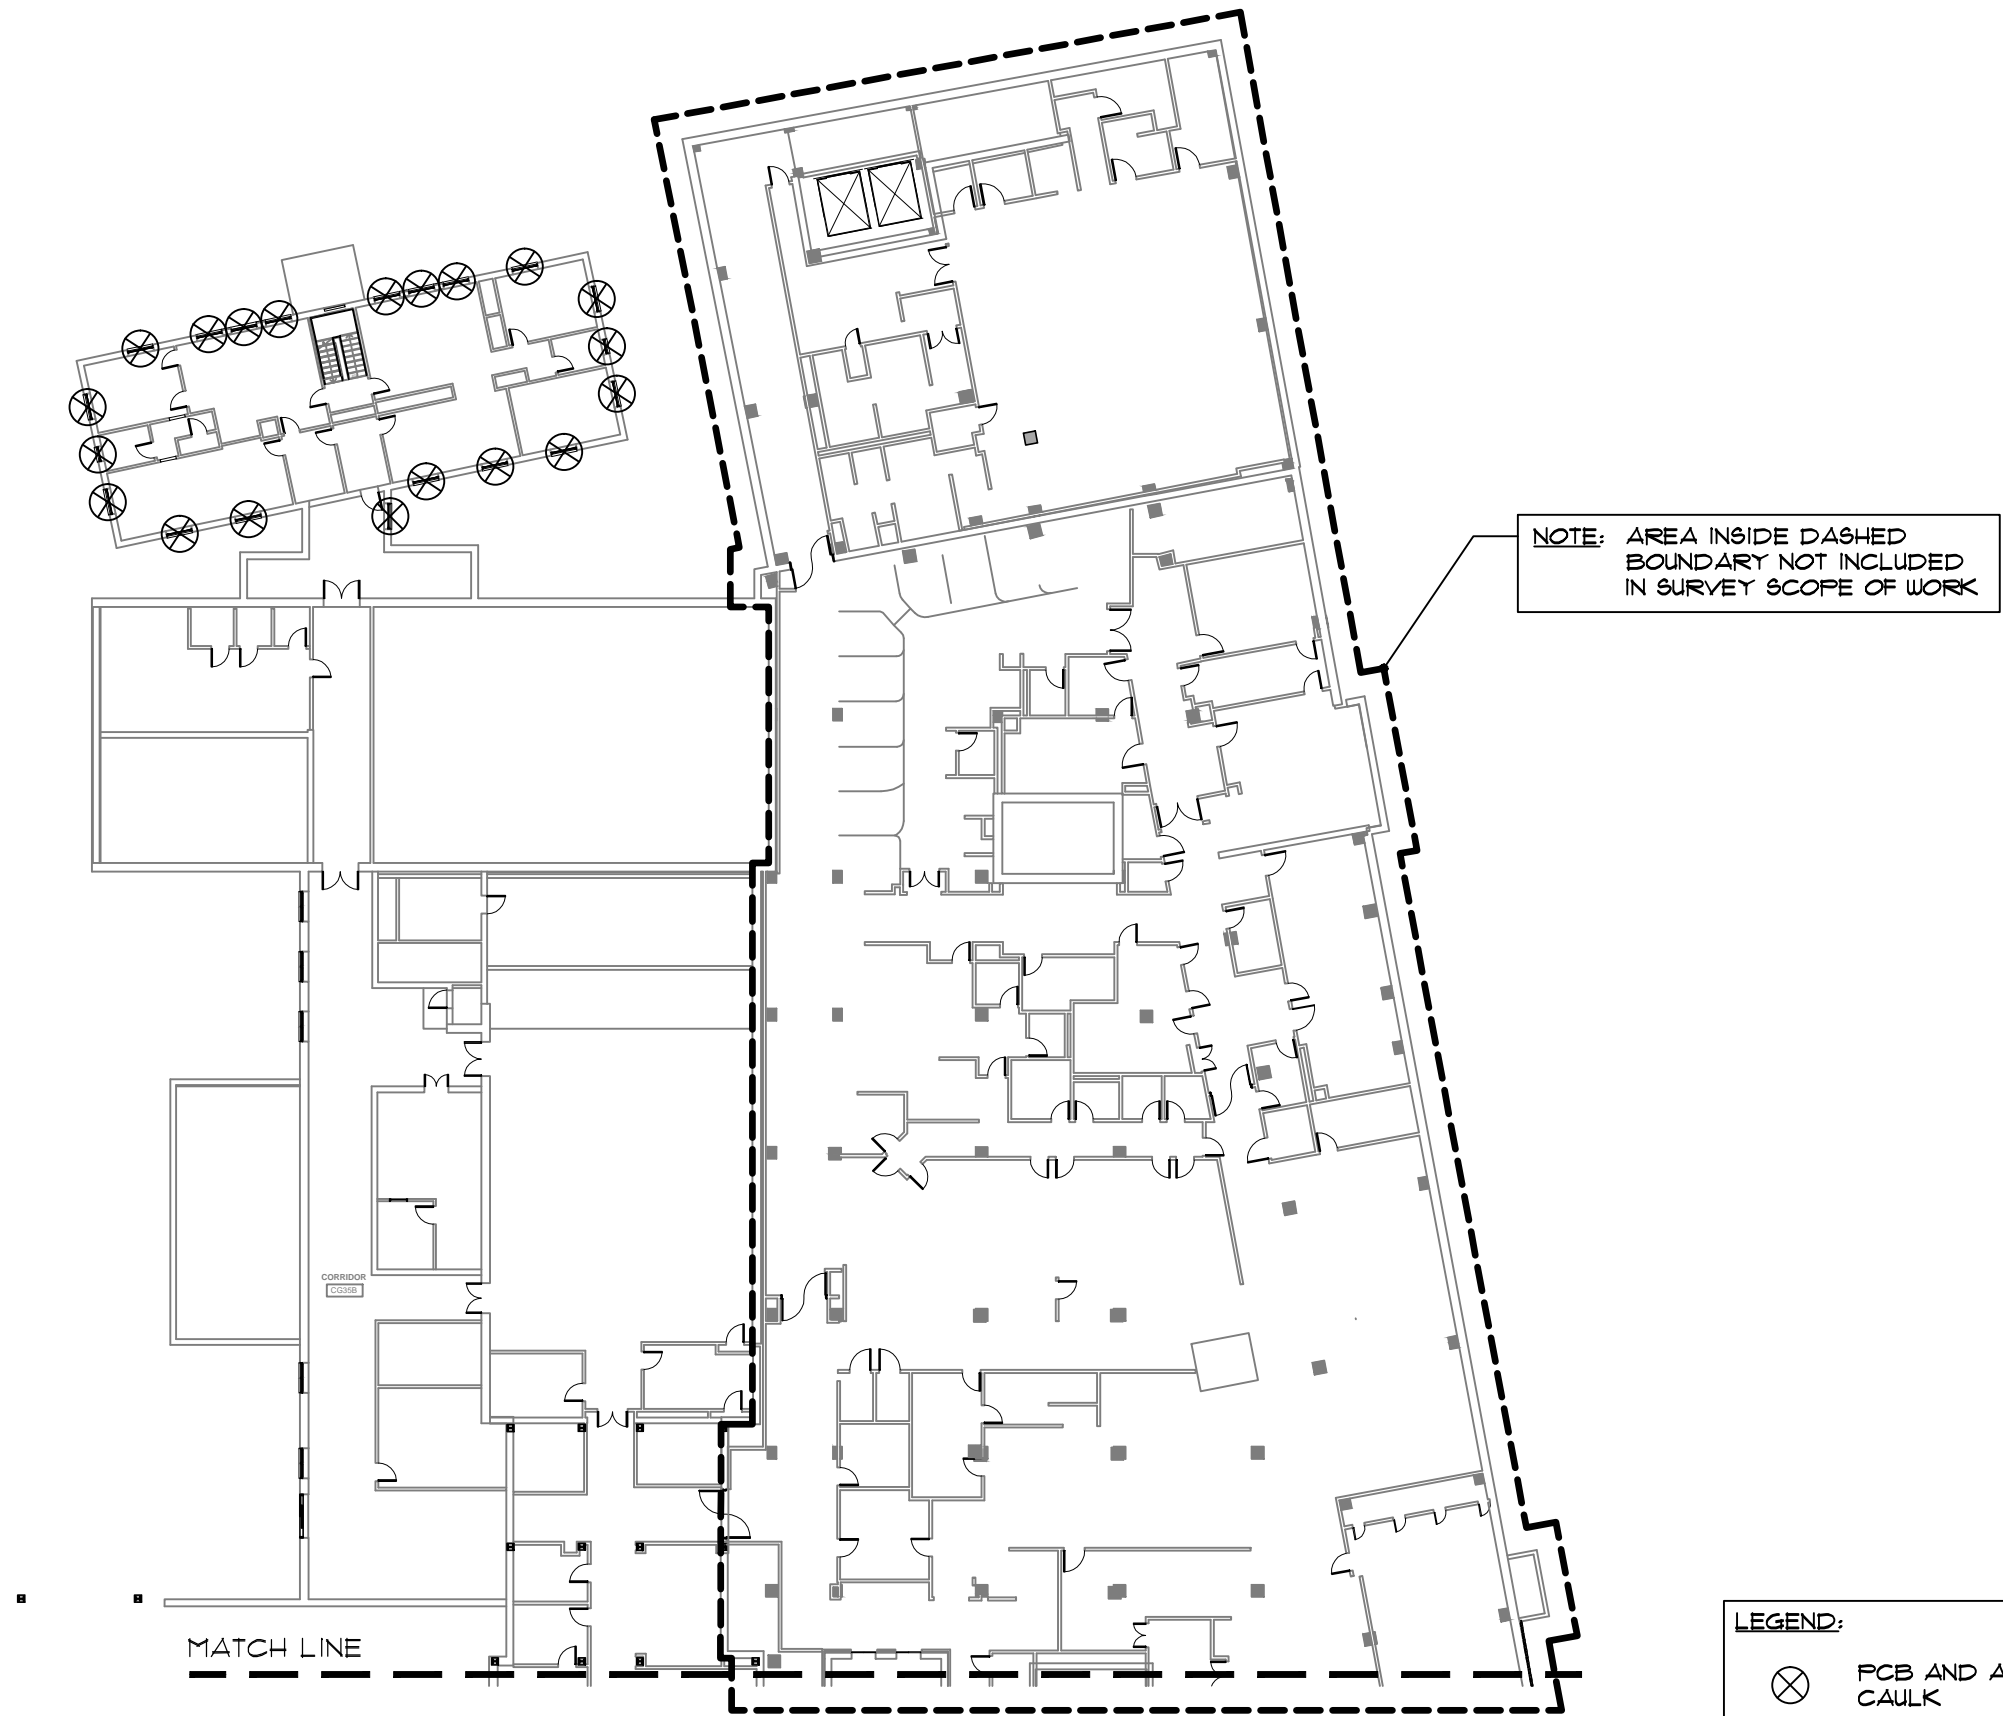
FIGURE
1A

LEGEND:	
	PCB AND ASBESTOS-CONTAINING WINDOW CAULK

Syracuse VA Medical Center 800 Irving Avenue Syracuse, New York 13210 Hospital - Ground Floor	
Limited Hazardous Material Pre-Renovation Survey

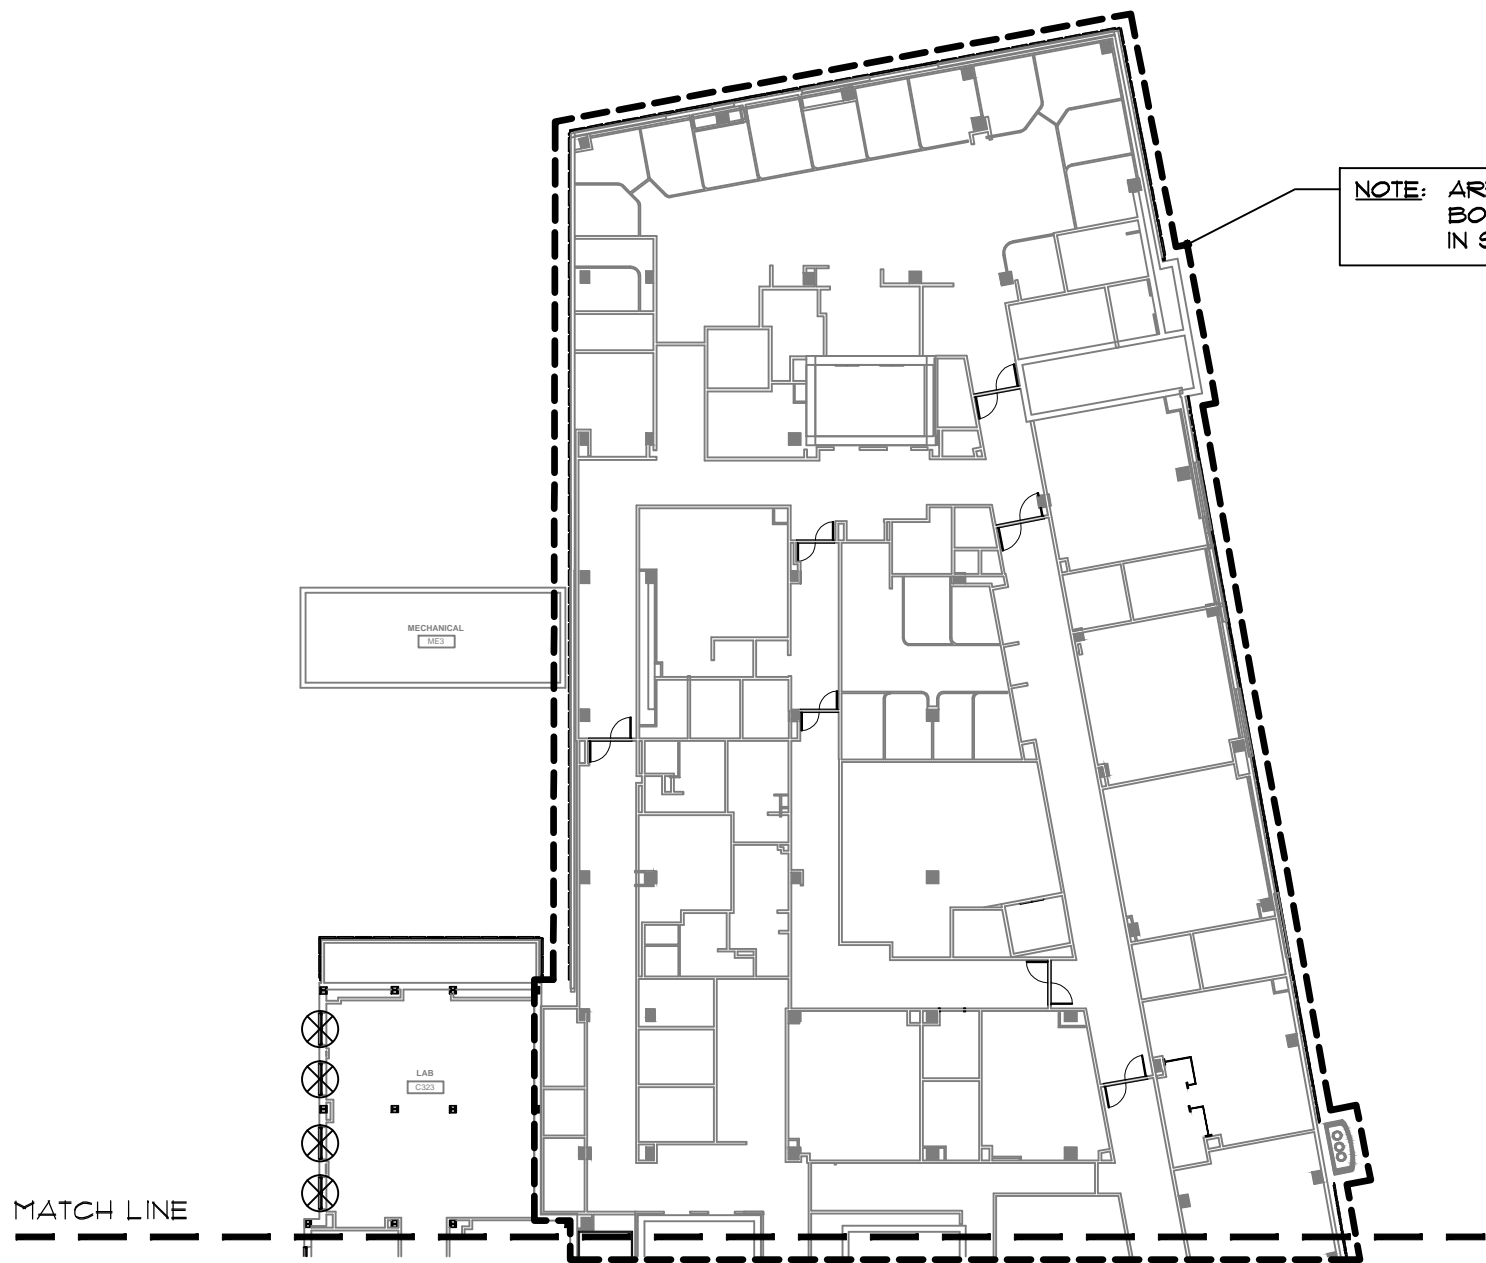
LEGEND:	
	PCB AND ASBESTOS-CONTAINING WINDOW CAULK

Syracuse VA Medical Center 800 Irving Avenue Syracuse, New York 13210 Hospital - Third Floor	
Limited Hazardous Material Pre-Renovation Survey
