<div>N ATIONAL C EMETERY A DMINISTRATION</div>	Drawing Title		Project Title		Project Number	
						Approved: Project Director		Location		Building Number	
							Date	Checked	Drawn	Drawing Number	
										917-NRM16-02-001

Office of
Facilities
Management

Department of
Veterans Affairs

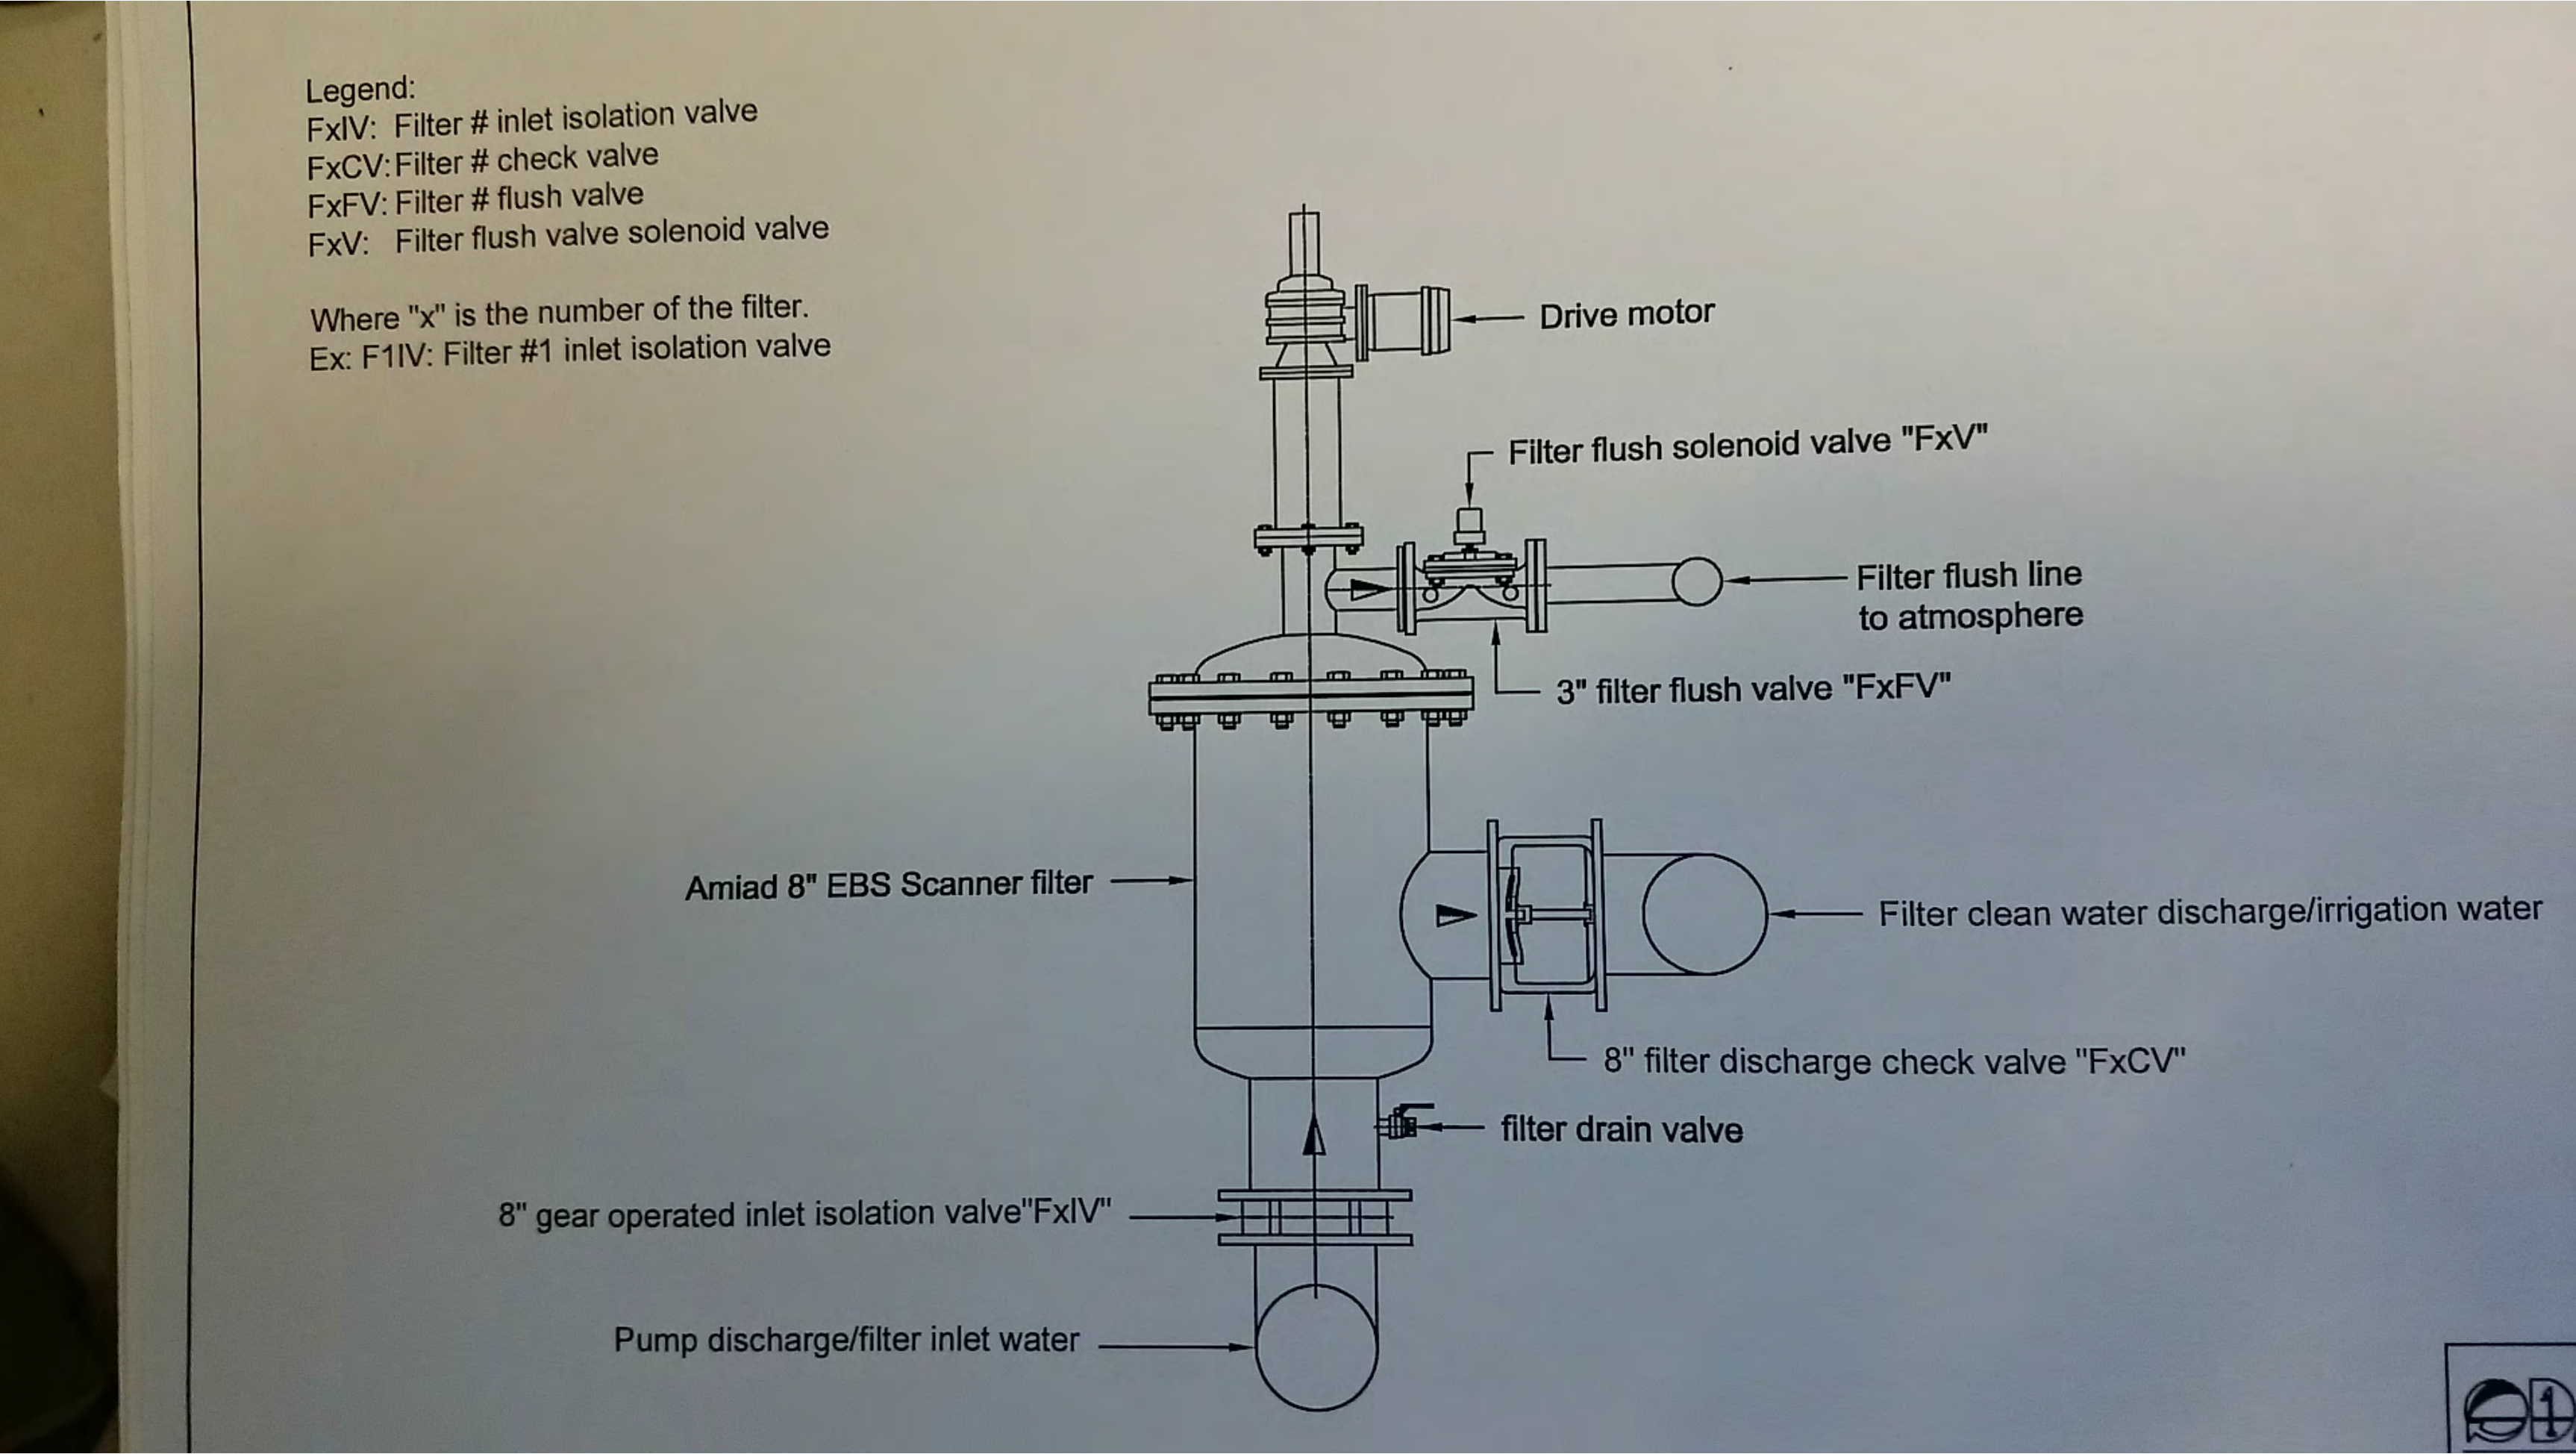
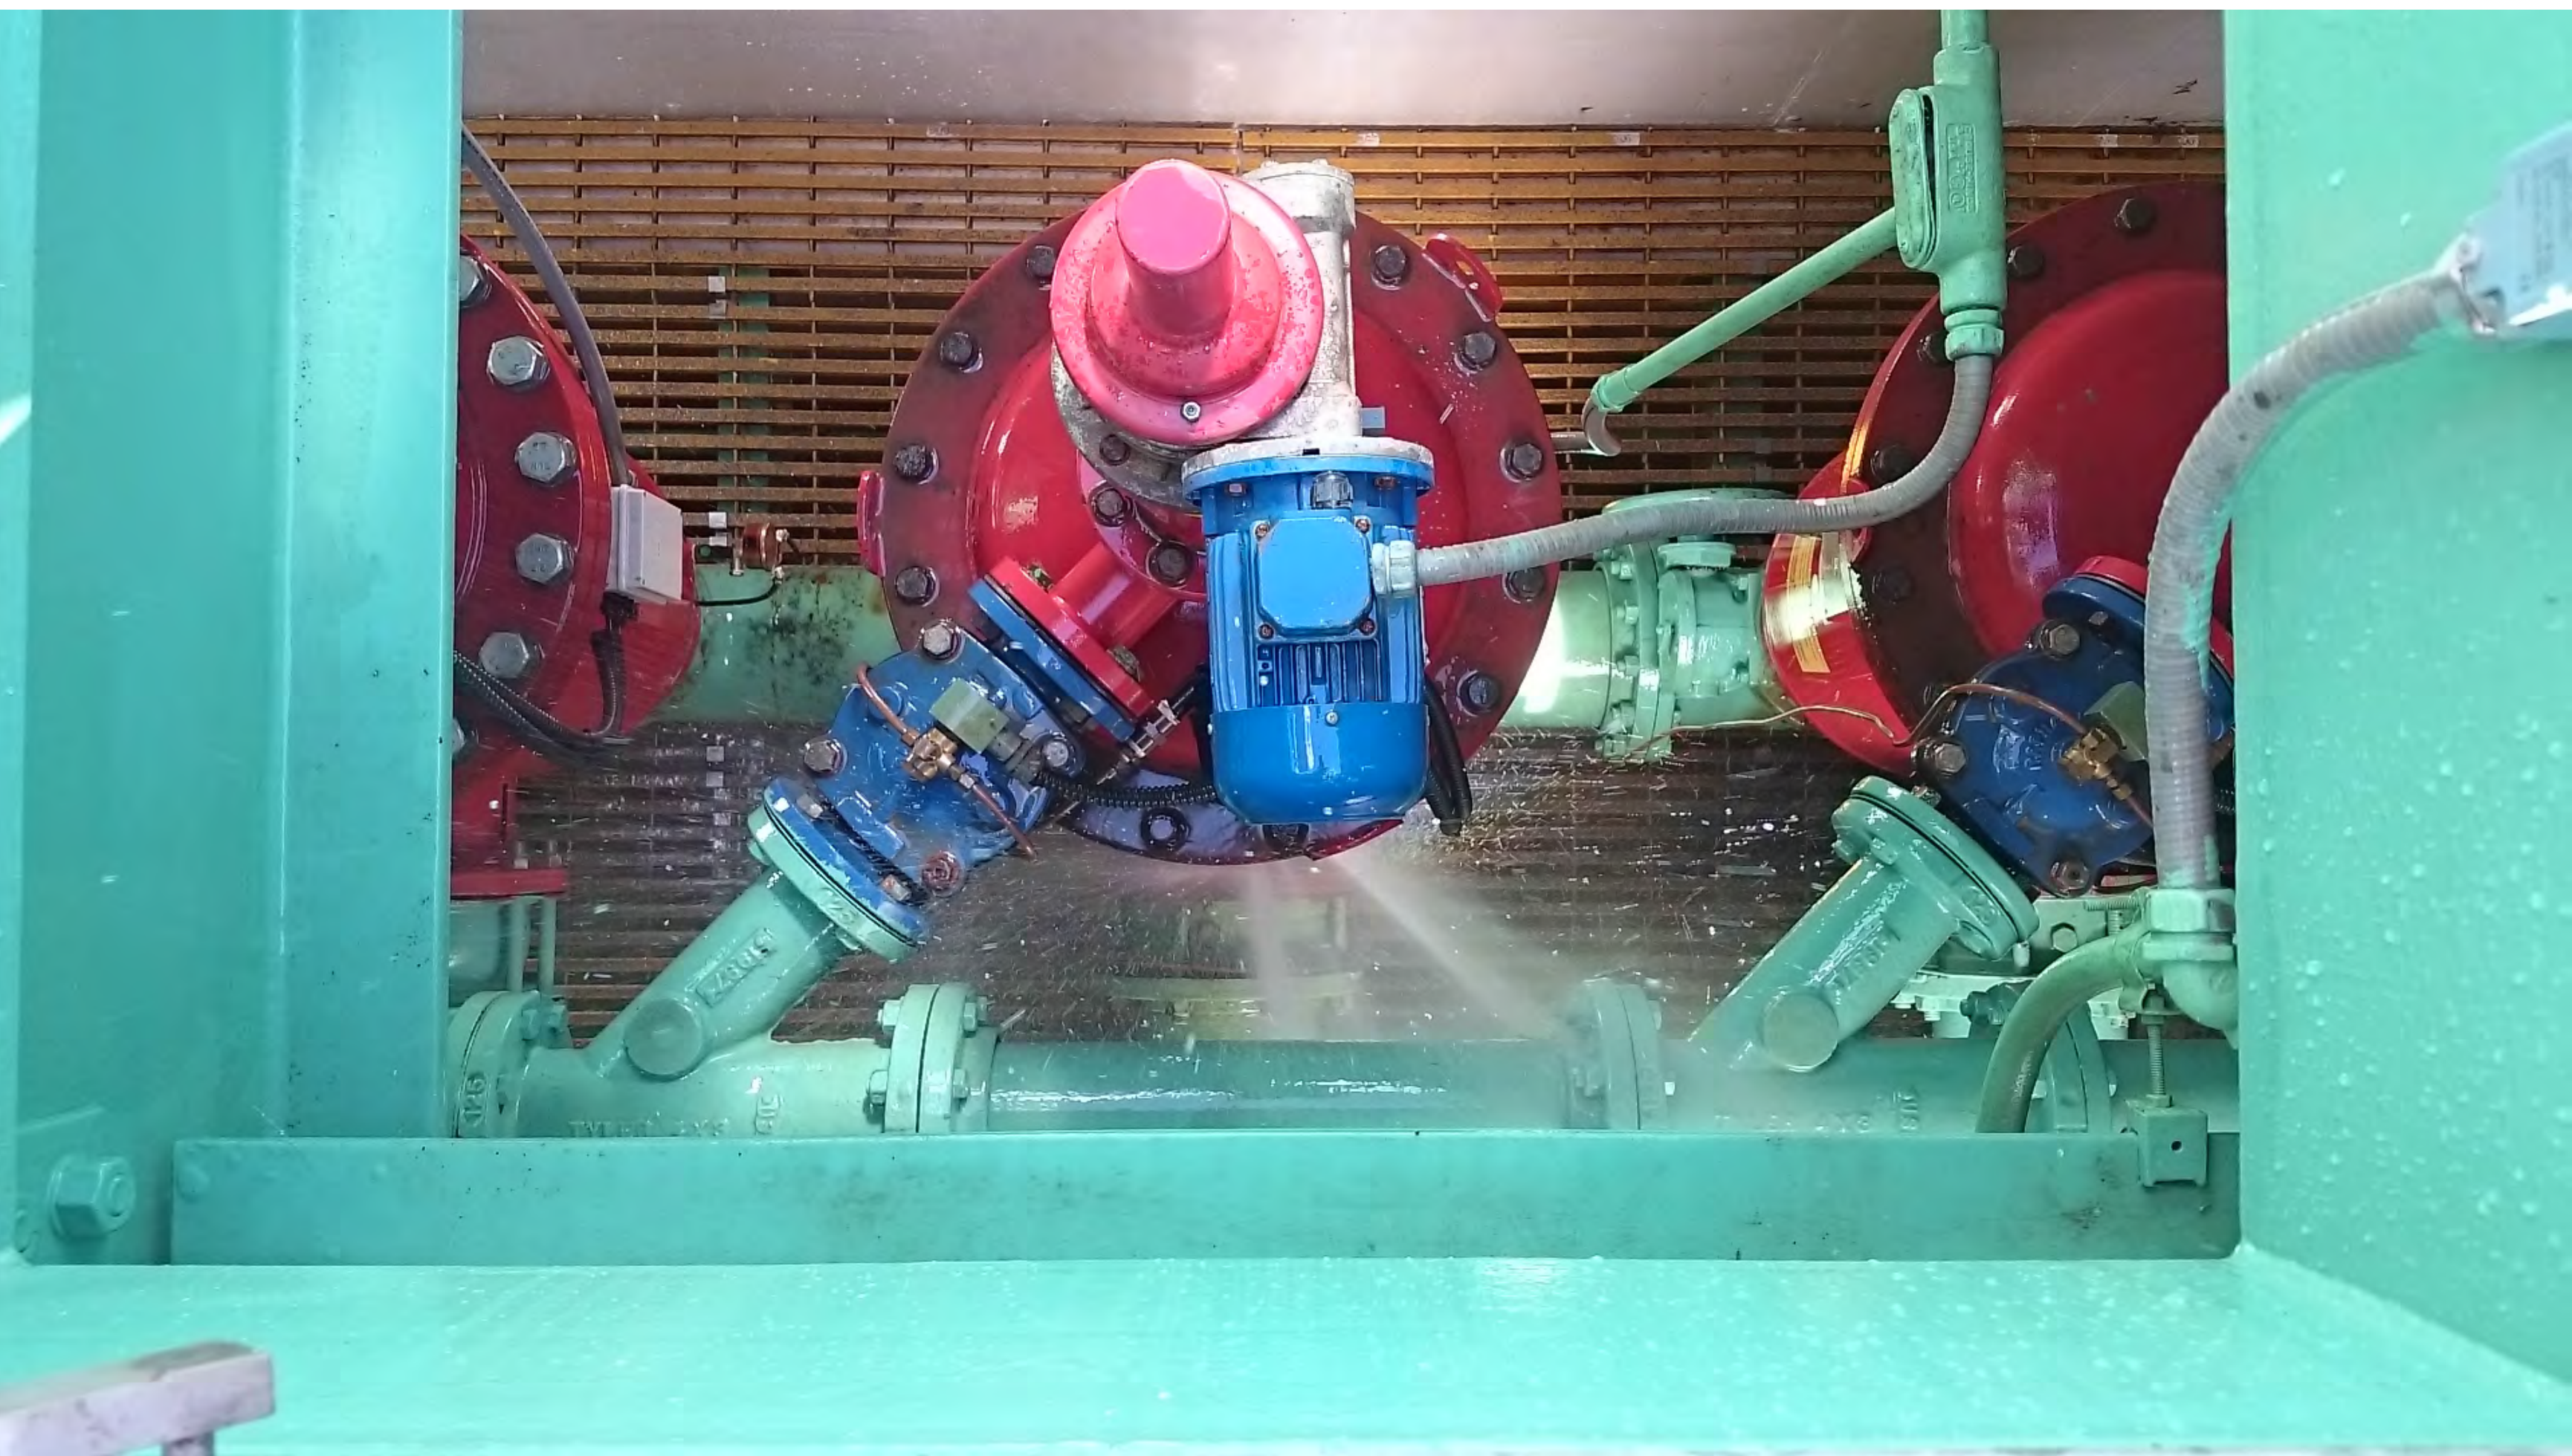
Details 1 and 2: Demolish and replace with new the filter in the above detail. Connect to existing valves and piping. The picture above and right shows the leaking filter (top view) to be replaced. Access is down a hatch and ladder.

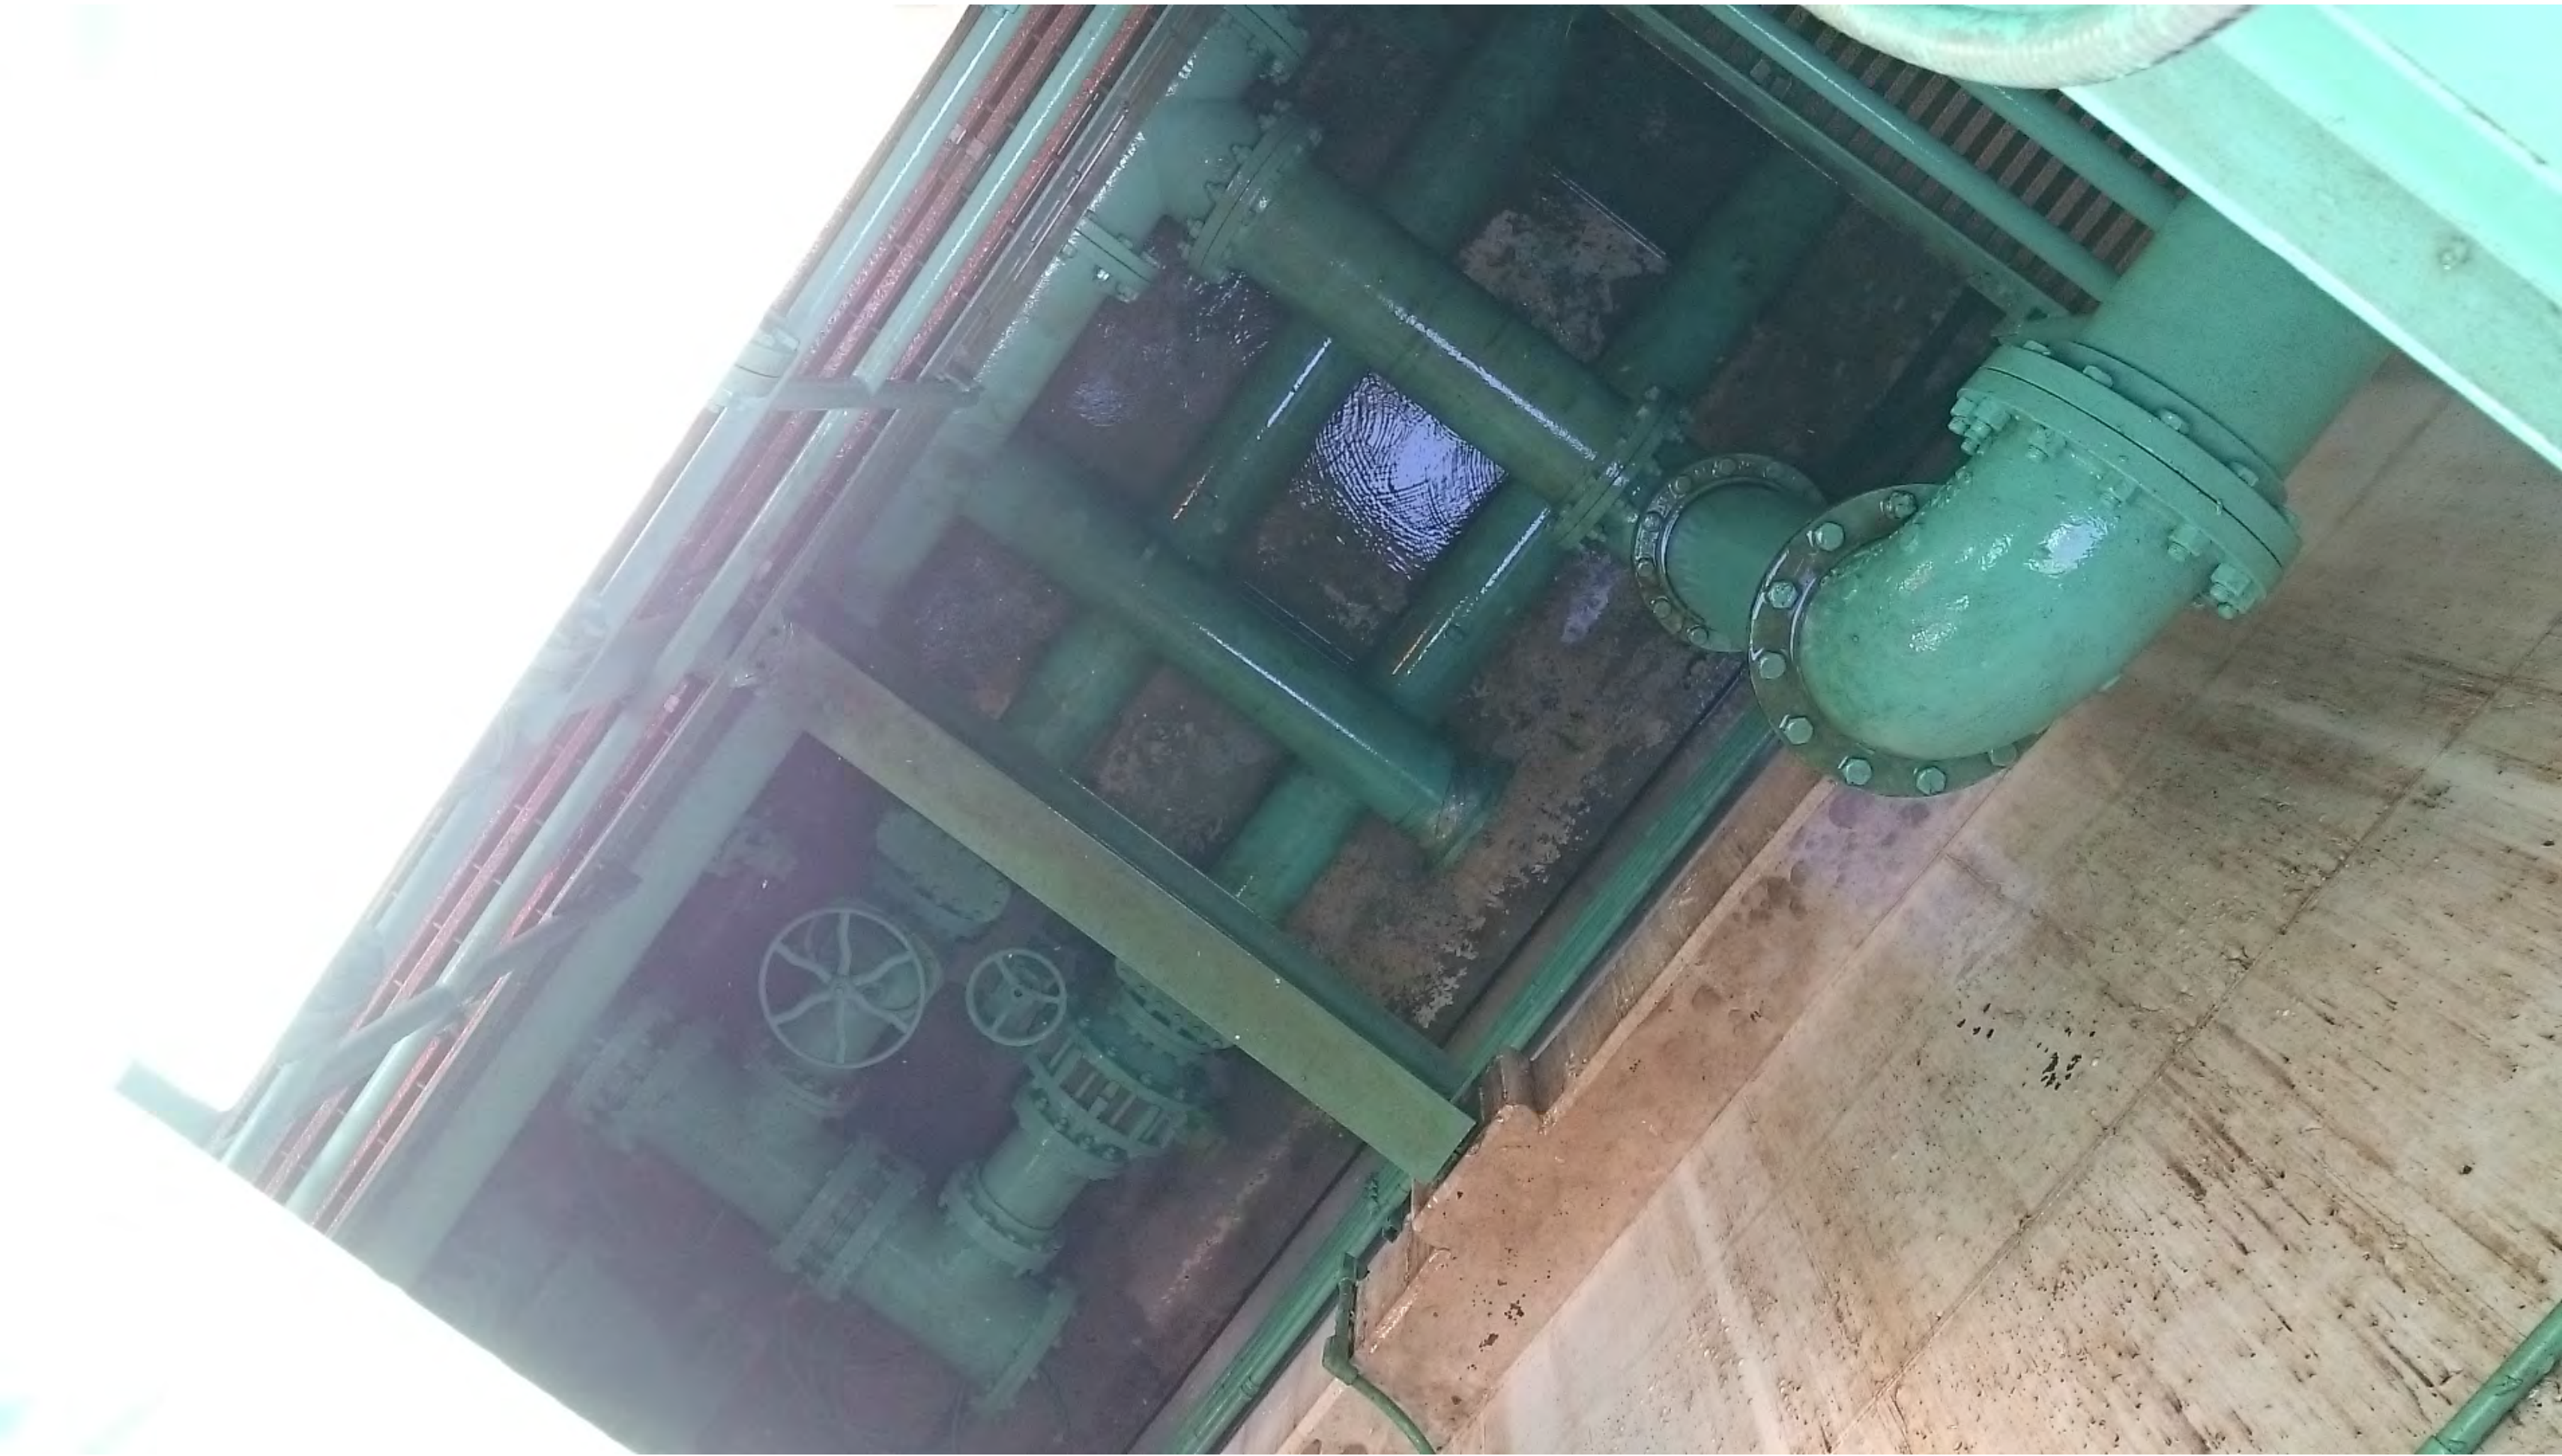
Details 3 and 4: Demolish and replace with new the irrigation system pumps (2). The picture above right shows not necessarily the (2) failed pumps for replacement, but the general access to the work space which is down a hatch and ladder.

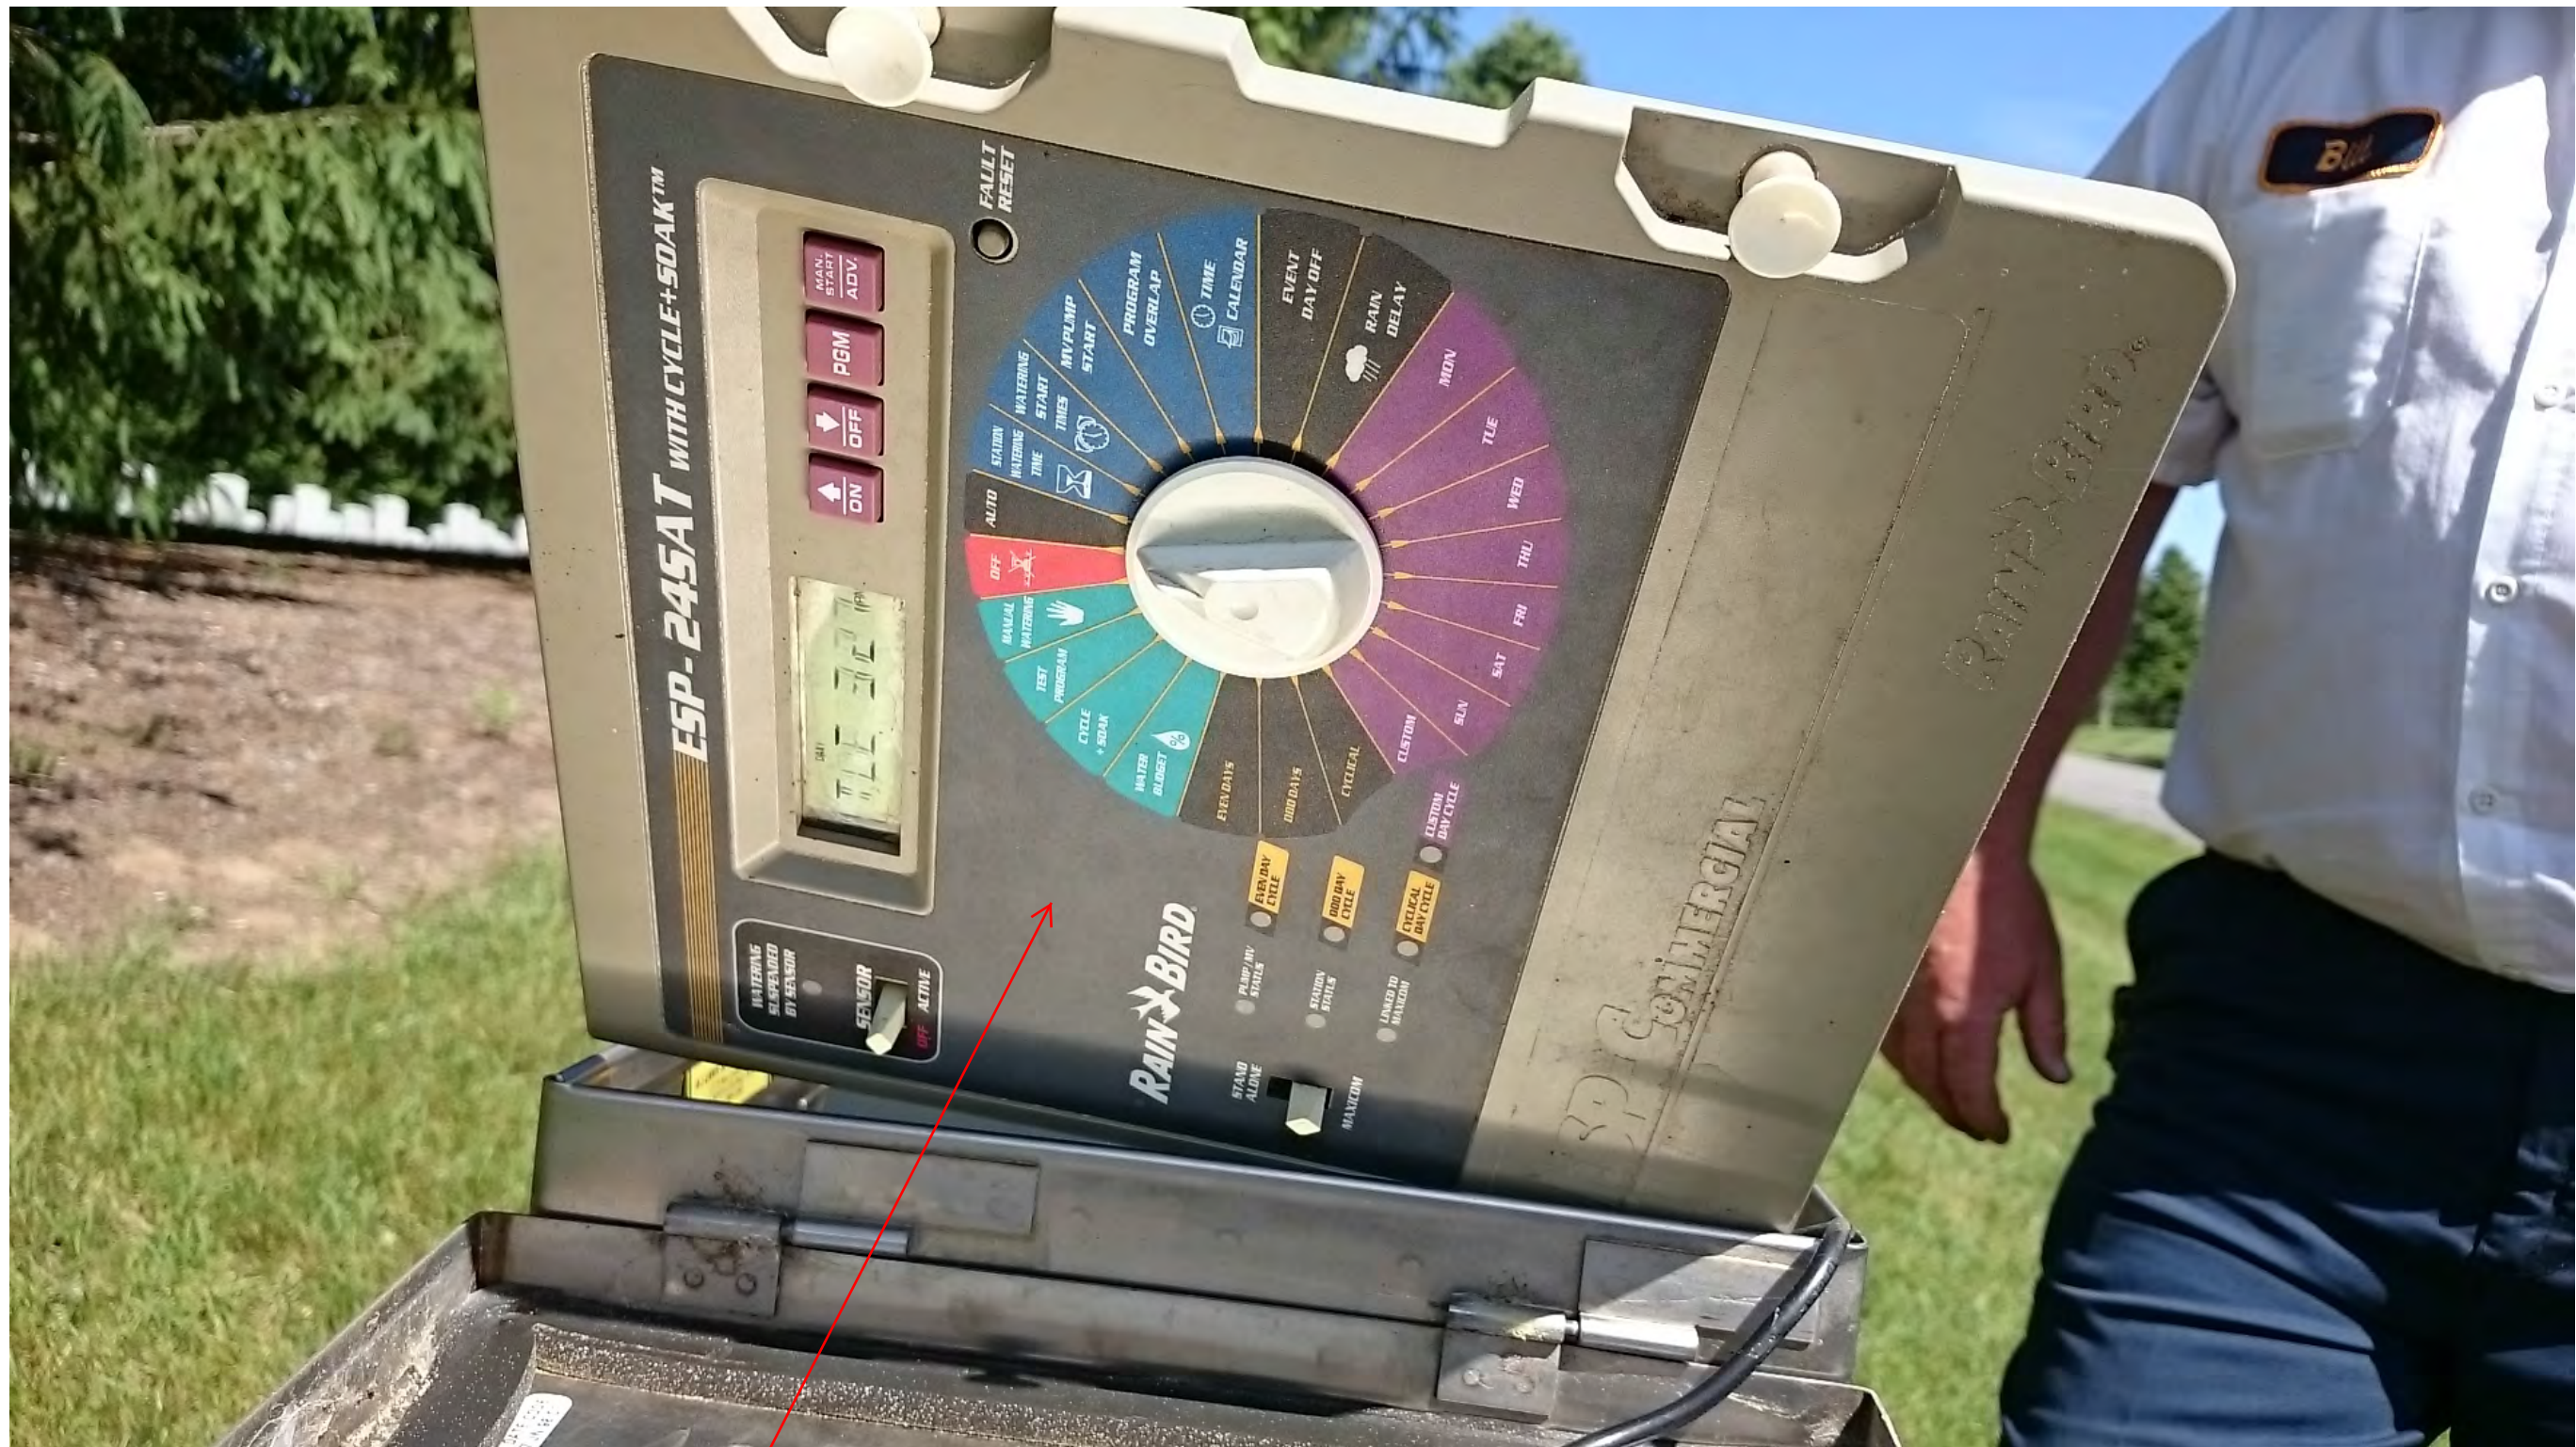
Details 2 and 3: Demolish existing graphical interface panel, circuitry, and all components including mainboard, antenna, and other electronics seen above. Install new to replace with a modern system and provide cemetery with a fully functional system.
