Building 36 - 1st Floor Abatements

PROJECT NO. 528A5-16-528

V.A. MEDICAL CENTER
CANANDAIGUA, NEW YORK 14810

Drawing Title
ASBESTOS ABATEMENT:
GENERAL NOTES

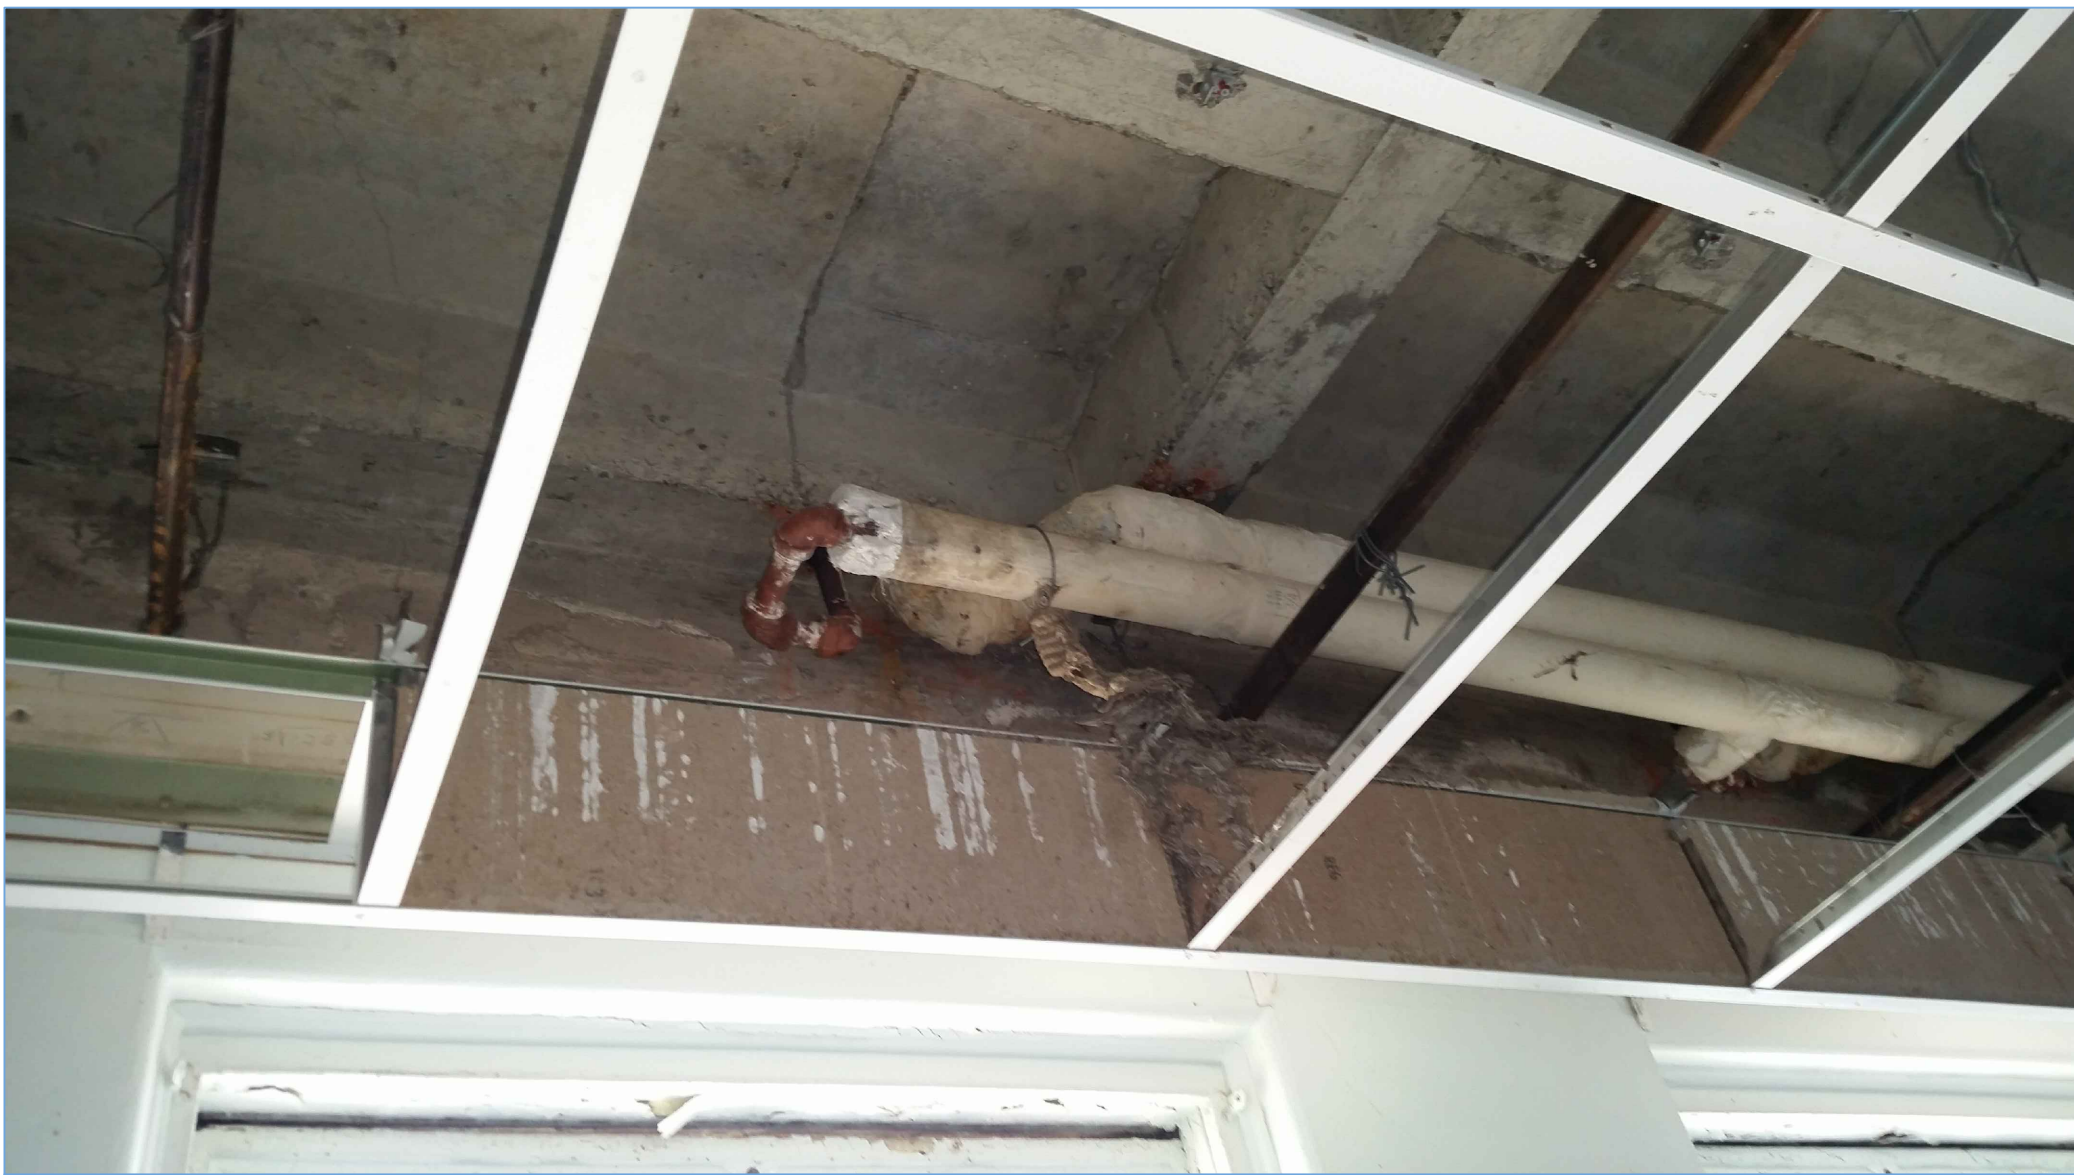
P3
NTS
ACM PIPING SYSTEM ABOVE CEILING ON EXTERIOR WALL

- 5. ACM PIPE WRAP, INSULATION AND MUDDIED FITTING MATERIALS LOCATED ABOVE THE CEILING PLENUMS SHALL BE ABATED
- 5.1. ACM PIPING WRAP, INSULATION AND MUDDIED FITTING MATERIAL LOCATED AT EXTERIOR WALL LOCATIONS SHALL BE ABATED AS FAR AS CAN BE REACHED WITHOUT DISTURBING THE EXTERIOR WALL SYSTEM.

- 5.2. IF THE ACM PIPING GOES INTO AN EXTERIOR WALL CHASE AND FULL REMOVAL IS NOT POSSIBLE WITH THE EXTERIOR WALL IN PLACE, THE REMOVAL END SHALL BE LAG WRAPPED WITH A CLEANABLE MATERIAL SO AS TO PERMIT LATER AGGRESSIVE CLEARANCE AIR SAMPLING PROCEDURES.

- 5.3. THEN EXTERIOR WALL CHASE OPENINGS SHALL BE SEALED WITH SPRAY FOAM INSULATION SO AS TO PERMIT LATER AGGRESSIVE CLEARANCE AIR SAMPLING PROCEDURES.
