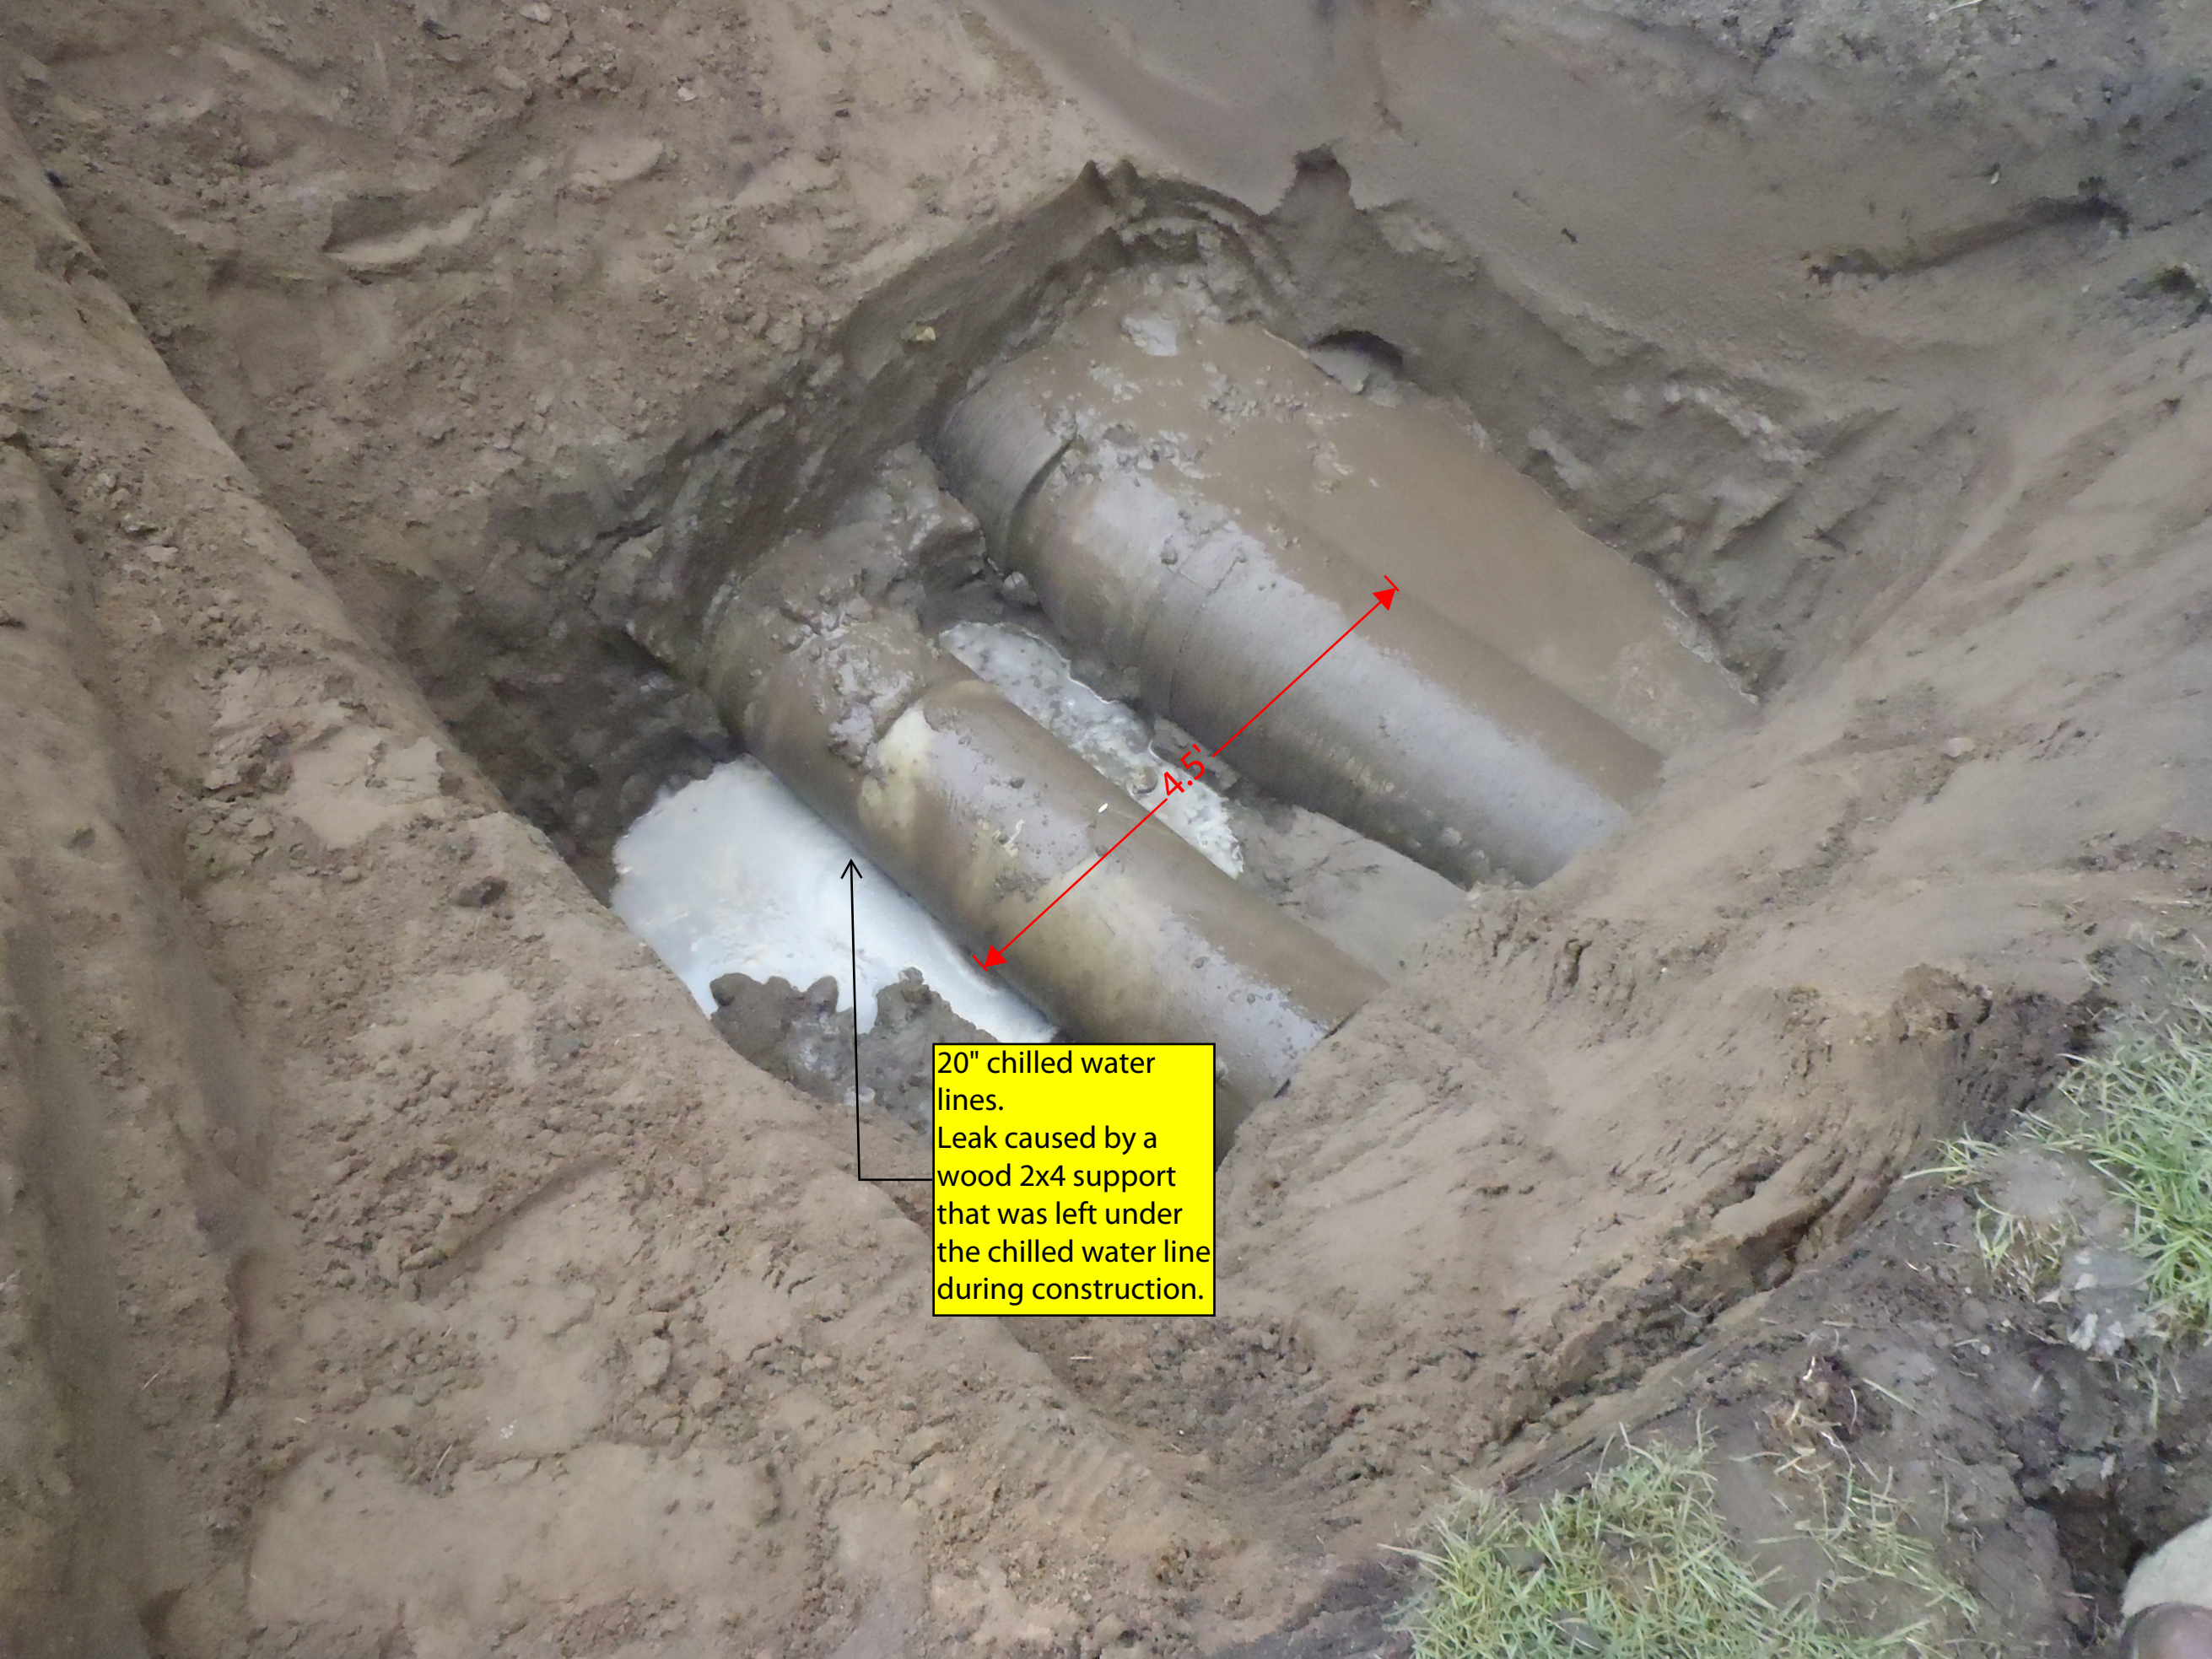
20" chilled water lines.
Leak caused by a wood 2x4 support that was left under the chilled water line during construction.
