Water Safety Program Assessment Report
for the
Edward Hines, Jr. VA Hospital

July 21, 2016

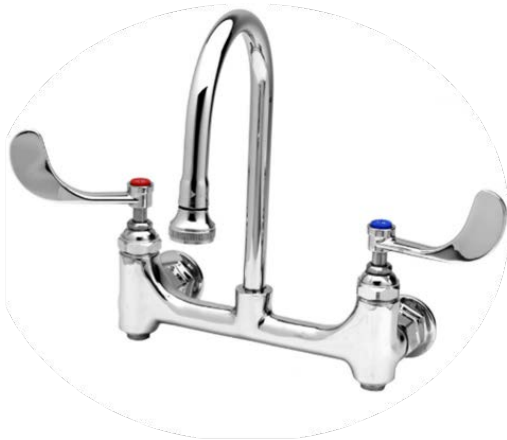
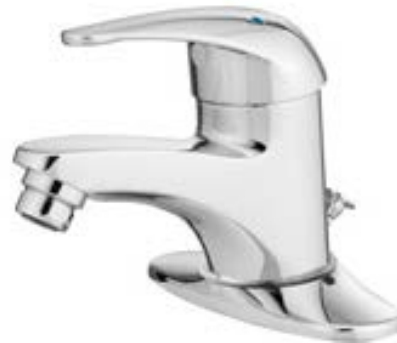
Hands-Free, Low-Flow faucets are for the majority of what is installed in patient care areas. These faucets allow for reduced risk of infection control (related to hand hygiene) and they greatly help conserve water consumption, but the Madison VA Hospital has found that these faucets have a higher risk of positive legionella. The hands-free faucets have more internal components which create a greater surface area for biofilm and Legionella growth. In addition, with the low-flow that comes with the hands-free faucets, there is not the proper circulation provided in areas to supply fresh water with the proper amount of chlorine. Also, with the low-flow fixtures, it is harder to keep proper temperatures (above 124°F for hot and below 67°F for cold) throughout the distribution lines.

- **Recommendation:** With prioritizing higher risk areas first, replace the hands-free, low-flow faucets with dual levered or other type of fixture. There are multiple types and you can research on what would best suit your needs. See pictures below:
