Storm Shutter Medic

December 31, 2015

Following are things we did and observed with the shutters we repaired:

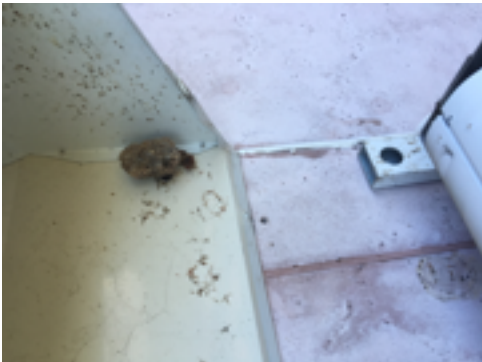
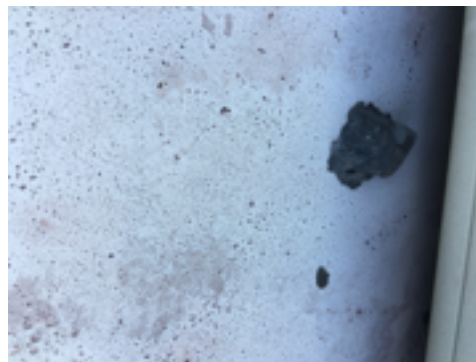
1. All shutters had wasp nest and mud dubbers that were cleaned out.

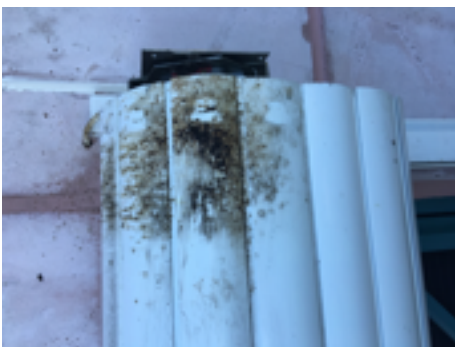
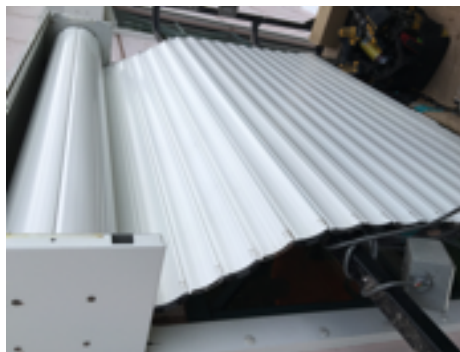
2. All shutters were hand cleaned and lubricated.

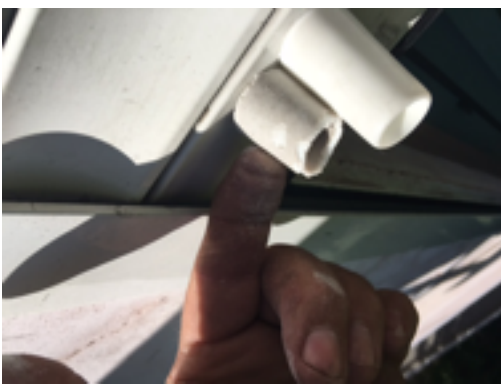
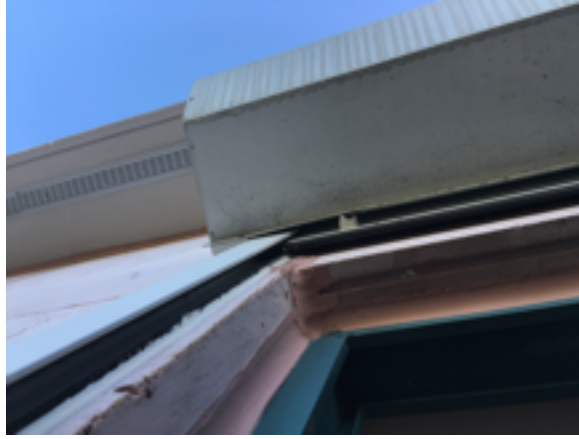
3. One of the biggest problems we found are the up-stops they were brittle and breaking or broken off. The function of the up-stops are to not allow the bottom slat to go up into the hood and run out of the track. Picture shown are new up-stops compared to broken one. Second picture is showing how it's going into the hood since it's half broken.

In conclusion, the main building's slats, hoods, tracks, and reels are in good condition. What needs to be changed in the other shutters are the majority of up-stops, switches, possible motors and overrides that are broken because of excessive cranking when jammed. Overrides should only be used in a power outage, or bad motor. They also all need to be cleaned and lubricated.

In building 47 the slats, hoods, tracks and reels are in good condition from what we have seen so far. They all need up-stops except the ones we replaced. This will correct the cranking it up manually. The cranking it down will be resolved with removing the slat hangers and attaching the top slat directly to the reel like main building. We also need to check all motors in that building. They also need to be cleaned and lubricated.

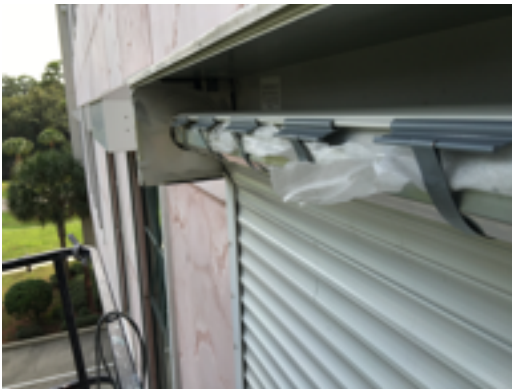
8. We found motors that were 520's and 540's these motors are not as strong to pull these shutters up and should have 550's in them. We changed out the ones that were really weak.

9. We found something we have never seen before. The wrapping was left on the reels. We don't know why they left that in there but this causes the guides to be jammed up and also slat hang ups. We removed all the wrapping in the ones we repaired.

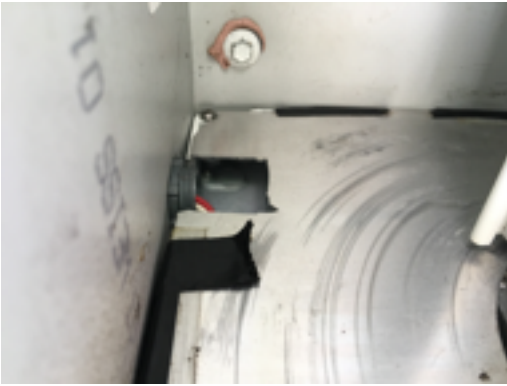
10. Safety plates were cut extremely deep and didn't need to be cut that extensive to go around the wire fitting at the top of the hood. You can tell by the marks on the sides of the safety plates that it was poor craftsmanship.

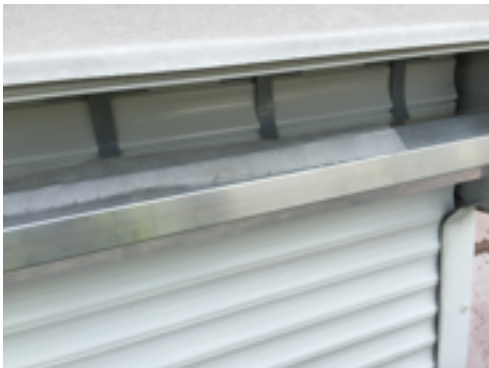
11. The slat hangers are bending backwards when cranking the override down to far from the inside you do not know when to stop. Our suggestion would be to remove the slat hangers and screw the top slat to the reel like they are in the main building.
