**VRG SERVICES, LLC**  
SERVICE DISABLED VETERAN OWNED BUSINESS

Prepared For:  
U.S. DEPT. OF VETERANS AFFAIRS  
10000 BAY PINES BLVD.  
BAY PINES, FLORIDA 33744

**SAMPLE LOCATION PLAN**  
BAY PINES VA BUILDING 100  
ROOMS 5C-119-123  
10000 BAY PINES BLVD.  
BAY PINES, FLORIDA 33744

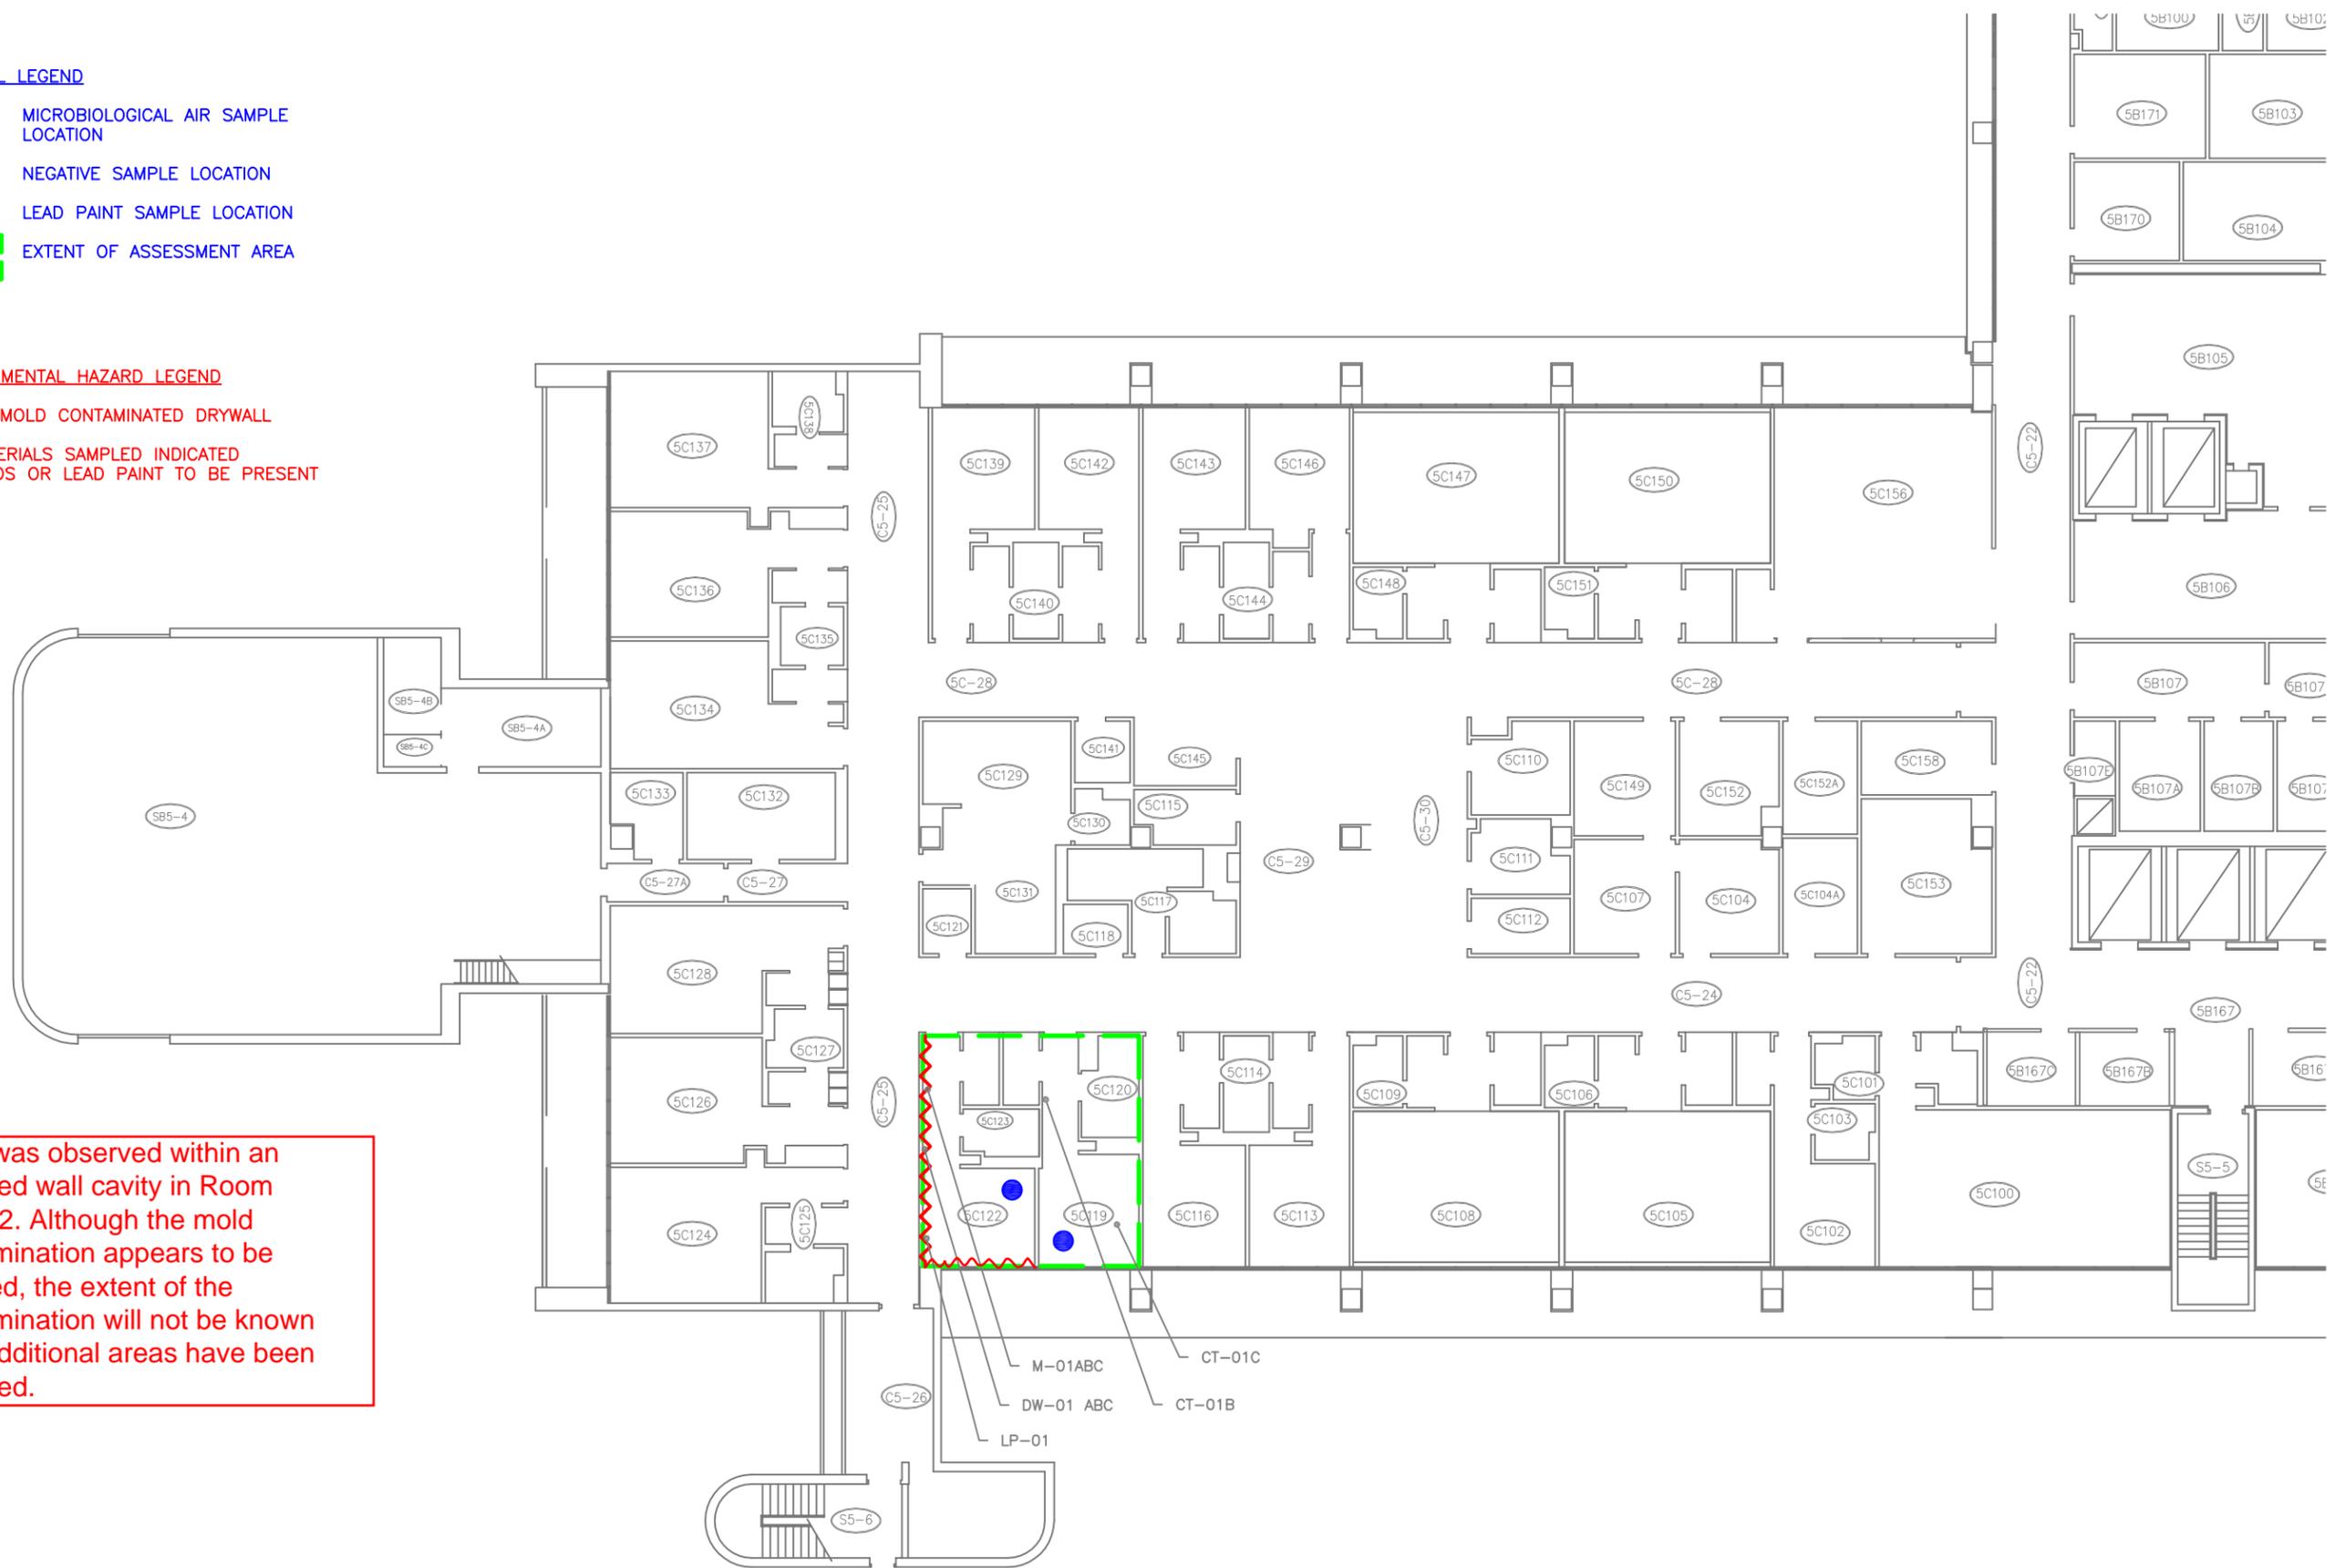
| SHEET<br><b>AS-1</b><br>OF 1 SHEET(S) |

- ~ MOLD CONTAMINATED DRYWALL
- NO MATERIALS SAMPLED INDICATED ASBESTOS OR LEAD PAINT TO BE PRESENT

Mold was observed within an exposed wall cavity in Room 5C-122. Although the mold contamination appears to be isolated, the extent of the contamination will not be known until additional areas have been exposed.
