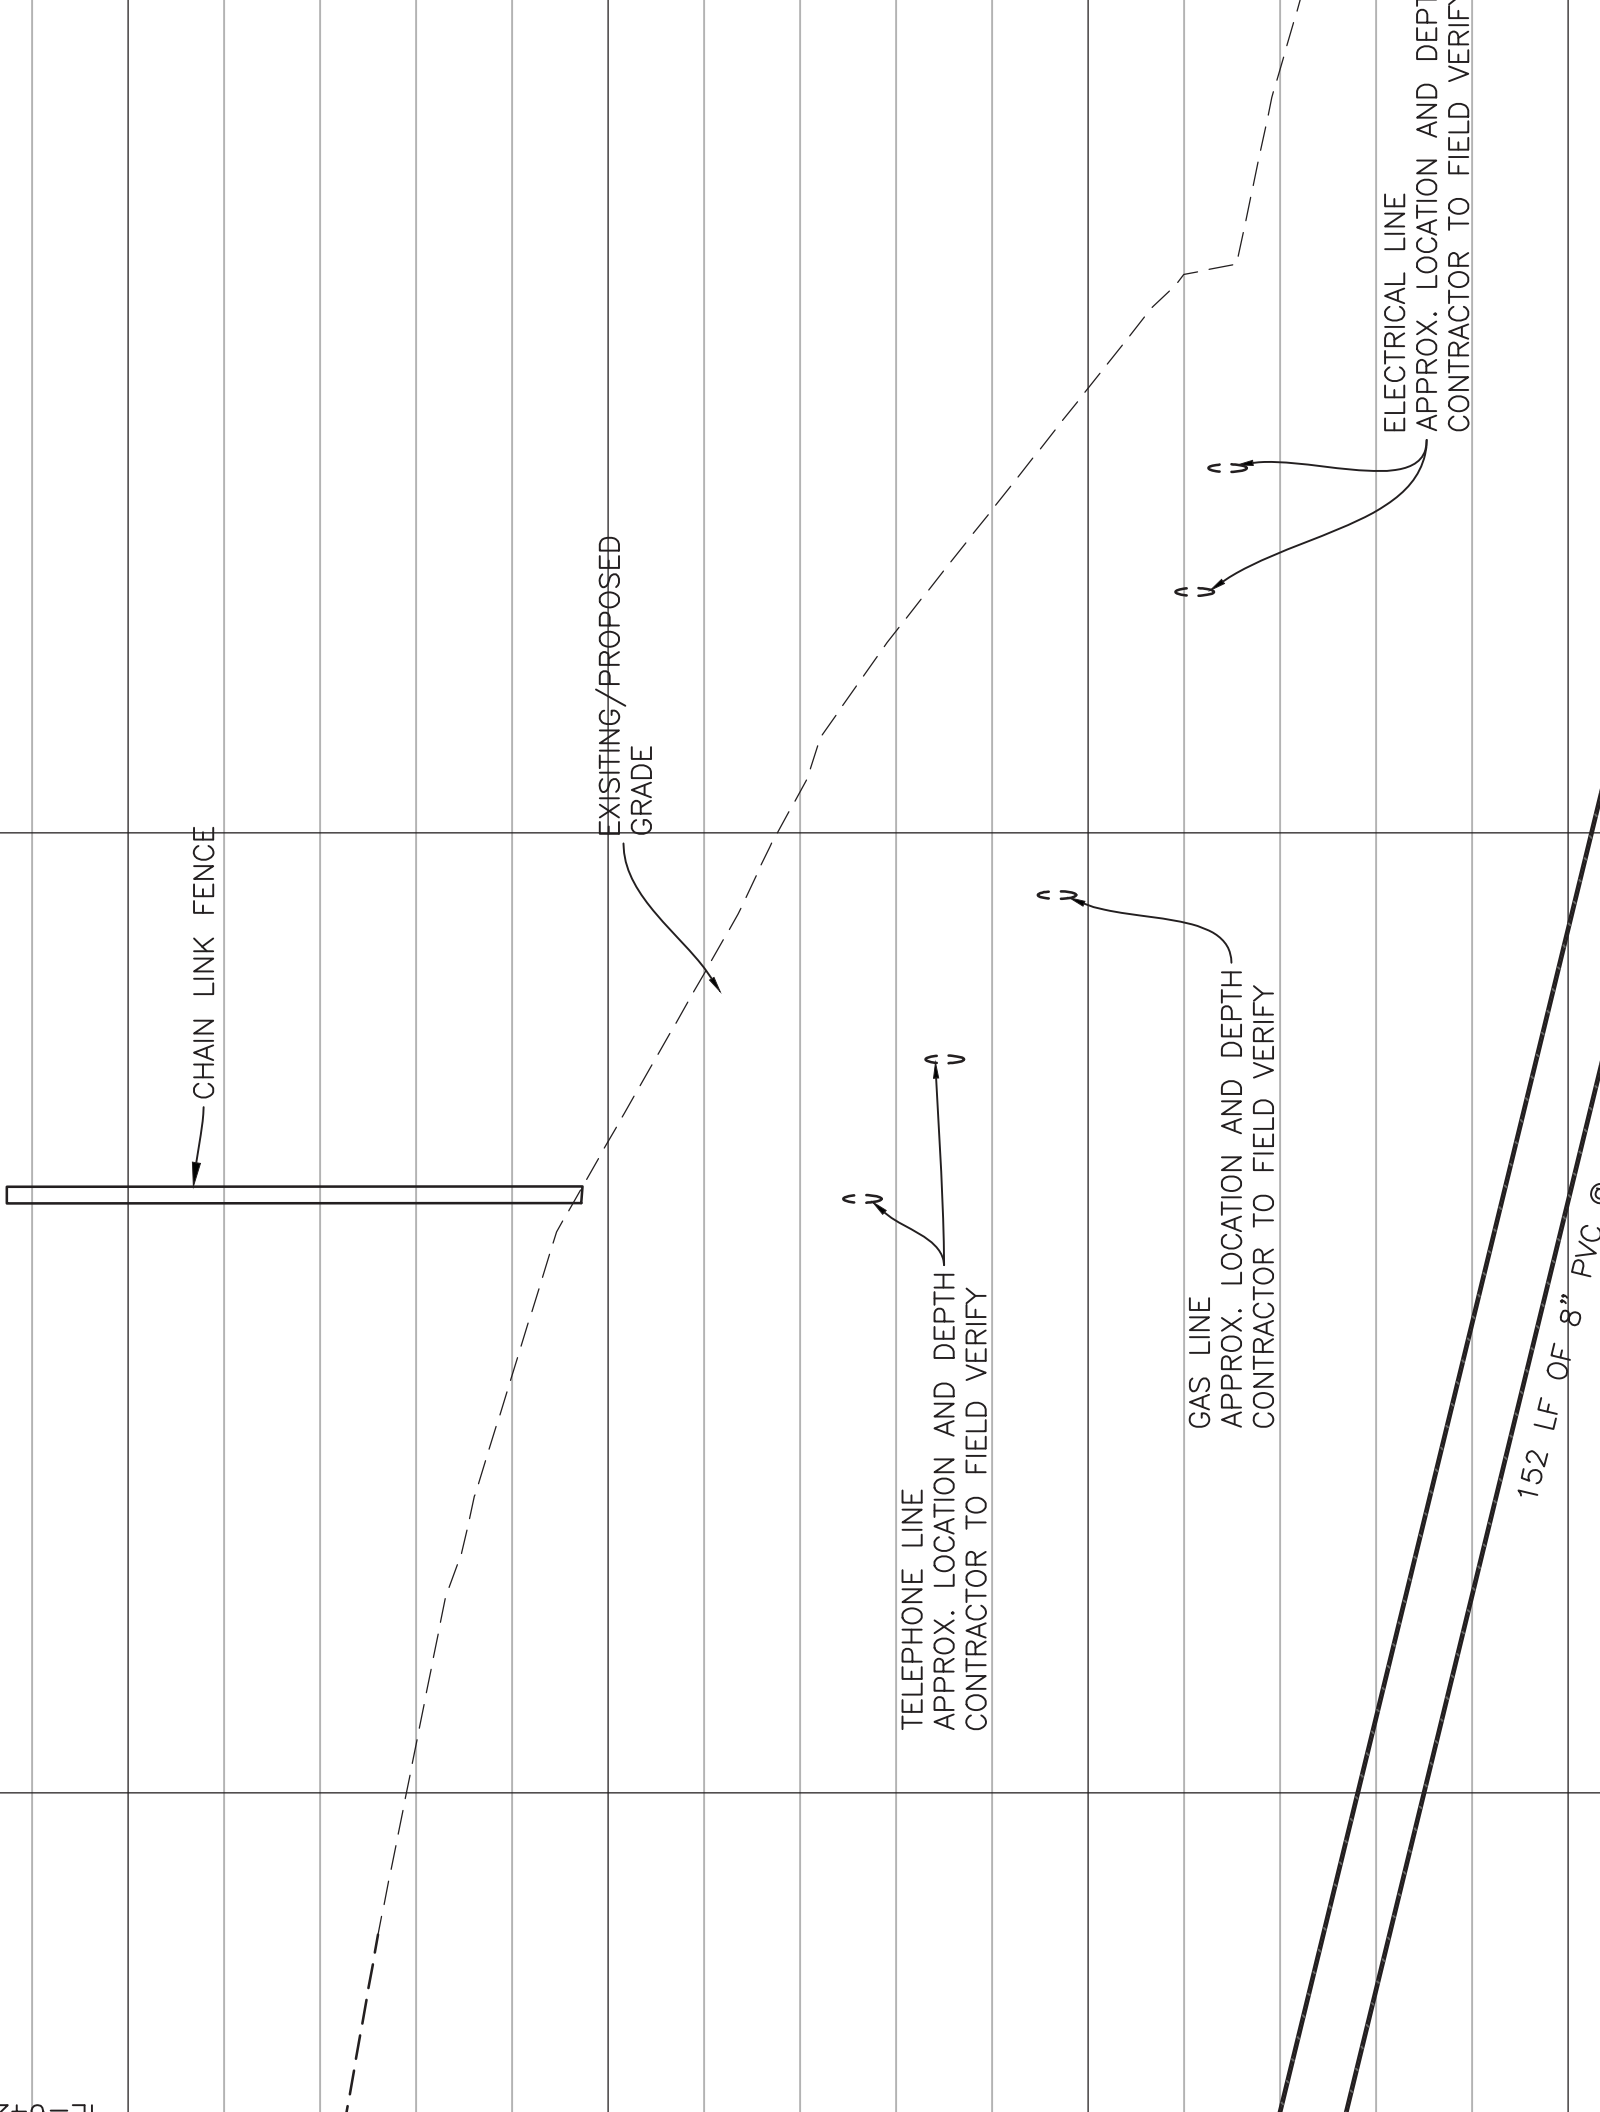
APPROX. LOCATION AND DEPTH  
CONTRACTOR TO FIELD VERIFY

152 LF OF 8" PVC

SS-7036 MANHOLE  
RE=636.77  
IE=631.77 (E)  
IE=631.77 (W)

.47%

EX. 15" VCP

SS-7042 MANHOLE  
RE=627.08  
IE=615.13 (E)  
IE=615.38 (W)  
IE=622.83 (S)

SS-7203 MANHOLE  
RF=637.00  
IE=617.93 (S)  
IE=617.93 (N)

IE=618.91 (W)  
IE=618.91 (NE)  
IE=620.56 (SE)
