Revisions	Date	VA WESTERN NEW YORK HEALTHCARE SYSTEM 3495 BAILEY AVENUE BUFFALO, NEW YORK 14215	CLINICAL ENGINEERING	DATE	ENGINEERING MANAGER	DATE	Drawing Title DETAILS	Project Title 2018 ROOF REPLACEMENTS	Date MARCH 8, 2018	
			INFECTION CONTROL	DATE	CARELINE MANAGER	DATE				
			SAFETY OFFICER	DATE	CHIEF OF STAFF	DATE				
			Medical Center Director	DATE	Associate Medical Center Director	DATE				
							Building Number 1	Checked RLR	Drawn RLR	Station No. 528
							Location V.A.M.C. BUFFALO, NEW YORK		18-S43-A104

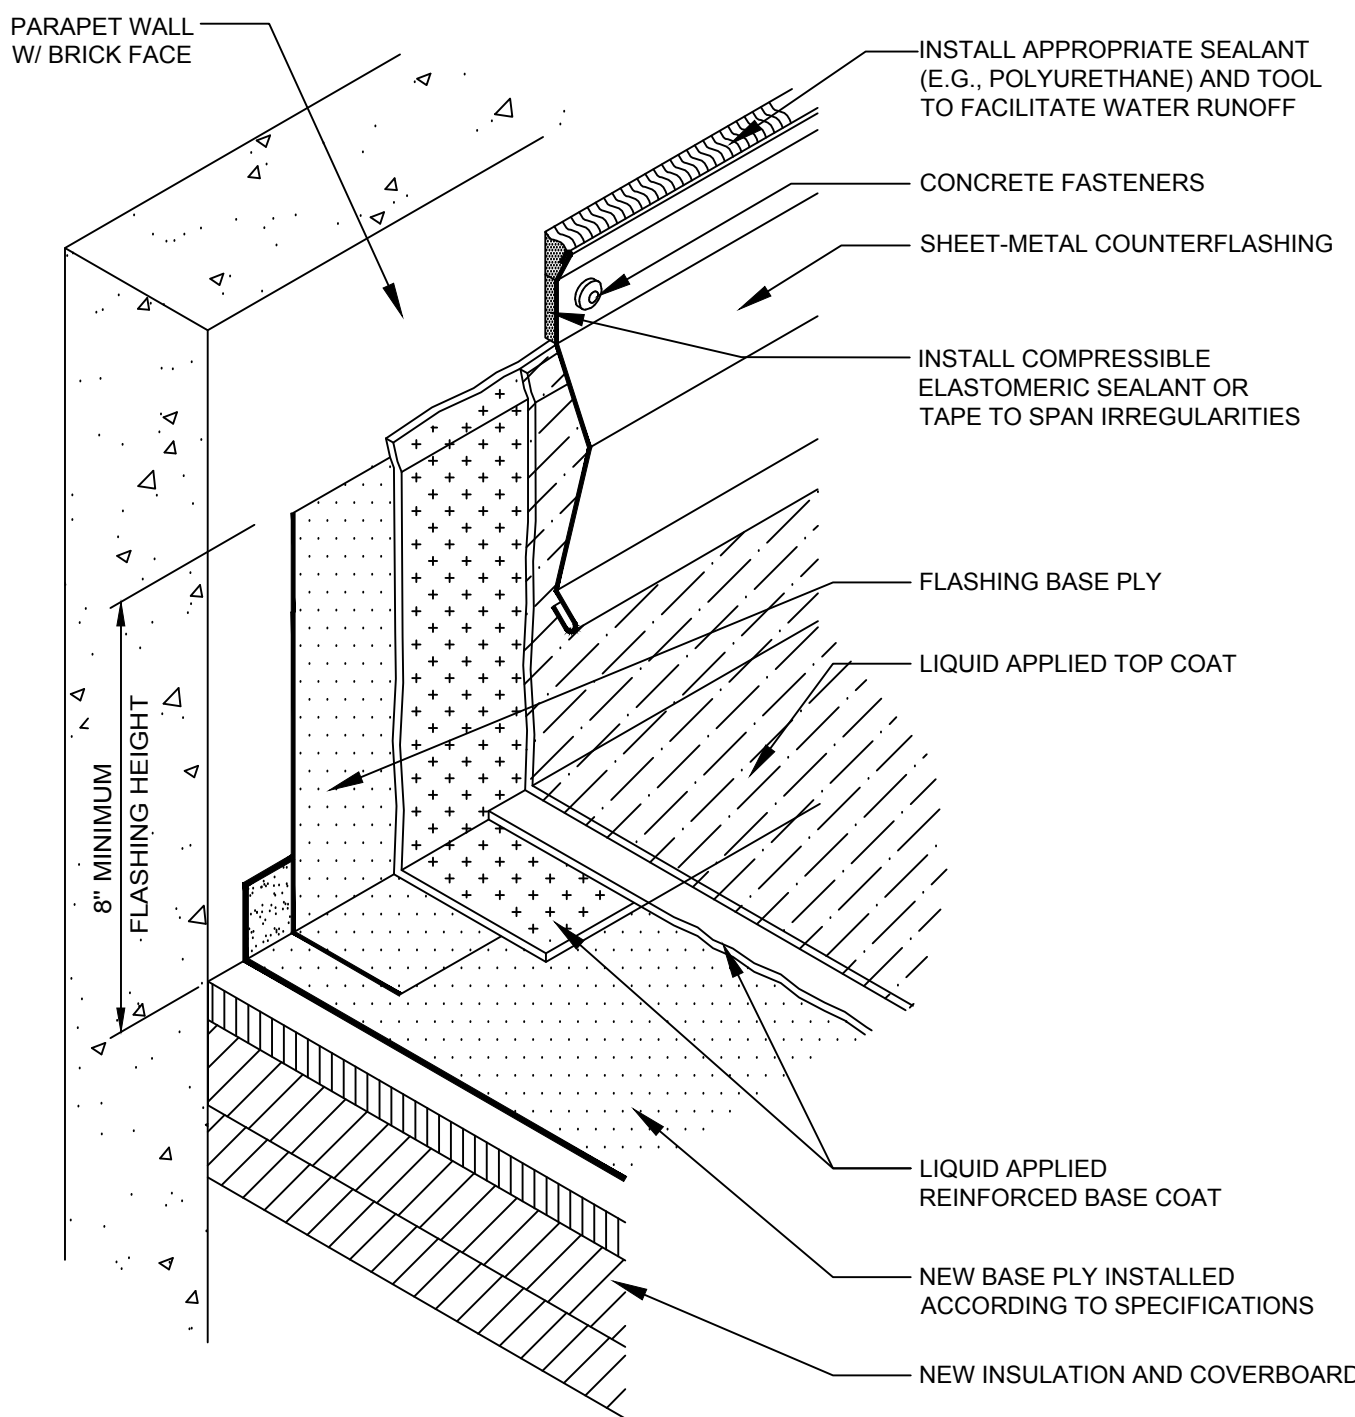
11A PARAPET DETAIL
NO SCALE

- NOTES
1. PRIME THE SUBSTRATE . FOLLOW SPECIFICATIONS AND MANUFACTURER RECOMMENDATIONS.
 2. REINFORCEMENT MUST BE FULLY SATURATED OR ENCAPSULATED IN BASE COAT AS DESCRIBED IN SPECIFICATIONS.
