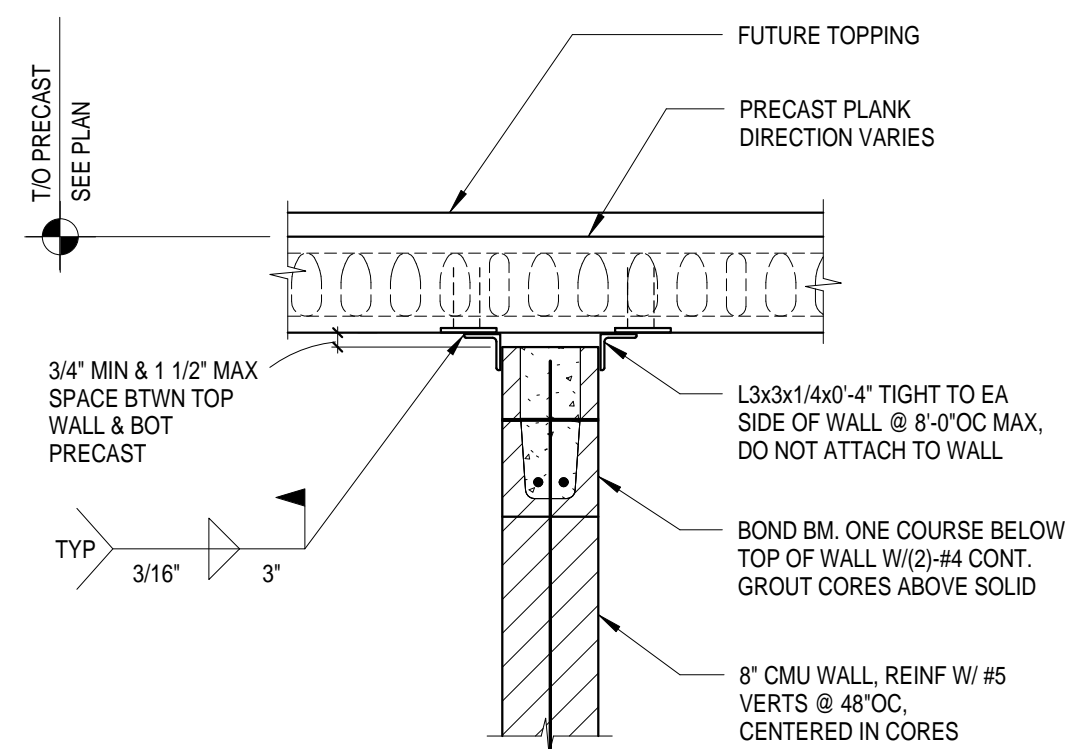
2 NON-BRG CMU LATERAL WALL SUPPORT BELOW PLANK TOPPED  
3/4\"/>

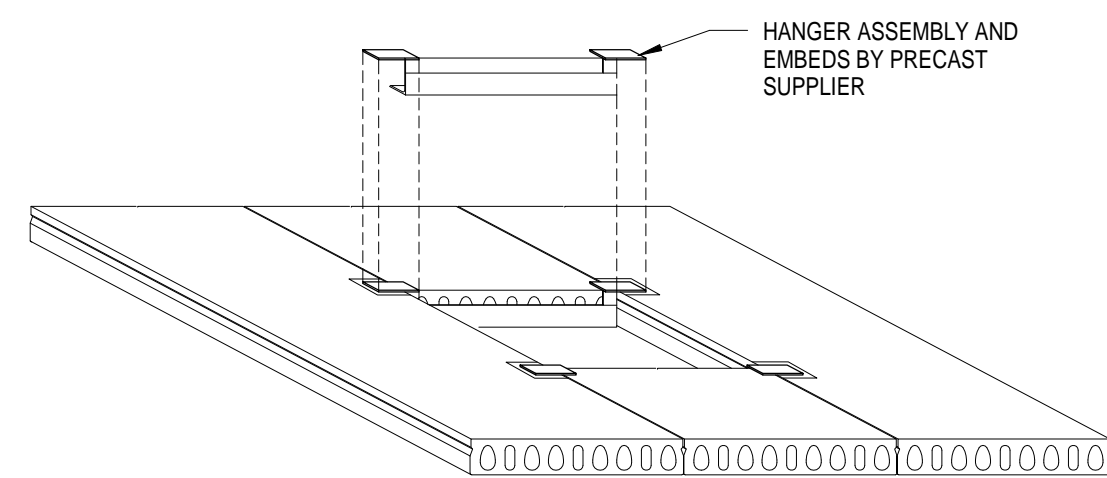
3 TYP PRECAST PLANK OPENING  
3/4\"/>

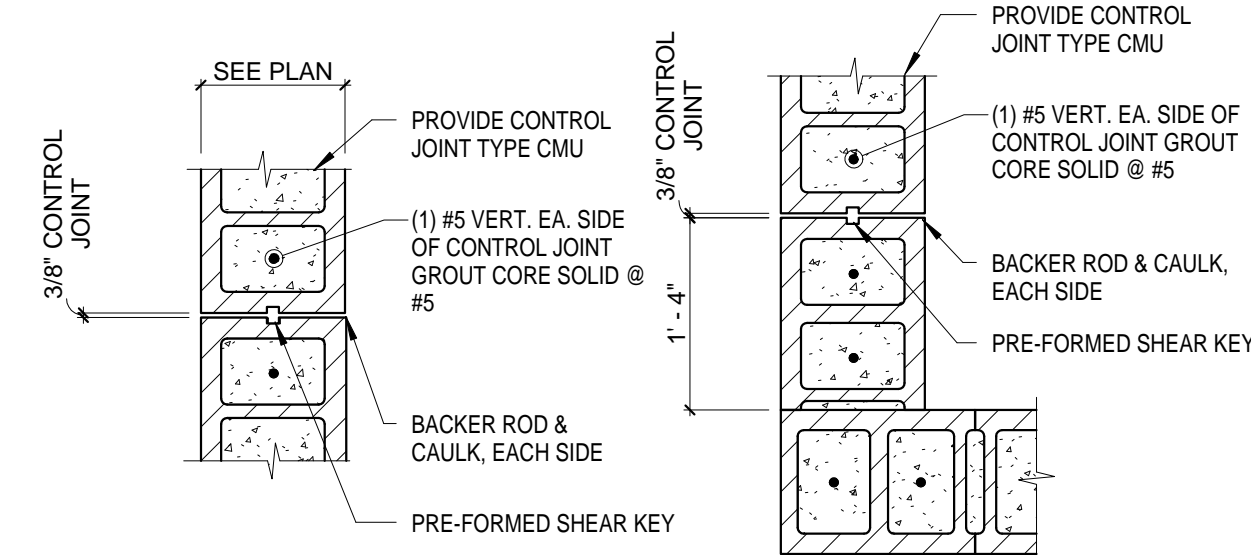
TYP. CONDITION

CORNER CONDITION

4 TYP CMU CONTROL JOINTS  
3/4\"/>

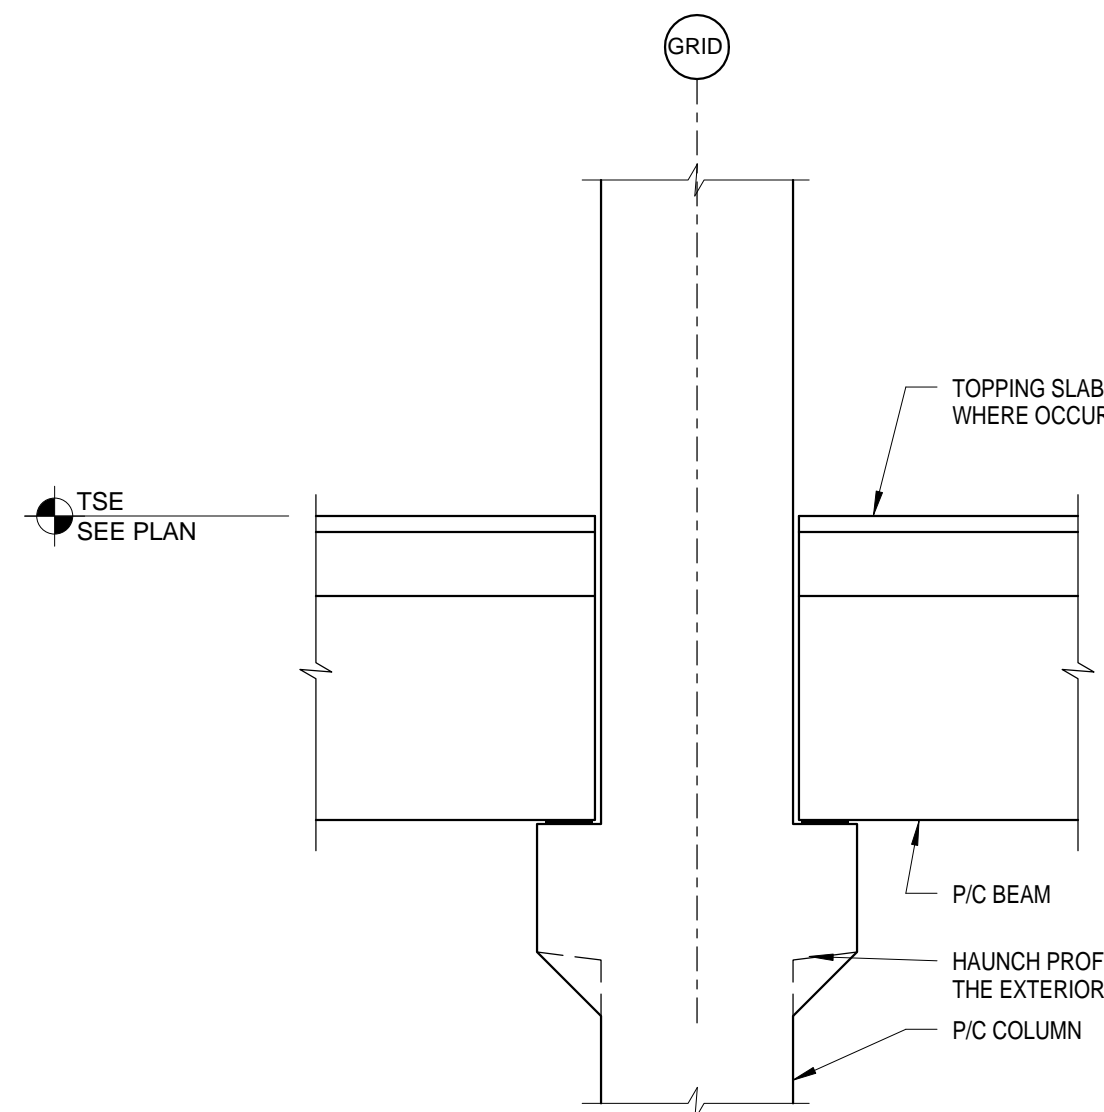
5 TYP PRECAST COLUMN  
1/2\"/>

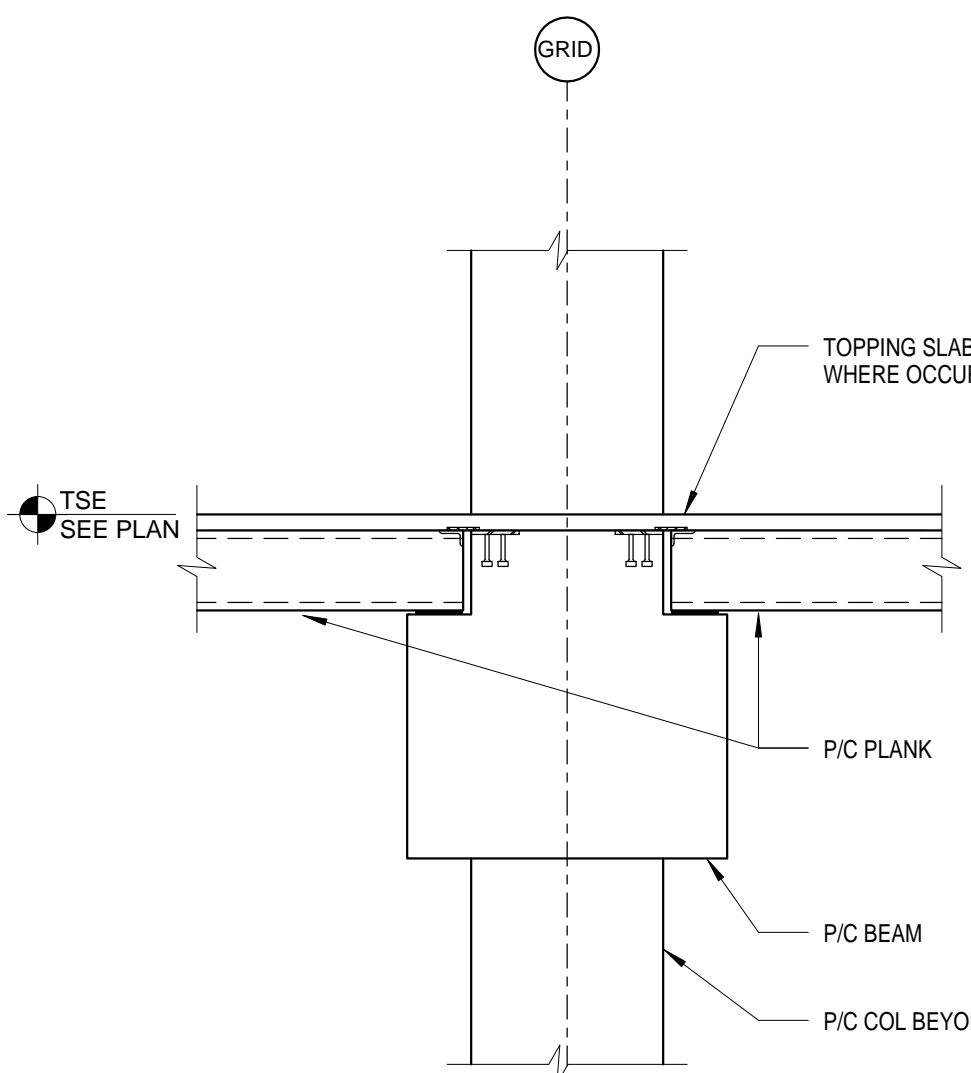
6 SOLID PRECAST SLAB BEARING  
1/2\"/>

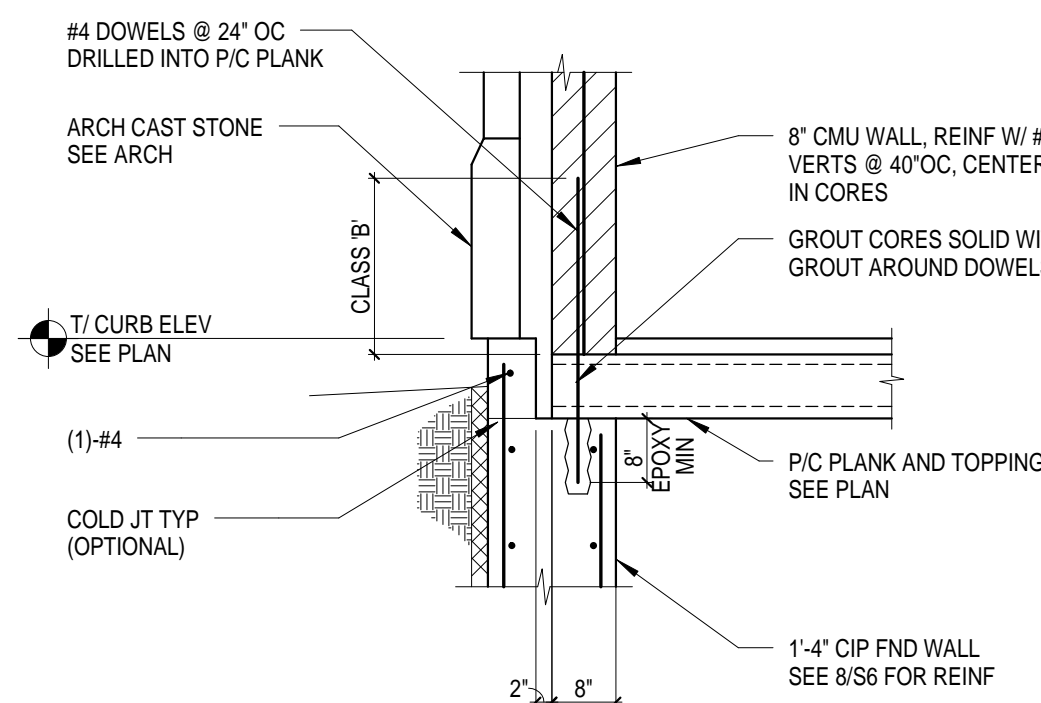
7 TYP EXTERIOR FND WALL  
1/2\"/>

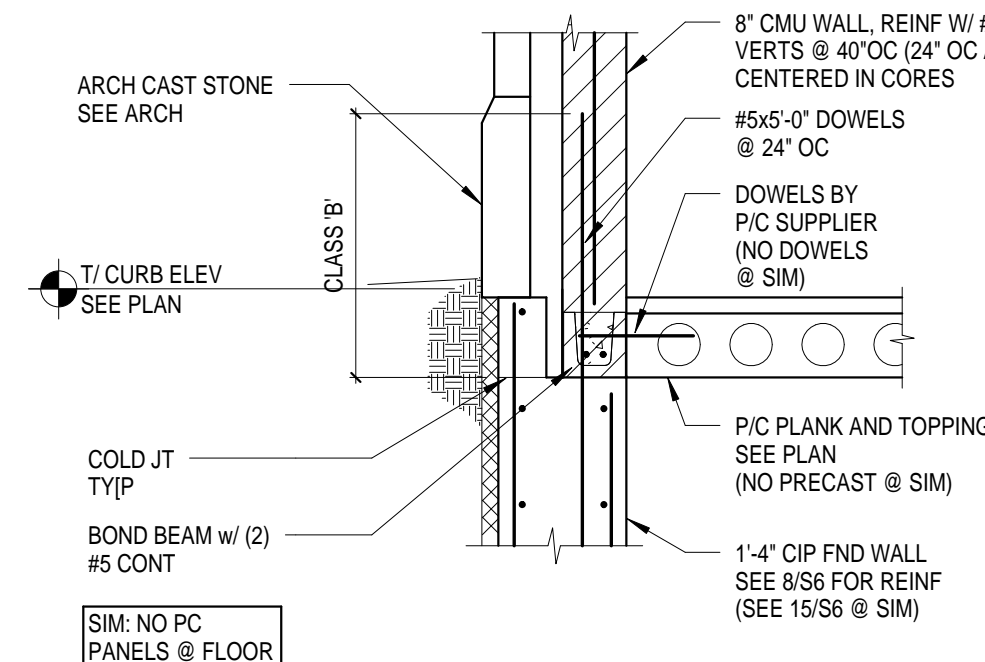
8 TYP EXTERIOR FND WALL  
1/2\"/>

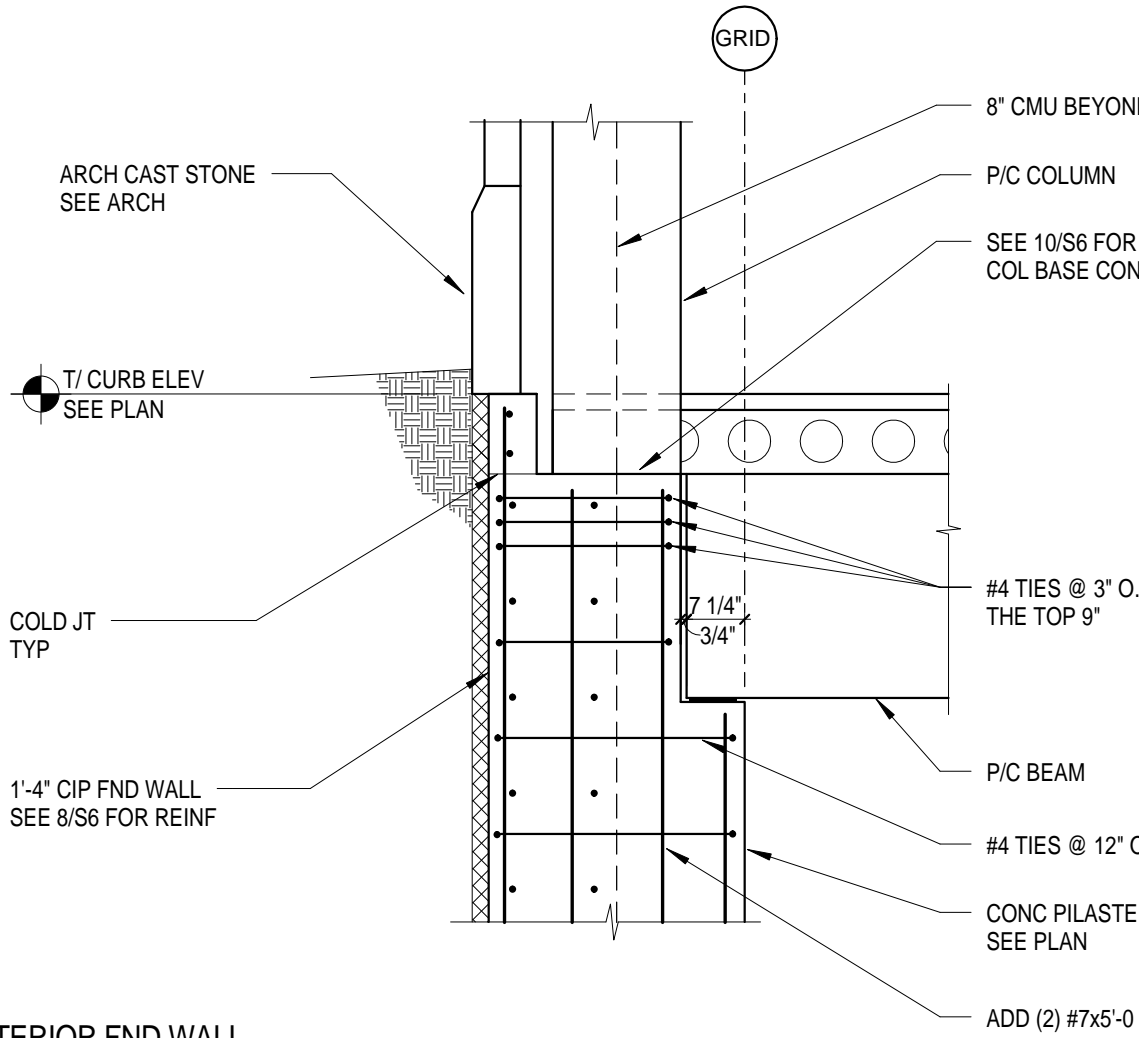
9 TYP EXTERIOR FND WALL  
1/2\"/>

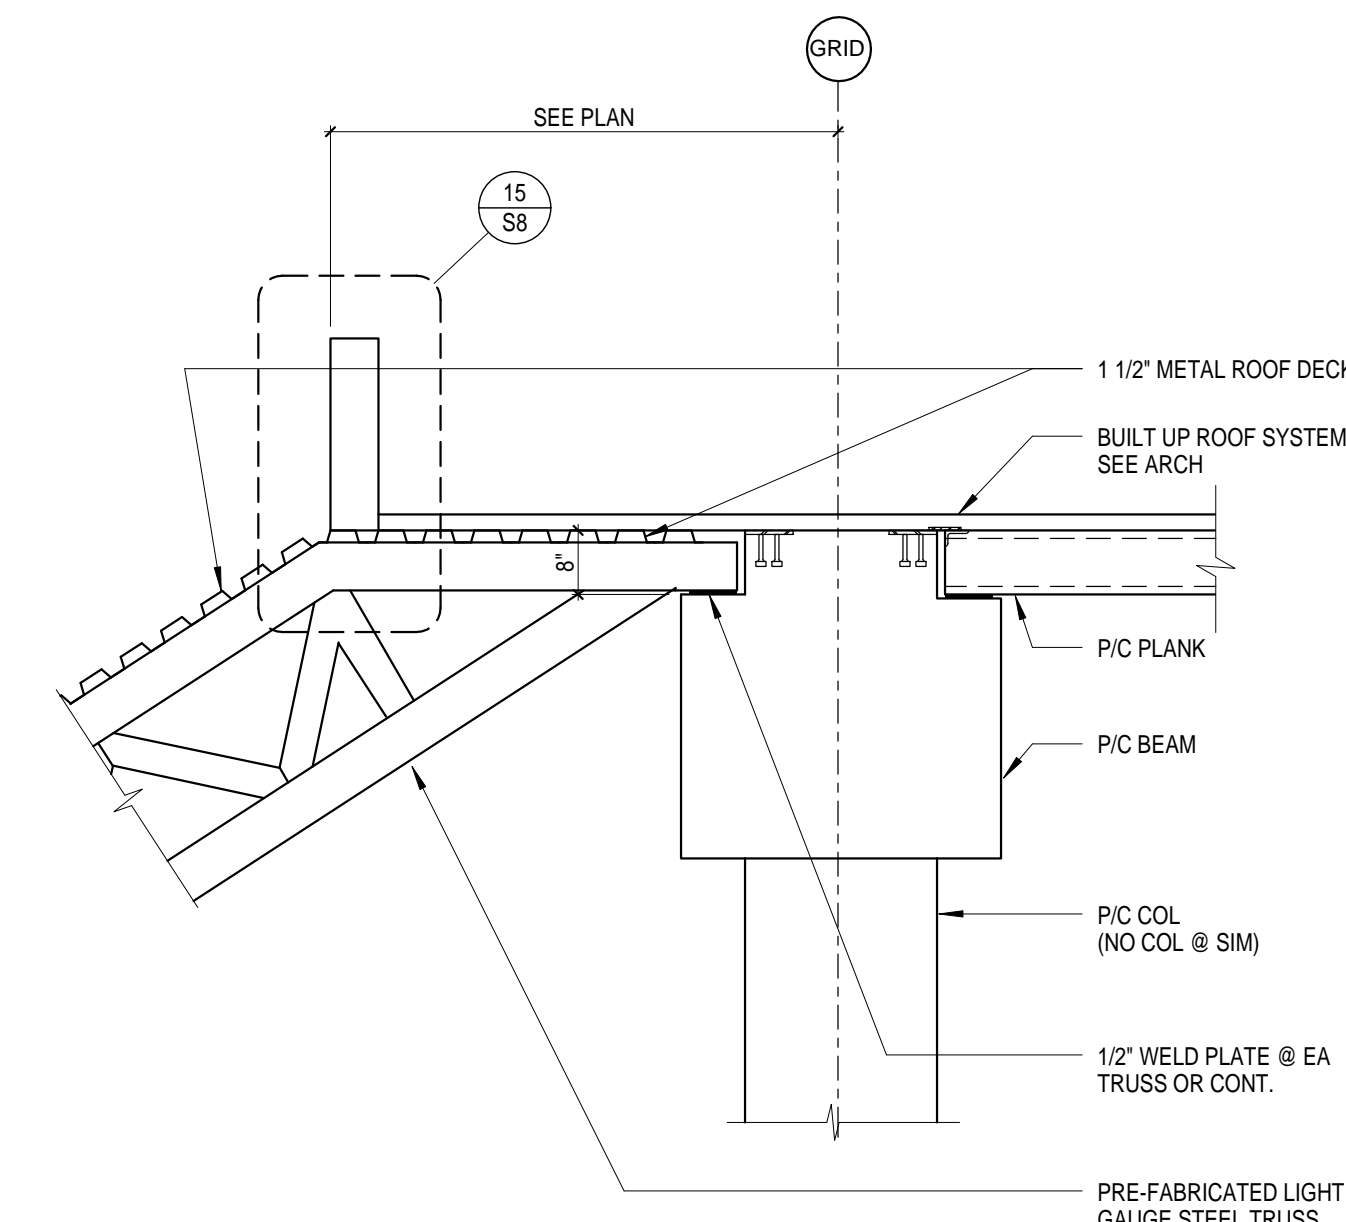
10 SOLID PRECAST SLAB BEARING  
1/2\"/>

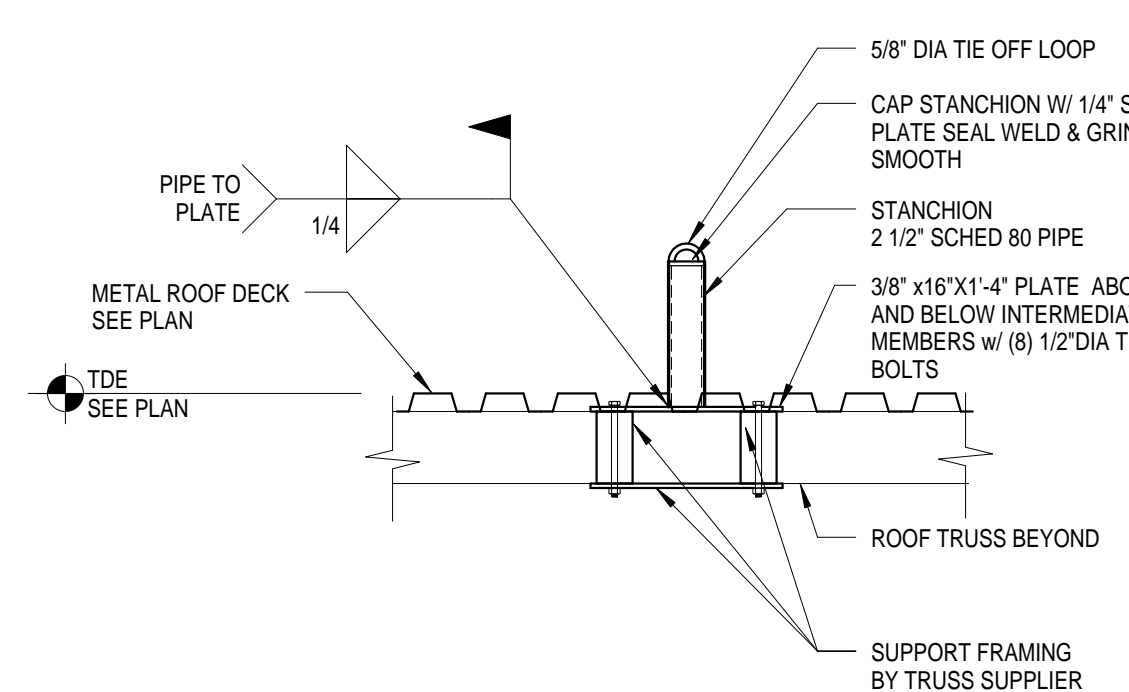
13 ROOF TIE OFF DETAIL  
3/4\"/>

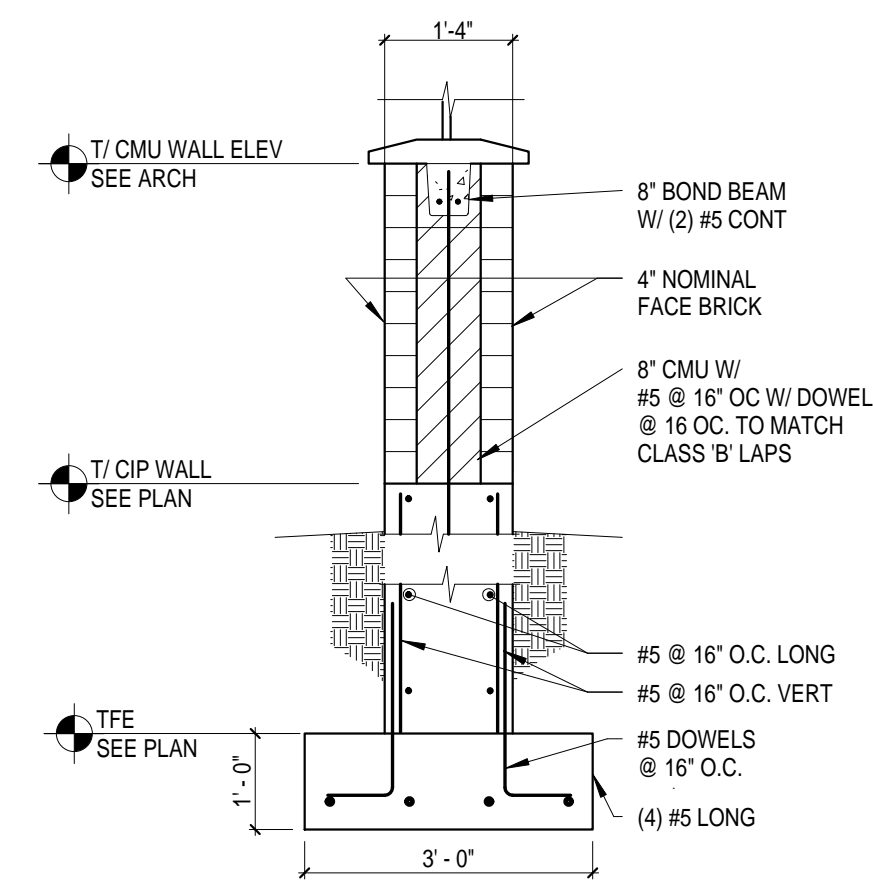
14 EXTERIOR COURT YARD PIER FOUND  
1/2\"/>

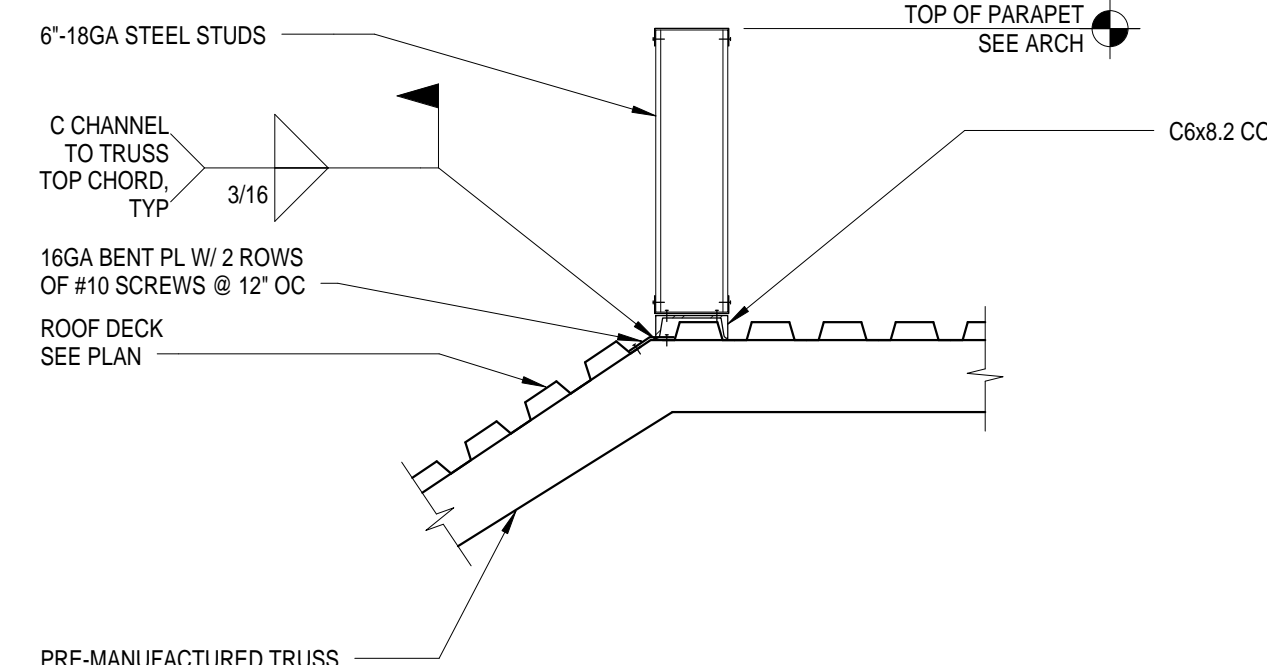
15 TYPICAL PARAPET CONNECTION  
3/4\"/>
