Drawing Title
ASBESTOS ABATEMENT ITEM TABLES & STANDARD DETAILS

Project Title
STEAM TRAP MONITORING, INSULATION AND PIPING UPGRADES

Location
VAMC - WADE PARK

Project Number
541-12-115
Building Number
1
Drawing Number
1-AA1
1 OF 1

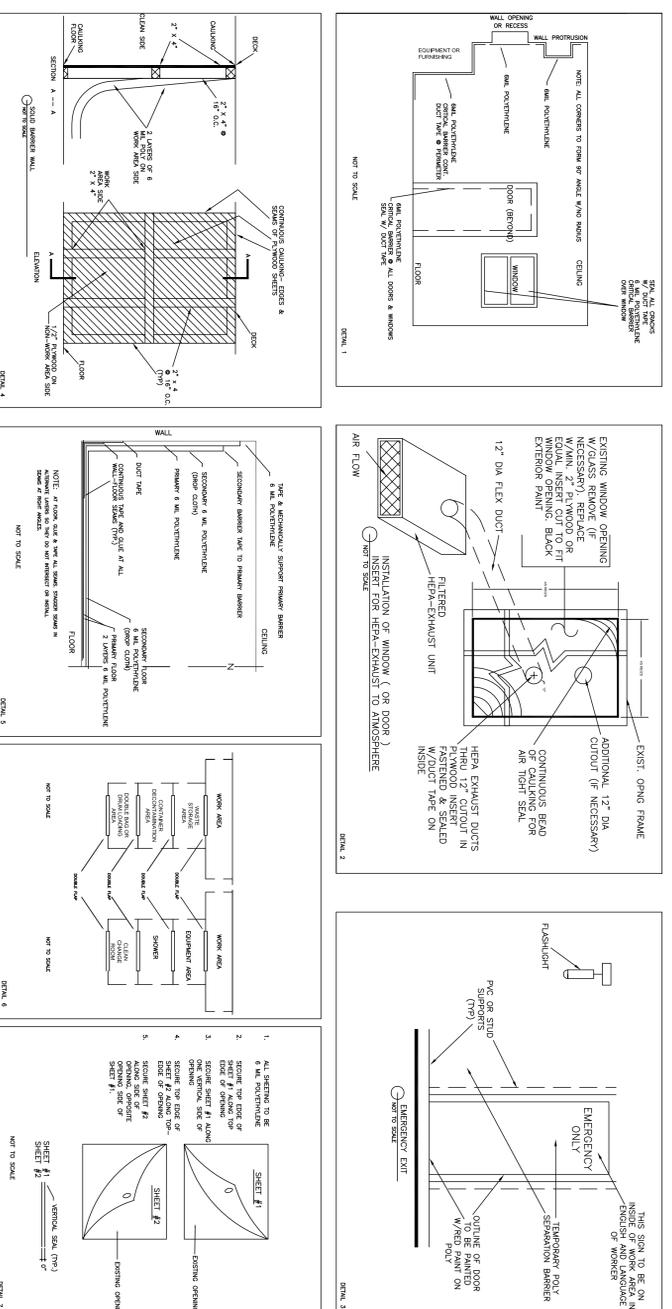
STANDARD ASBESTOS ABATEMENT DETAILS

- NOTES:**
- (1) MAINTAIN STAFF AND PUBLIC SPACE THROUGHOUT PROJECT. ALL WORK SHALL BE COMPLETED DURING OFF-HOURS. CEILING GRIDS AND TILES SHALL BE REINSTALLED EACH DAY FOR REGULAR HOURS.
 - (2) INSTALL 6 MIL. POLYETHYLENE DROP CLOTH BELOW PIPE INSULATION JOINTS TO AT LEAST 6 FEET FROM INSULATION JOINTS TO PREVENT ASBESTOS REMOVAL.
 - (3) INSTALL THREE STAGE PDF AND W/DEE DECONTAMINATION UNITS (SEE SPECIFICATIONS SECTION 028213.13) IF REQUIRED BY OSHA.
 - (4) REMOVE AND DISPOSE OF ASBESTOS-CONTAINING PIPE INSULATION AND/OR PIPE INSULATION JOINTS IN ACCORDANCE WITH APPLICABLE PROVISIONS OF SECTION 028213.13 OF SPECIFICATIONS.
 - (5) SEE DETAILS THIS PAGE.
